# 1 & 2 Holystone Grange Cottages

Holystone, Morpeth, Northumberland, NE65 7AN

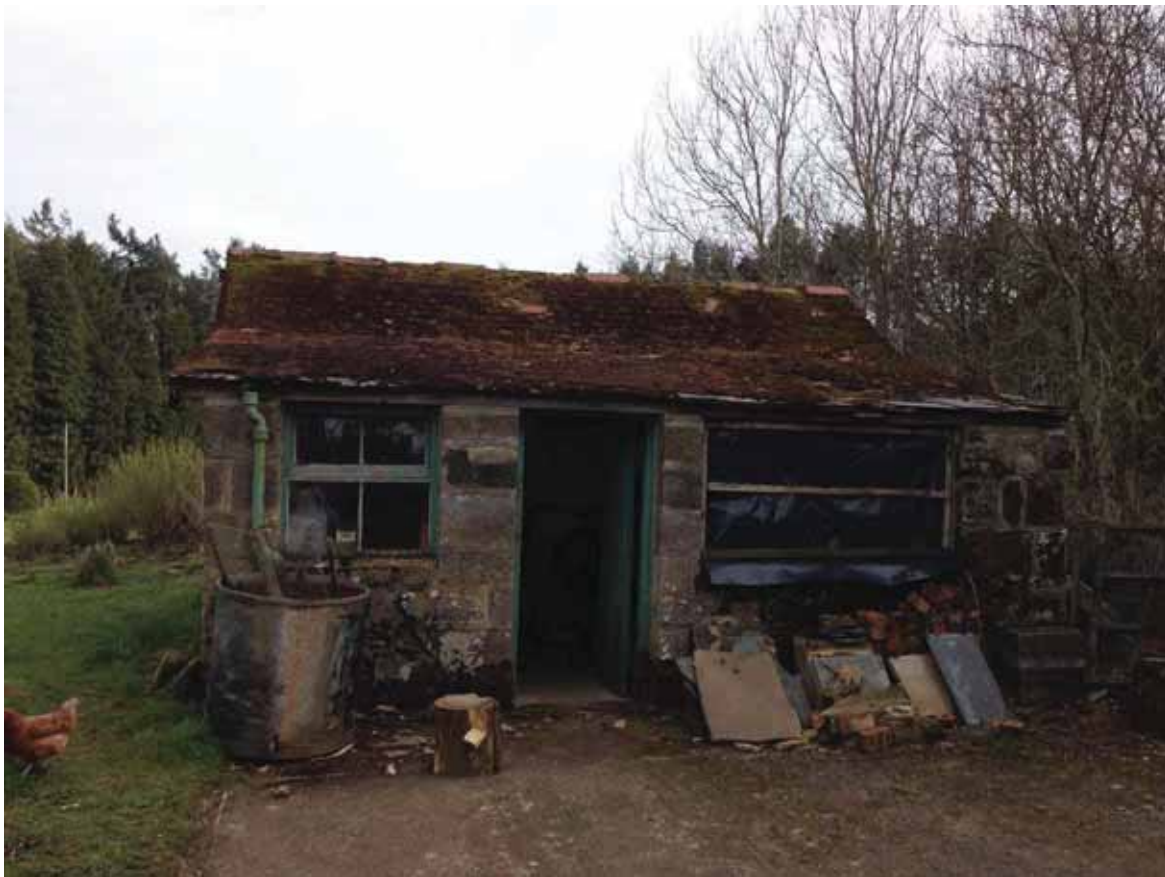
North elevation showing a heavy moss covering to the roof along with defective and missing timber elements to the openings.

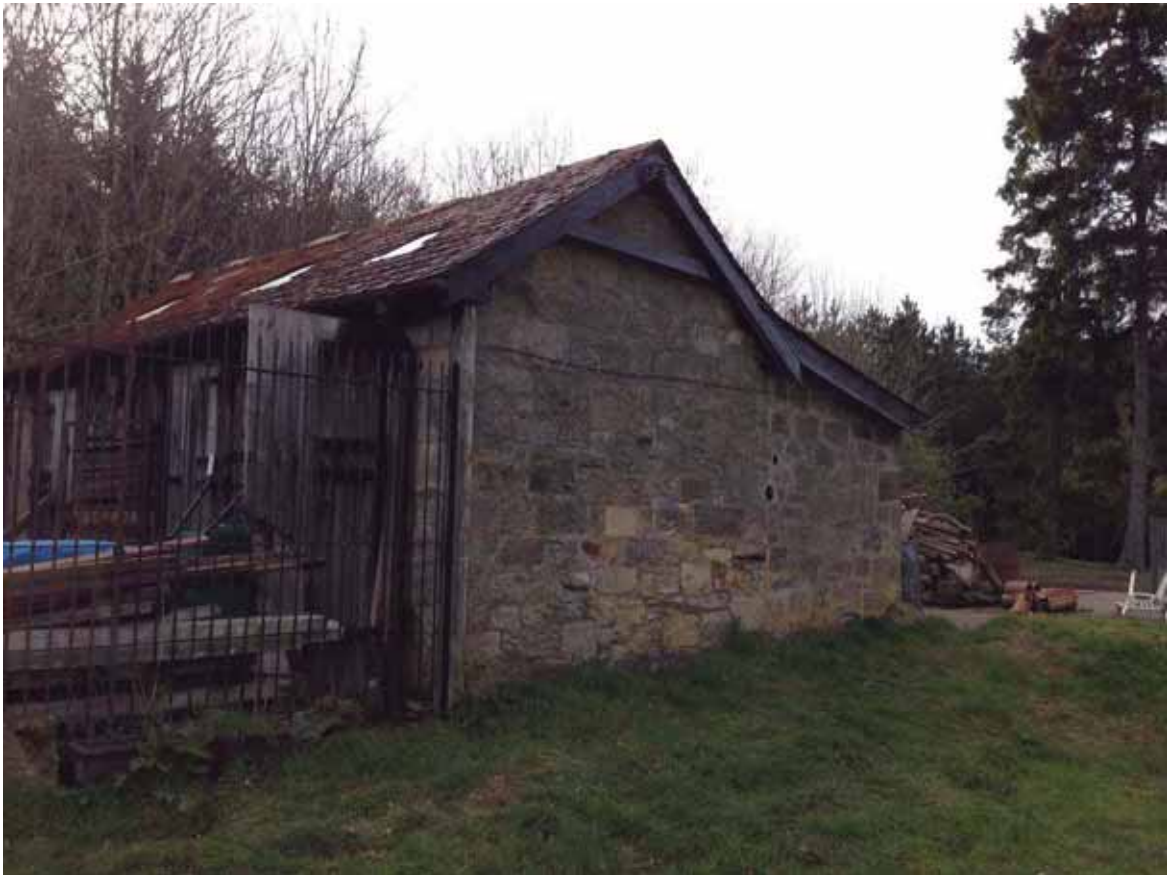
East elevation showing the remedial high level pointing to the lean-to section and the generally good condition of the stonework. Also the railings surrounding the kennel run to the south

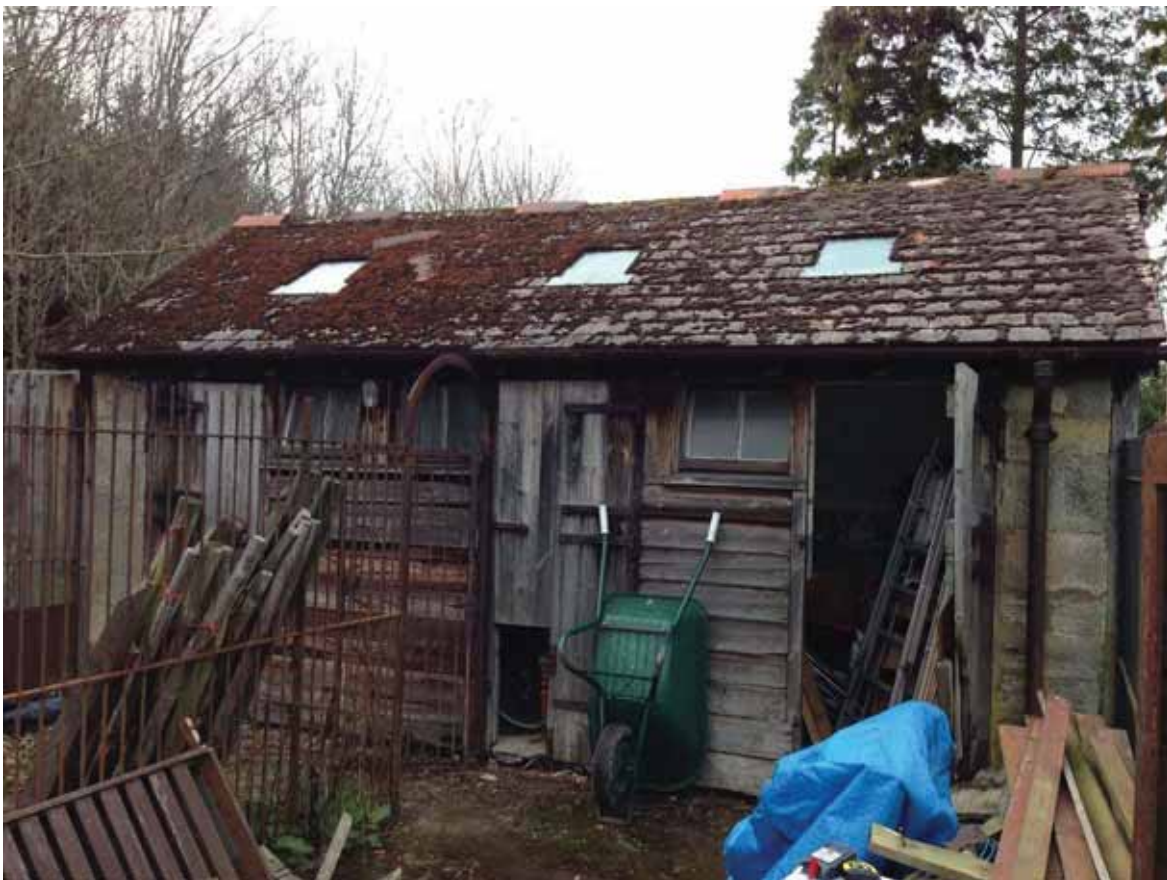
South elevation showing moss to the roof and the lack of decoration to the timber elements and defective boarding.

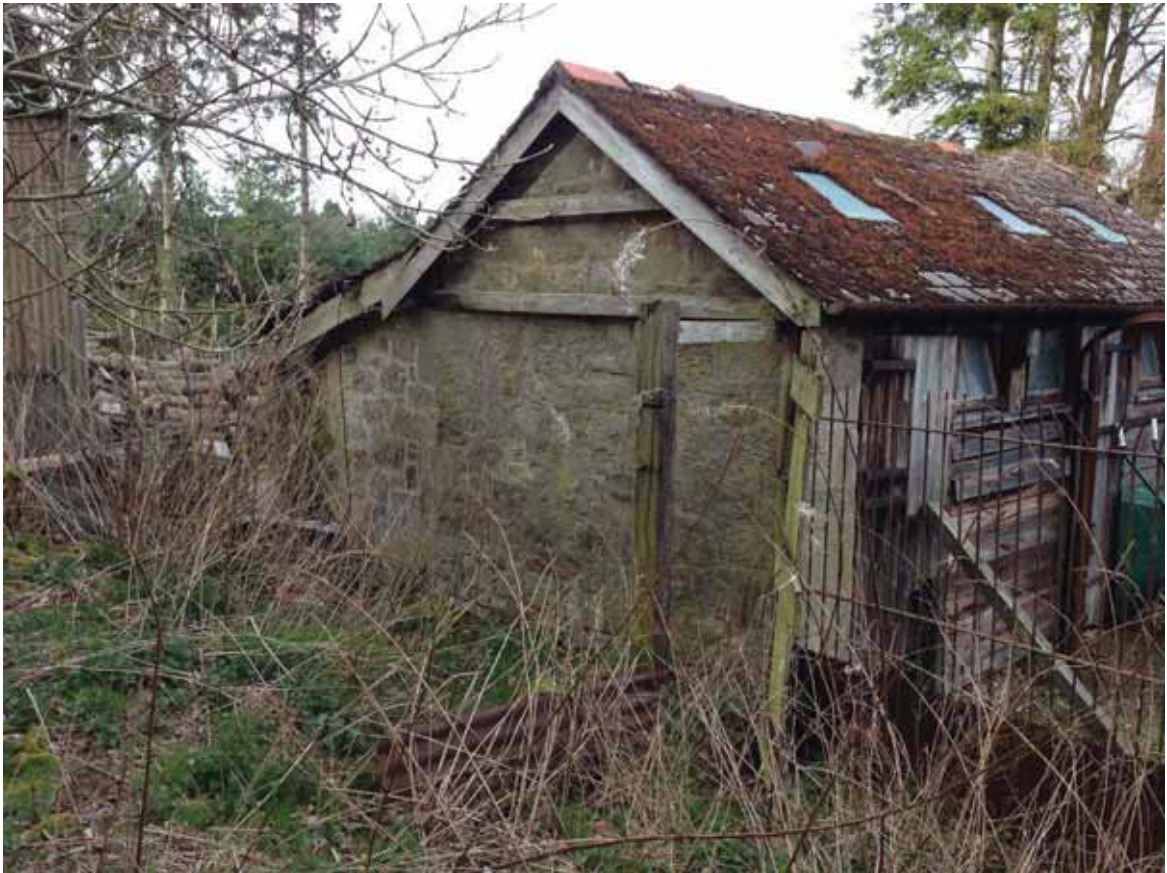
West elevation showing defective barge and gable timbers, but good condition of stonework with signs of remedial pointing to the lean-to section.

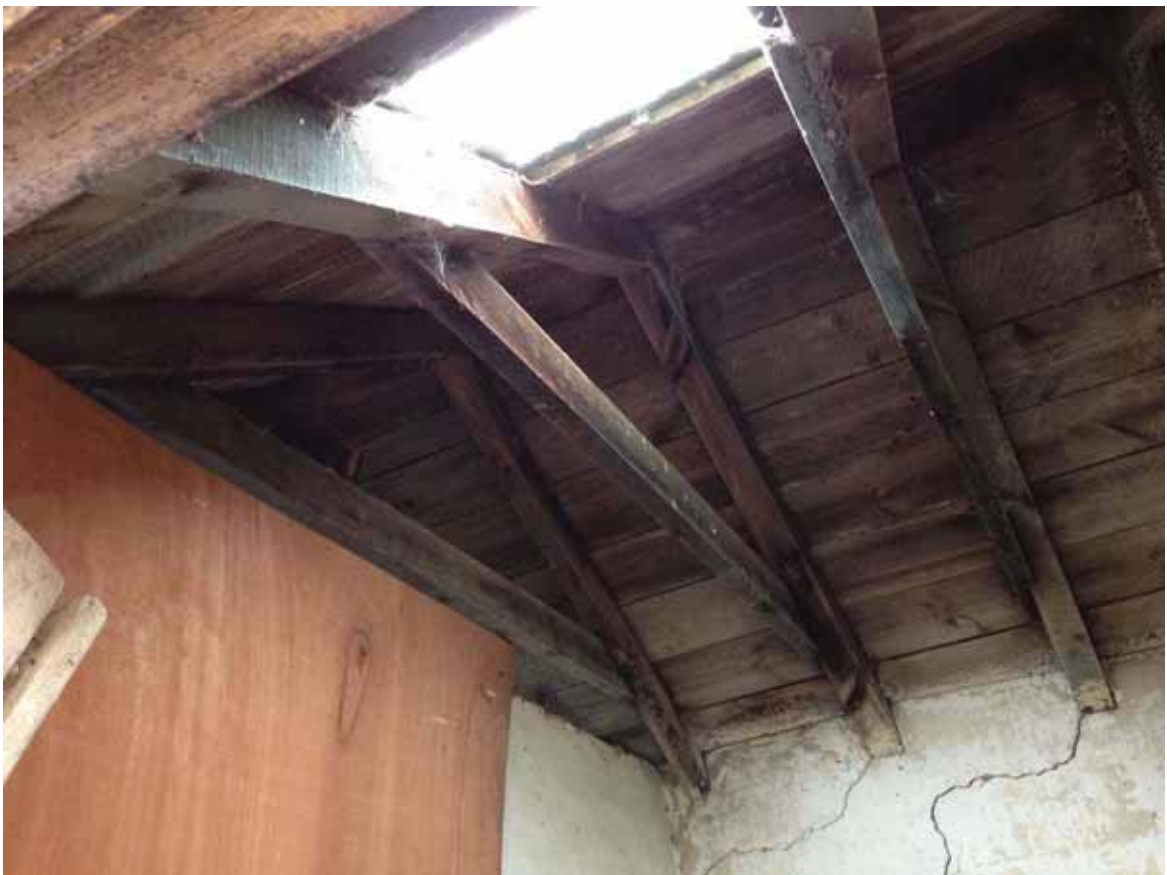
Internal roof structure showing the good condition of the timbers and sarking board. The cracking shown below the timbers was to the plaster finish only and was checked from both sides.

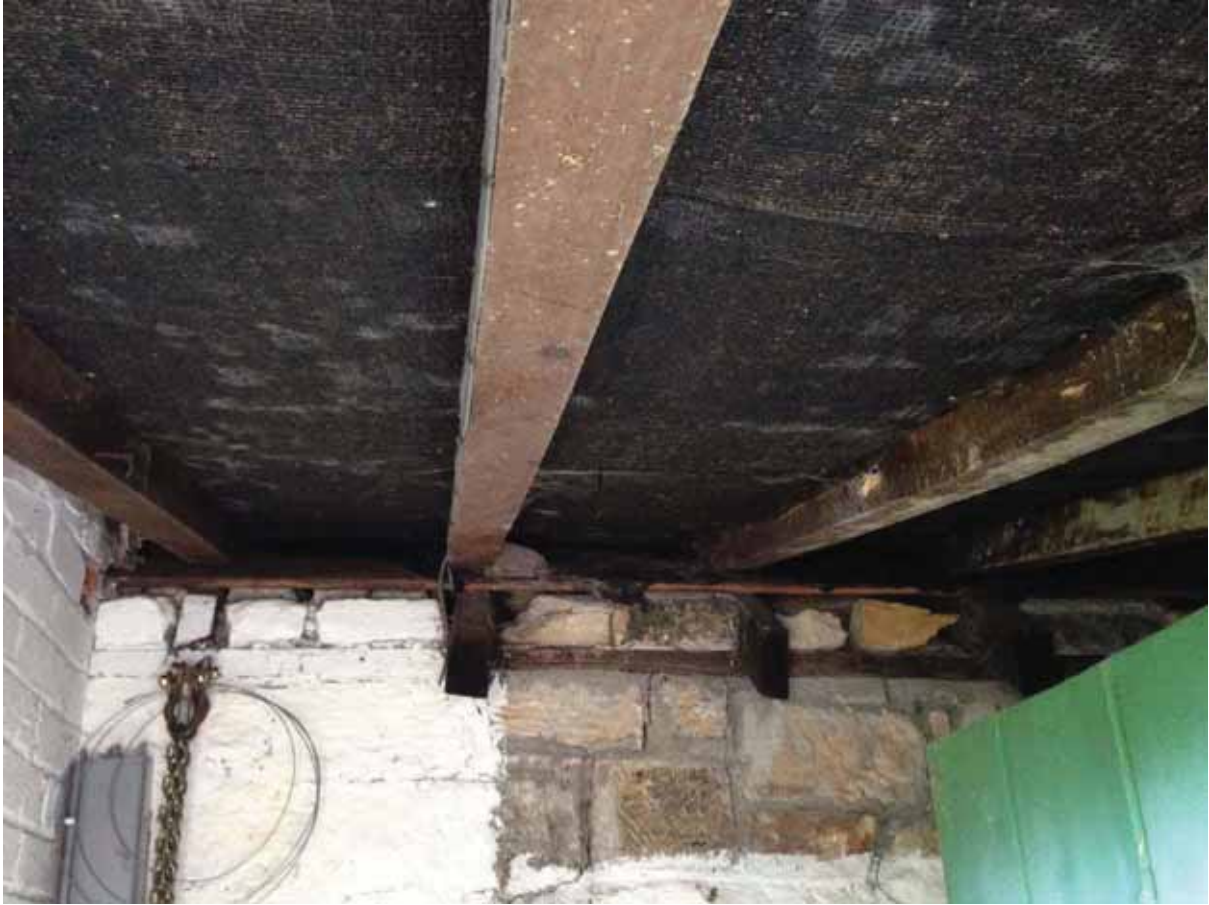
Photo of the lean-to roof and the existing felt underlay with the timbers in good condition
