Messrs J & A Waugh
Thompson's Walls, Kilham
Bat Scoping Survey Report
06/04/2010

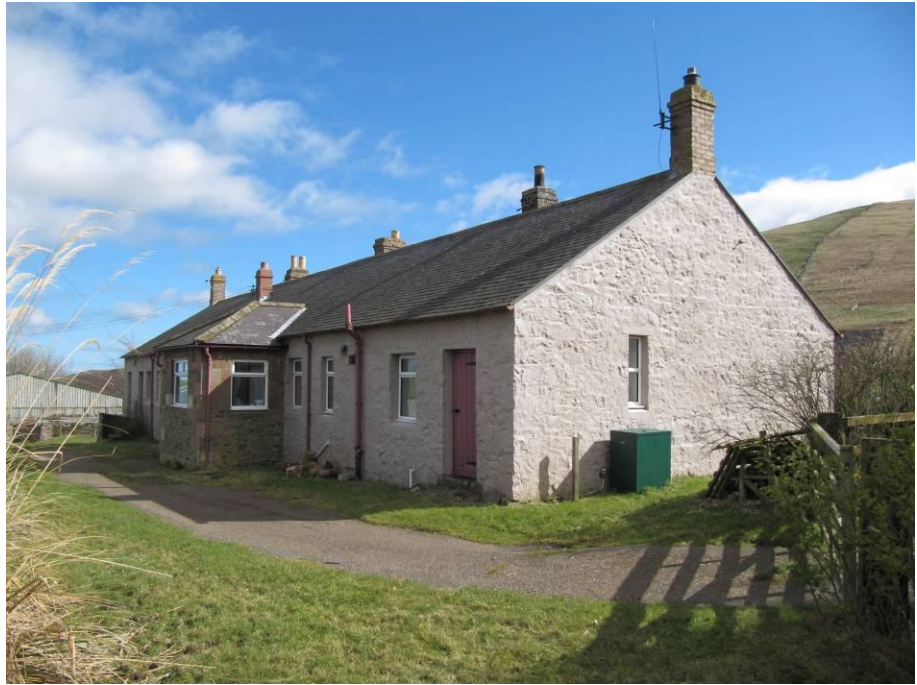
Photo 1. Bungalow (building 1), viewed from the south-west.

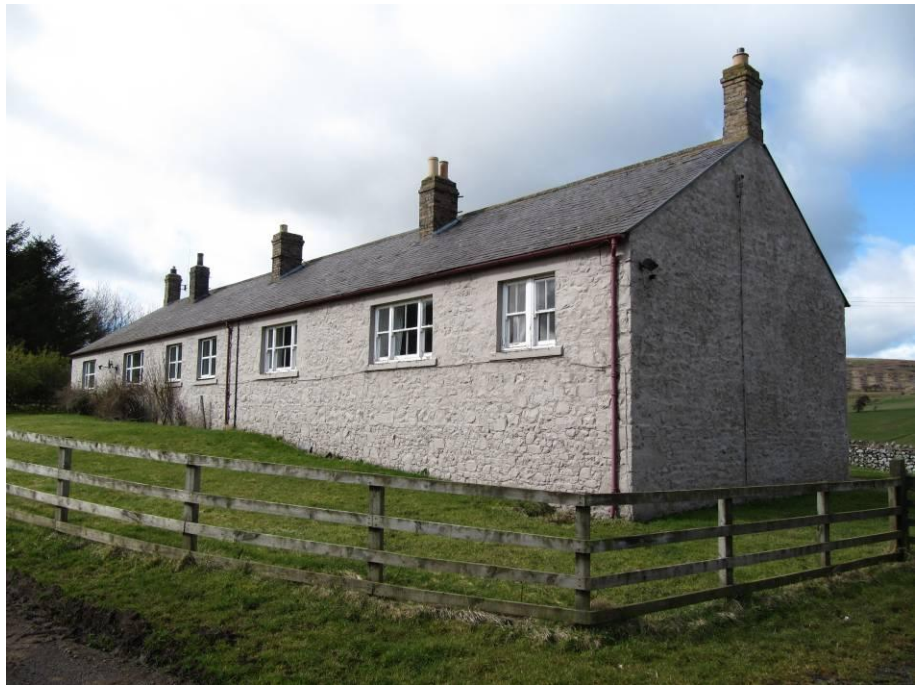
Photo 2. Bungalow (building 1), viewed from the north-east.

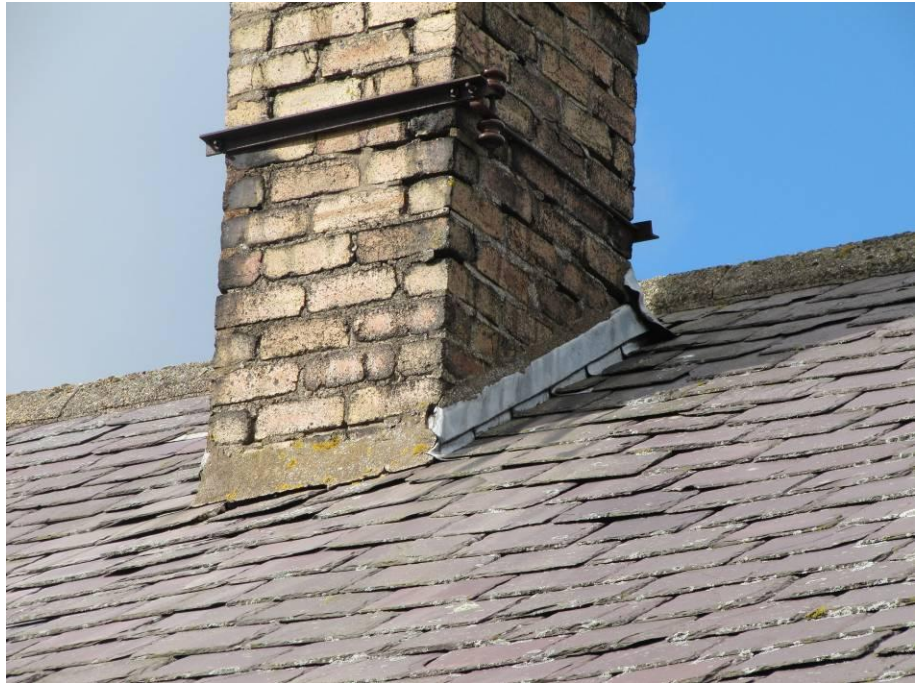
- 3.3.5 All buildings were searched for potential to support roosting bats. The bungalow (building 1) contains an attic space with multiple access points through broken and ill-fitting tiles, around the wall plates and where holes have been made for electricity cables to pass through a gable wall. The roof within the bungalow is not lined, but small crevices are present between the slates and roof timbers and between the roof timbers and gable walls. Crevices are also present where mortar has been lost from both the gable walls and chimneys. Crevices of potential roost value are also present in gaps beneath lead flashing and where mortar has been lost at the base of chimneys.

Photo 3. Chimney and surrounding roof on bungalow (building 1).
Note potential crevice behind poorly fitted lead flashing.

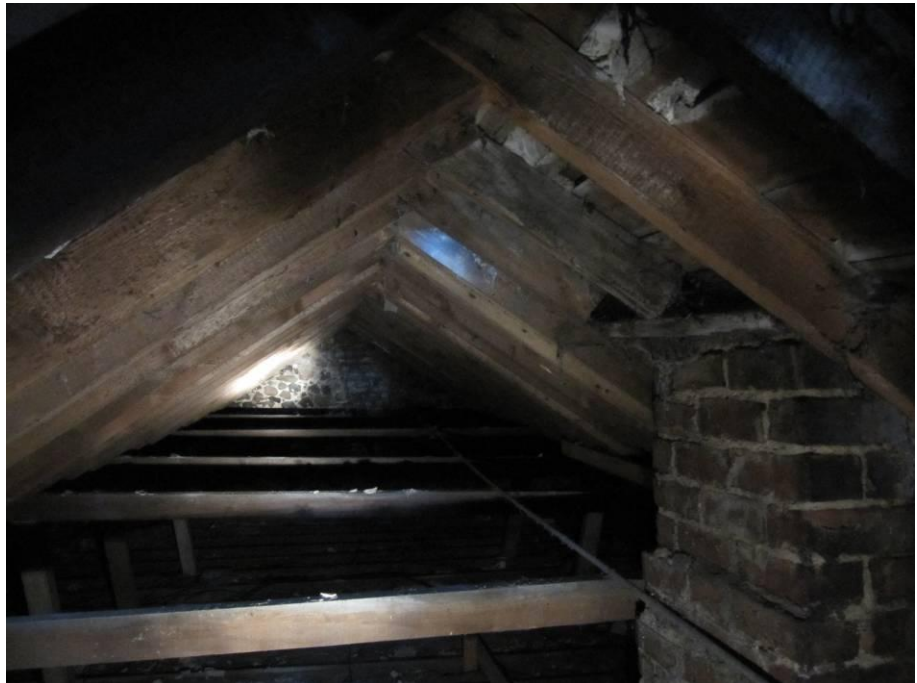
Photo 4. Interior of bungalow (building 1) roof void. Note light entering through gap created by missing roof slate.

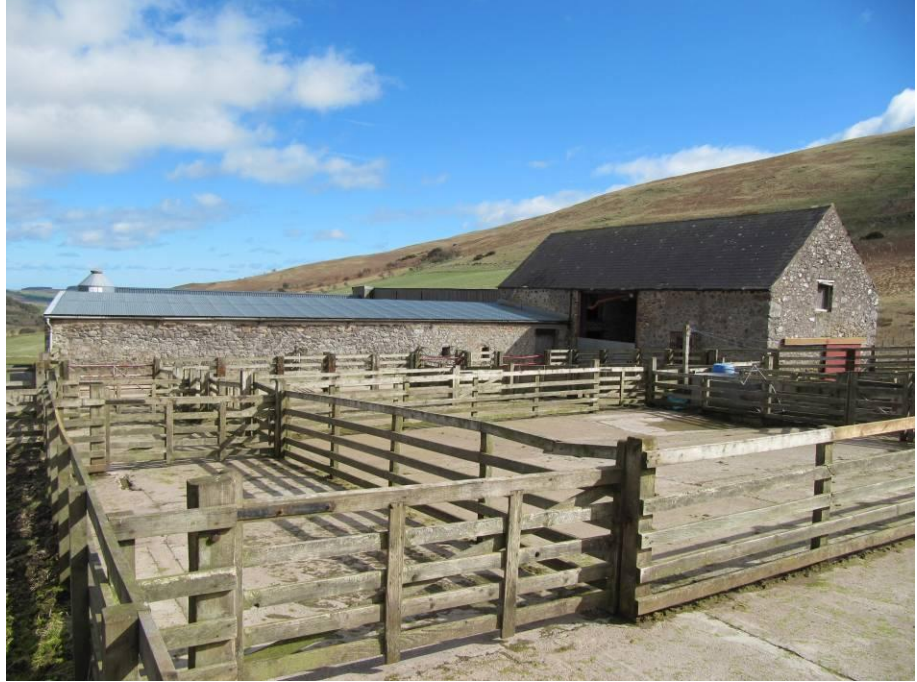
Photo 5. Traditional two-storey and store barns (buildings 2a and 2b), viewed from the south-west.

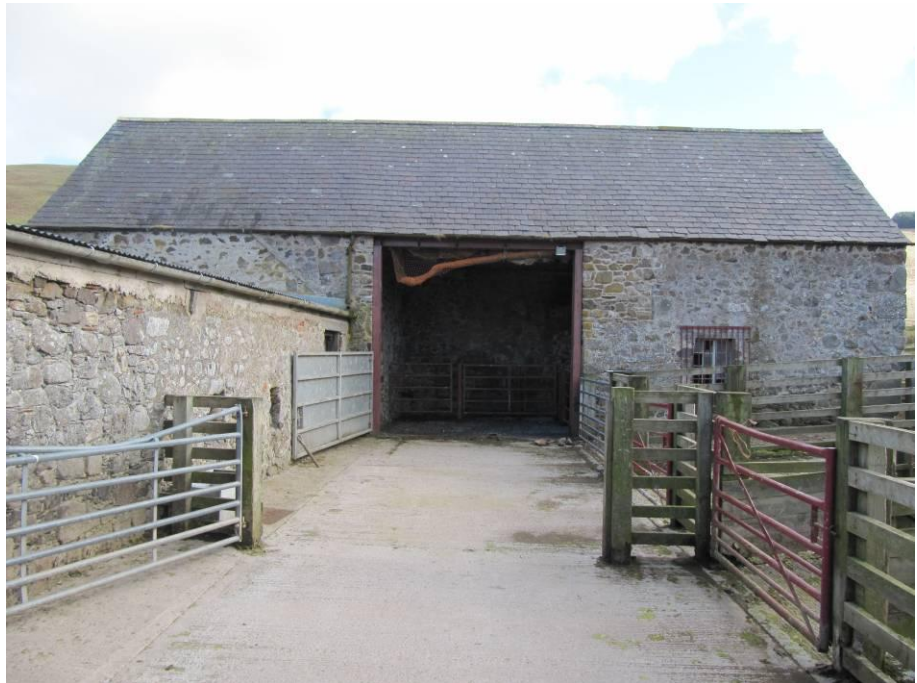
Photo 6. Traditional two-storey and store barns (buildings 2a and 2b), viewed from the north-west.

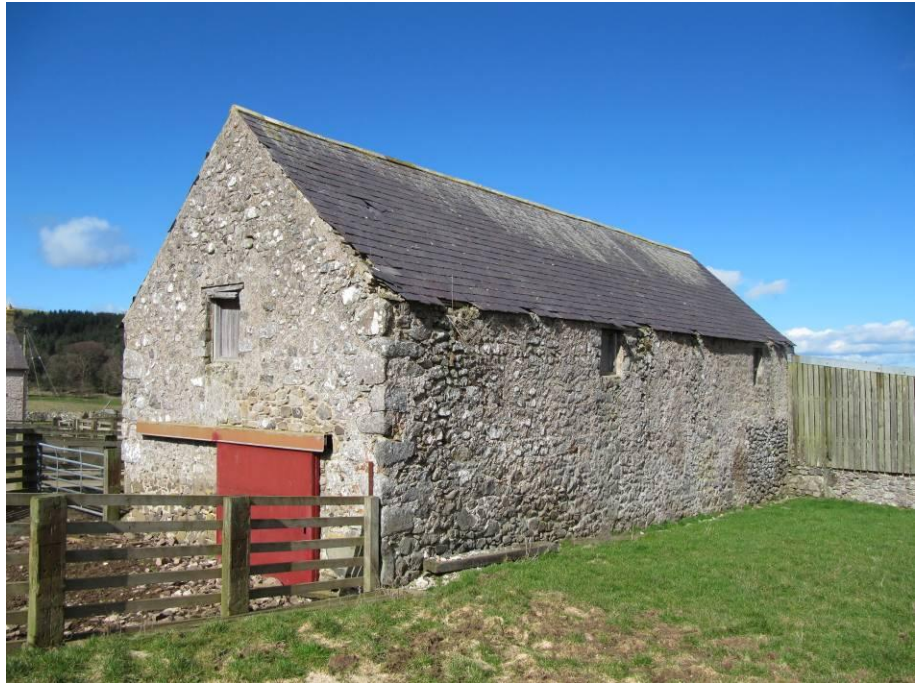
- 3.3.6 The stone walls on the traditional barns (buildings 2a-d) have numerous gaps due to missing mortar and cracks. These gaps are present on both the exterior and interior walls of most buildings and are likely to provide access to crevices and possibly larger voids within the rubble-filled walls. There is free access to an open roof void in all buildings. Numerous crevices are present within the two-storey barn (building 2a) between the slates and roof timbers and between the roof timbers and gable walls. All other buildings have corrugated or sheet steel and timber roofs. These contain a small number of gaps between overlapping roof timbers. The two-storey barn (building 2a) and the north-eastern stall and store building (building 2d) were both assessed as being of high potential because of the numerous crevices within their stone walls and the crevices within the roof structure of the former building. The two open stores were assessed as being of medium potential because of the limited number of crevices present within their lower stone walls.

Photo 7. Traditional two-storey barn (building 2a), viewed from the south. Note missing roof slates and missing mortar with potential crevices in walls.

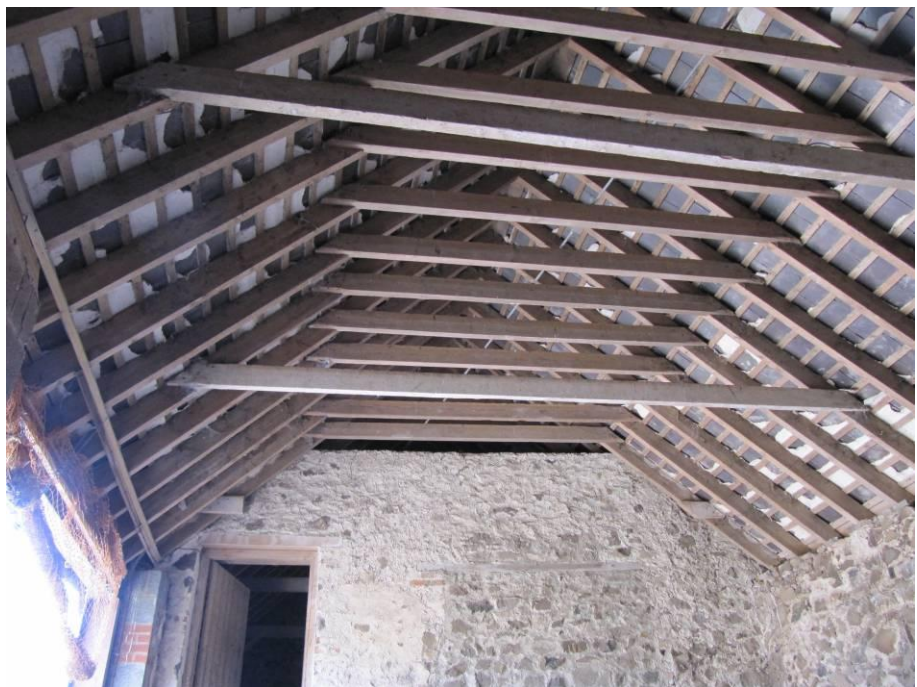
Photo 8. Roof void of traditional two-storey barn (building 2a) with access to first-floor hay-loft.

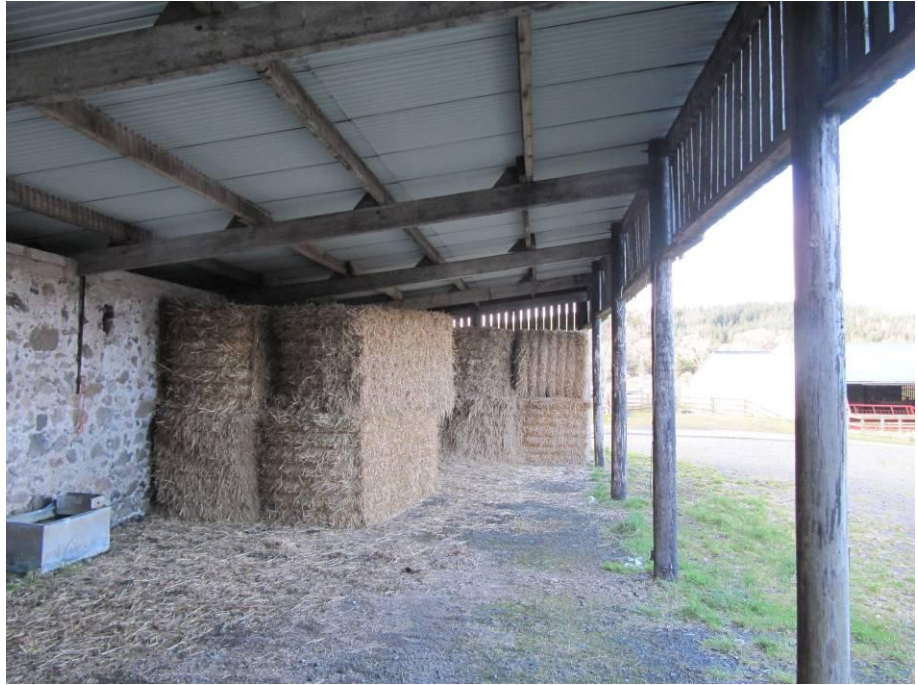
Photo 9. Traditional store barn (building 2b), viewed internally from the south-east.

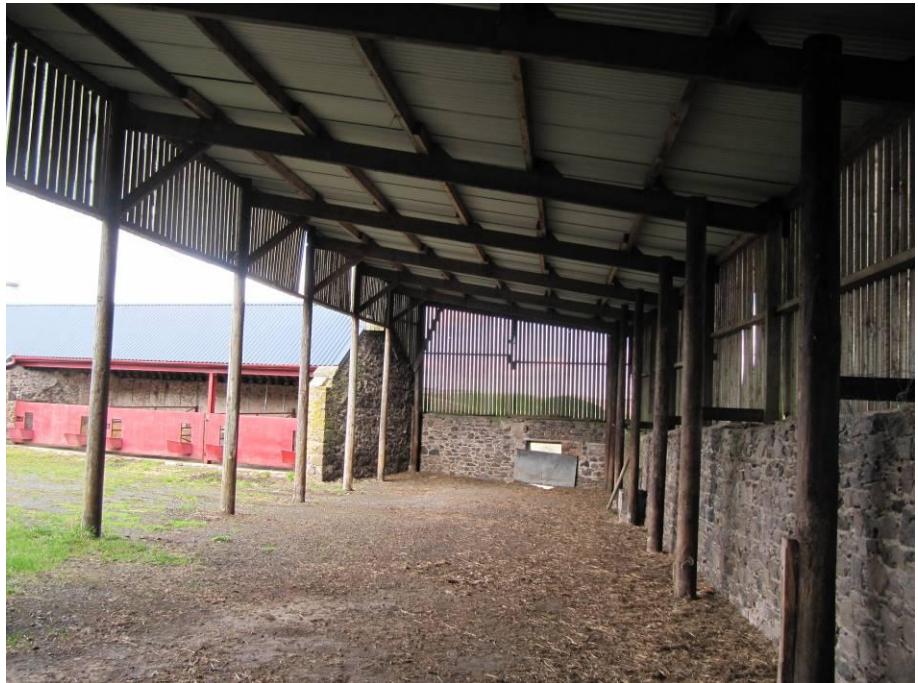
Photo 10. Traditional store barn (building 2c), viewed internally from the south-west.

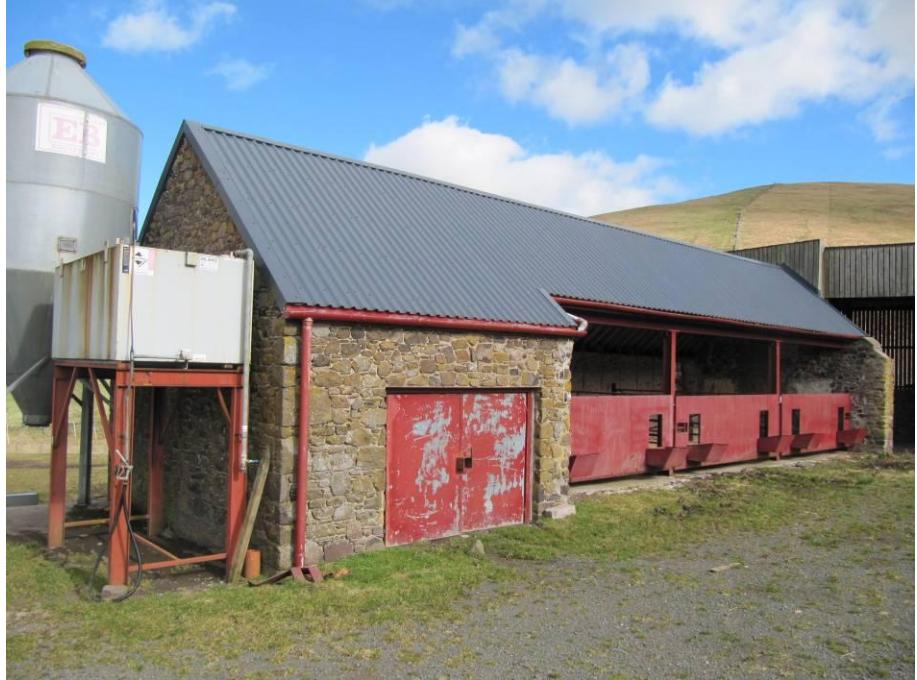
Photo 11. Traditional stall and store (building 2d), viewed from the south-west.

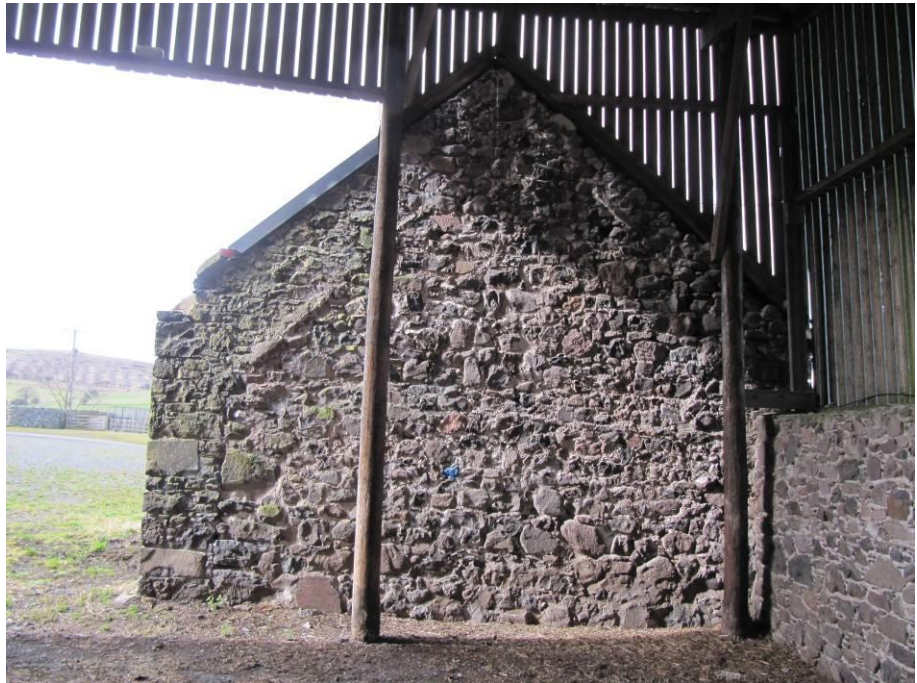
Photo 12. Gable of traditional stall and store (building 2d), viewed from the south-east. Note missing mortar and potential crevices in wall.

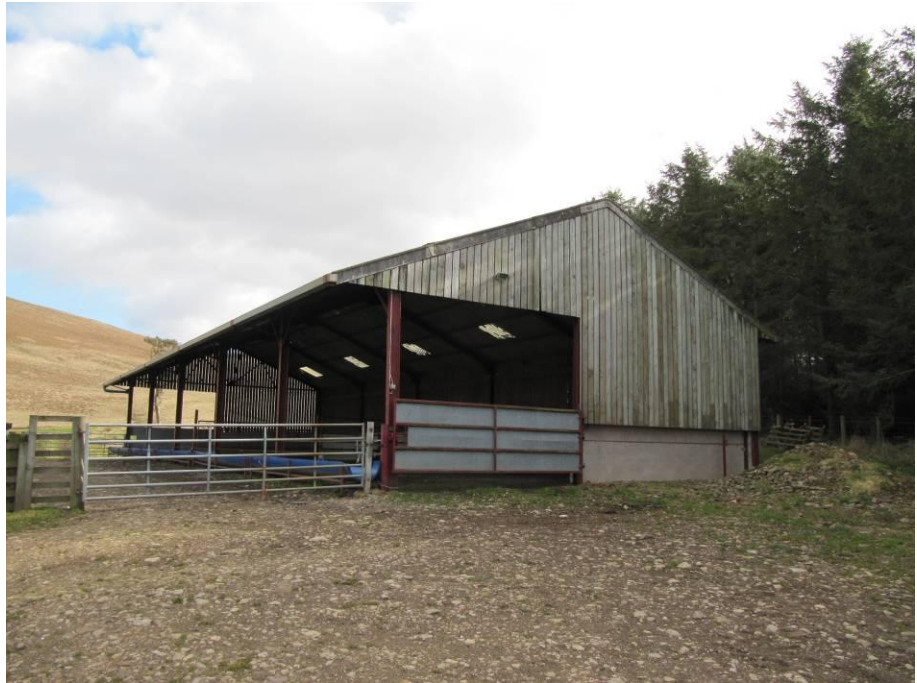
- 3.3.7 The two modern steel-framed barns (buildings 3 and 4) are both of low potential to support roosting bats. These buildings are open with high light and draught levels. They contain no voids and very few crevices, other than those between over-lapping roofing sheets and those between timber Yorkshire boarding and steel girder sections. These crevices are sub-optimal to bats and are unlikely to be used when higher quality potential roosting sites are present within the adjacent traditional buildings. Although these large open barns are unlikely to be used as day-time roosts, barns of this construction may be used as night-roosts by resting bats and they often provide a useful early-evening foraging space before light-levels drop in the surrounding landscape.

Photo 13. Modern steel-framed barn (building 3), viewed from the north-west.

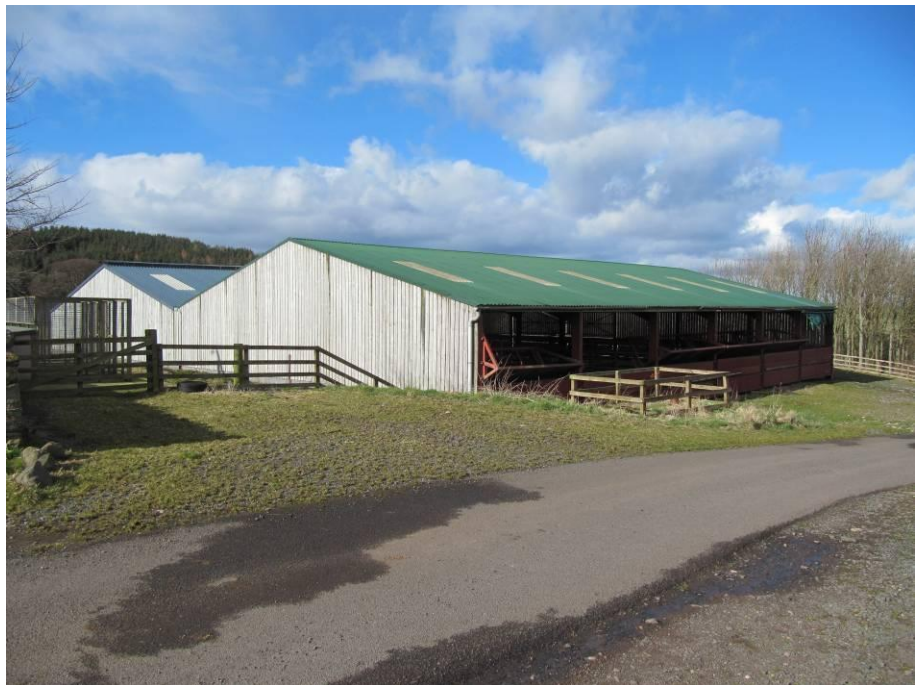
Photo 14. Modern steel-framed barn (building 4), viewed from the south.
