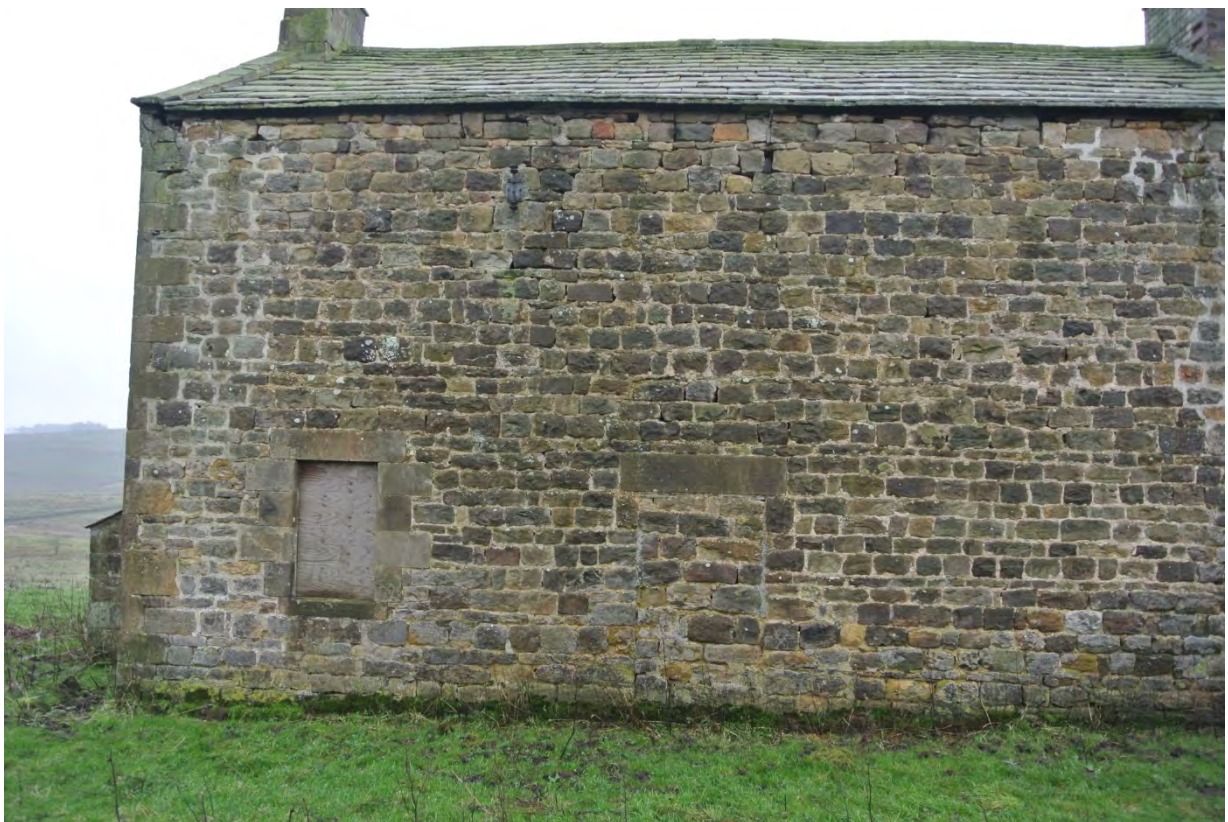
Existing North Elevation showing door to be reopened and location for Bedroom 3 window

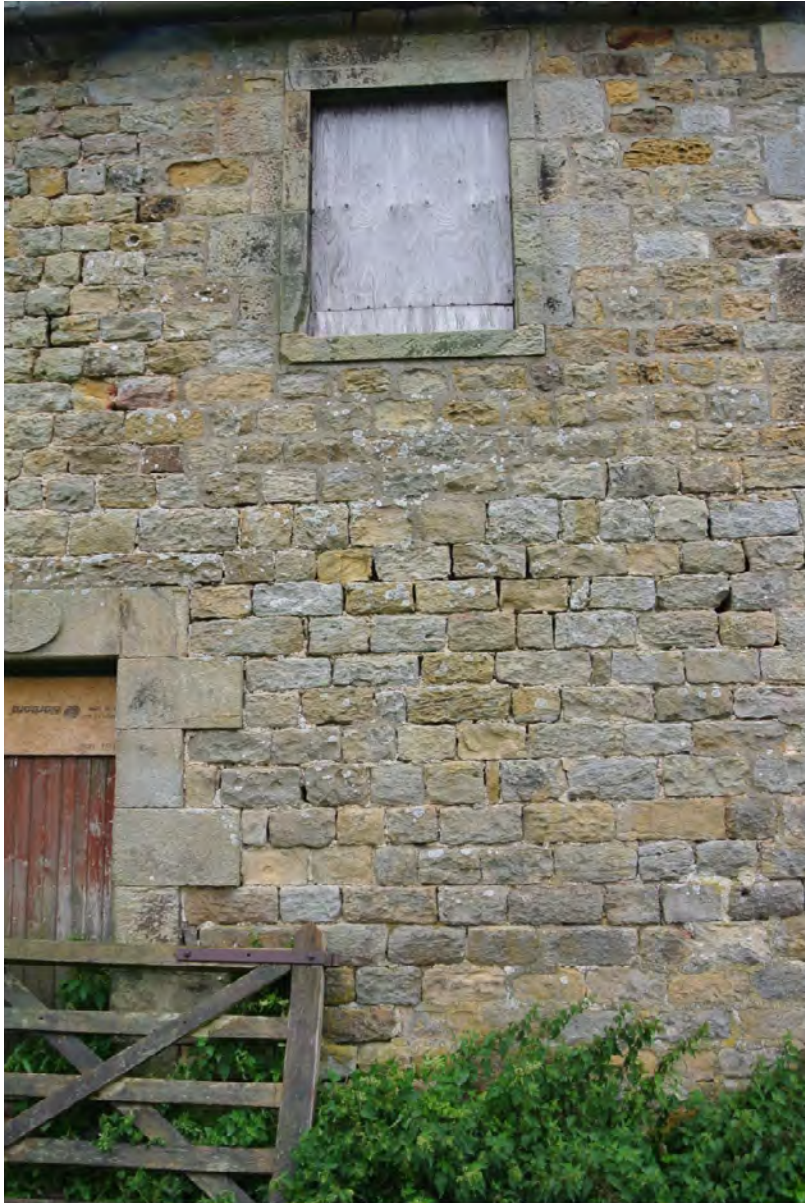
Part South Elevation showing location of new kitchen window

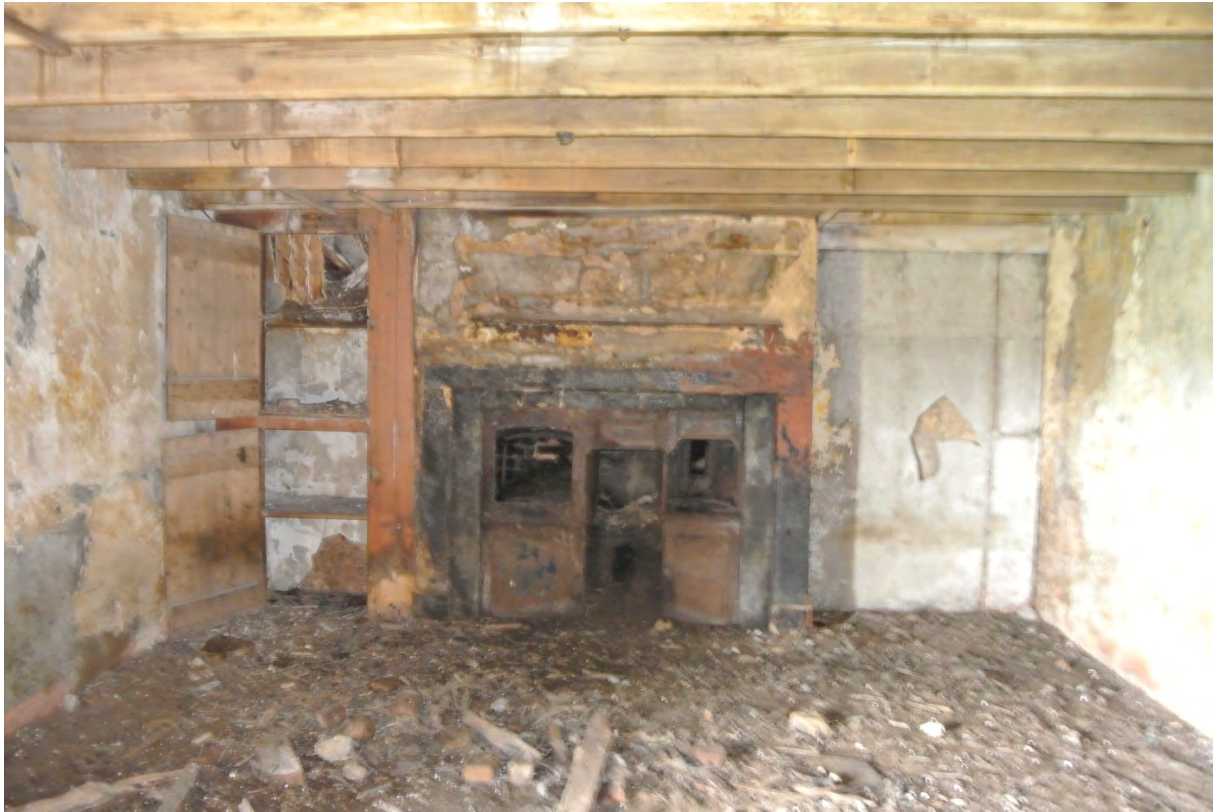
Internal view of West gable at ground floor showing range to be removed, fibre cement dry lining (ACM) to RH side of range and cupboard to LH side of range to be removed.

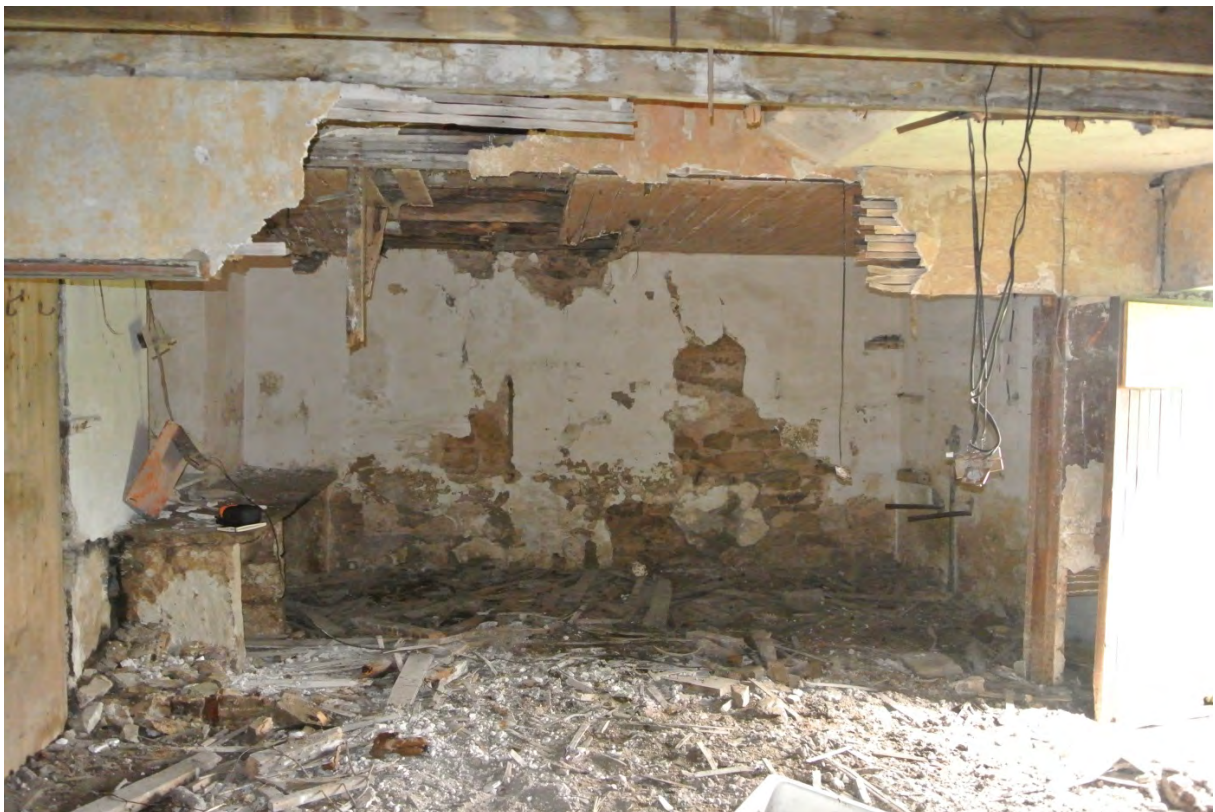
Internal view of East gable at ground floor showing stone shelf at LH side and remnants of partitions

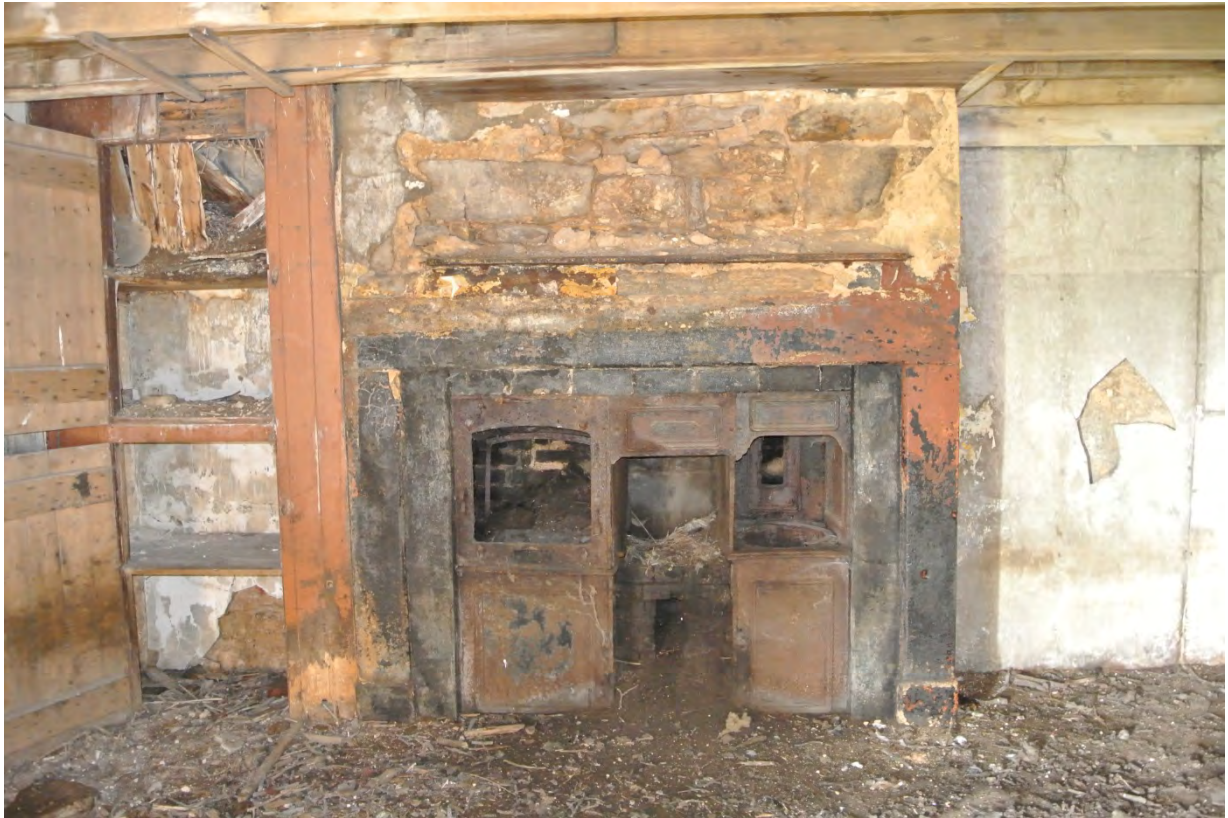
Closer view of range to be removed (decorative pieces to be retained and displayed in refurbished property)

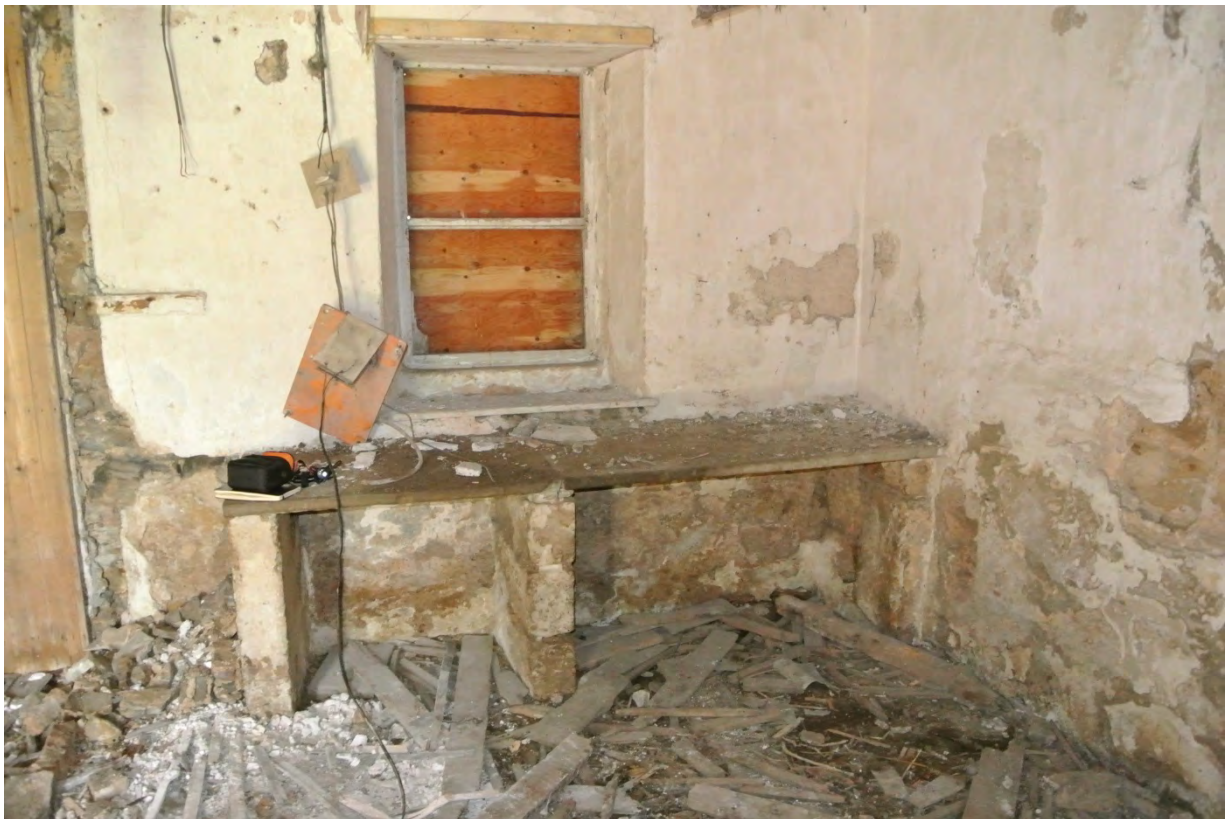
Closer view of stone shelf to removed / reused and existing window to be renewed.

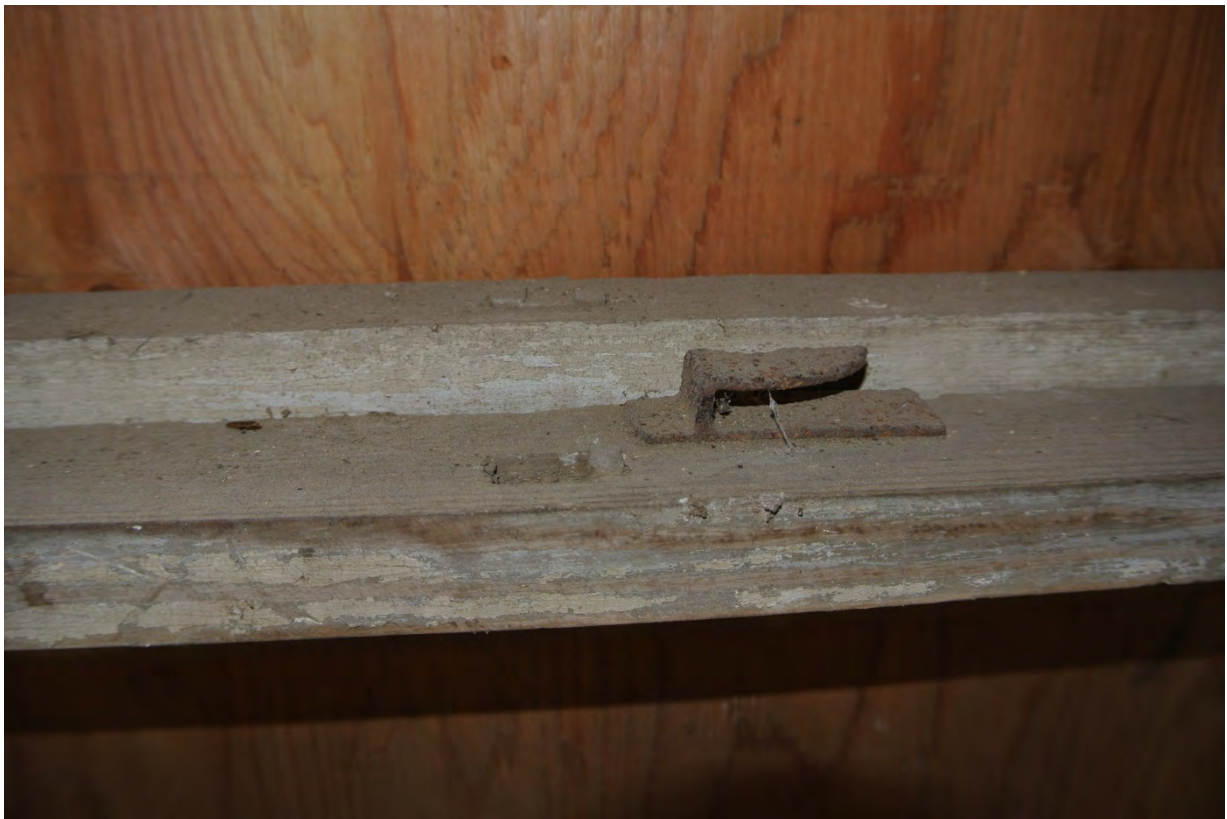
Detail of sliding sash window to South elevation in Area 1 showing mullion / glazing bar tenon hole

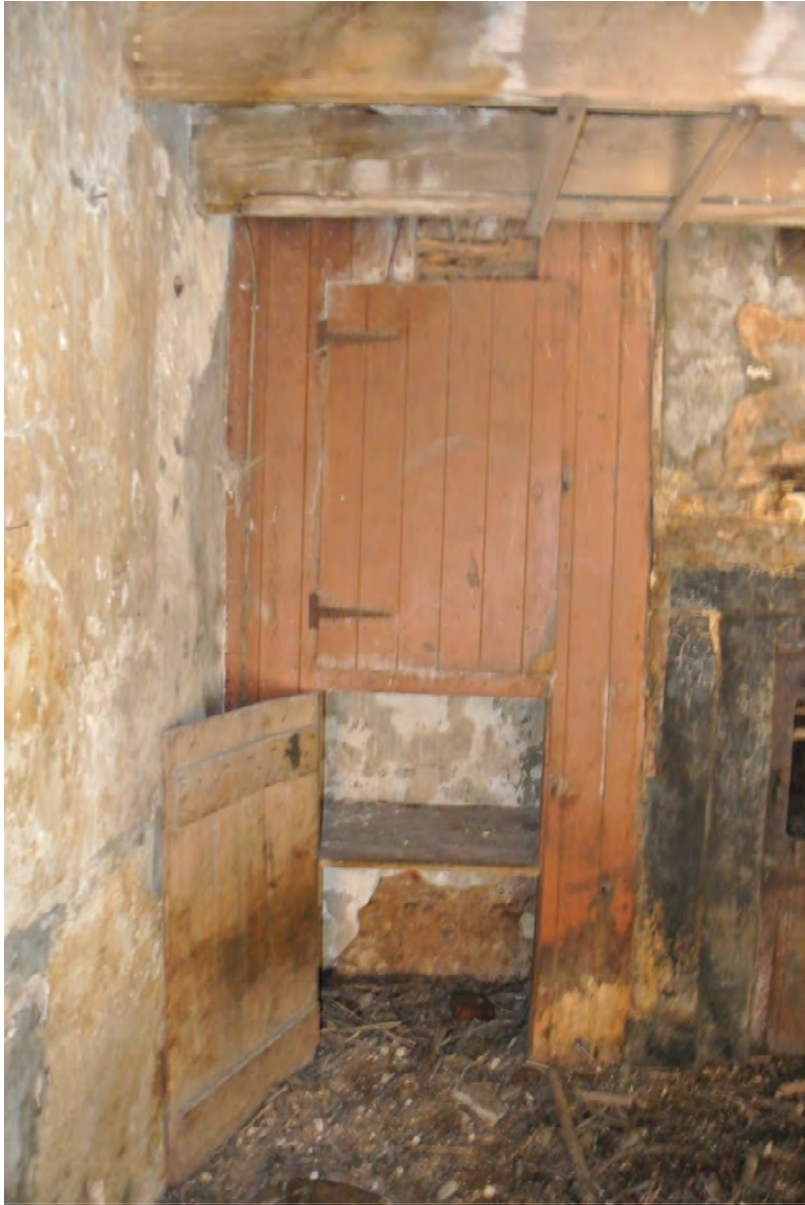
Detail of cupboard to be removed (LH side range) where new door to be formed to access extension

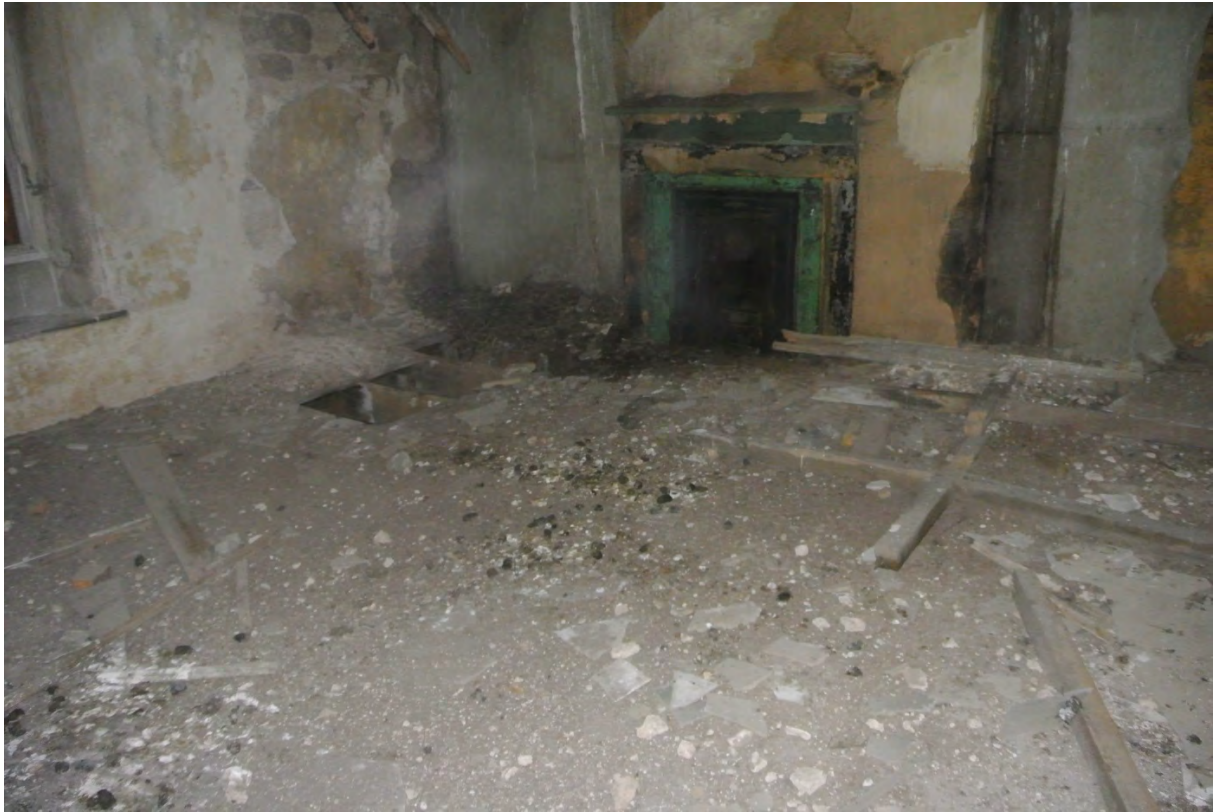
Internal view of West gable at first floor showing fireplace to be overhauled, fibre cement dry lining (ACM), rotten floor etc..

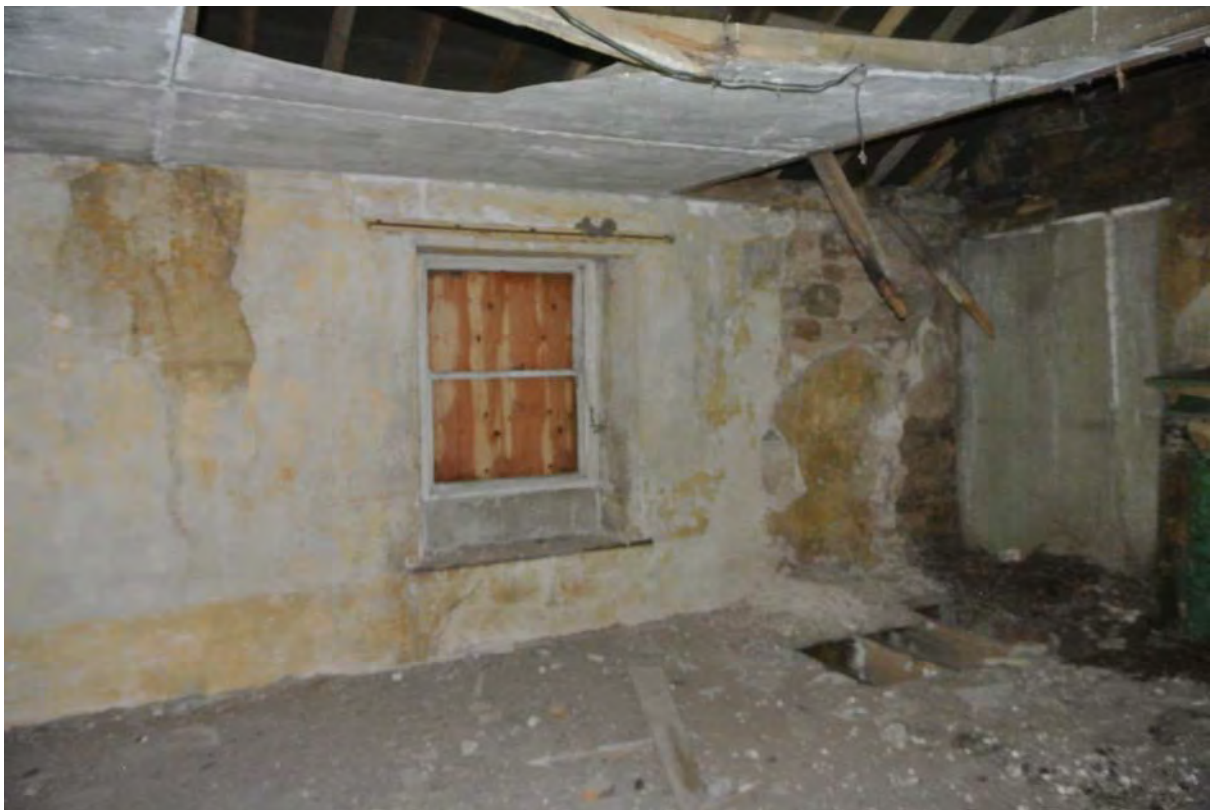
View of South wall in area 6 showing window and fibre cement dry lining / ceiling

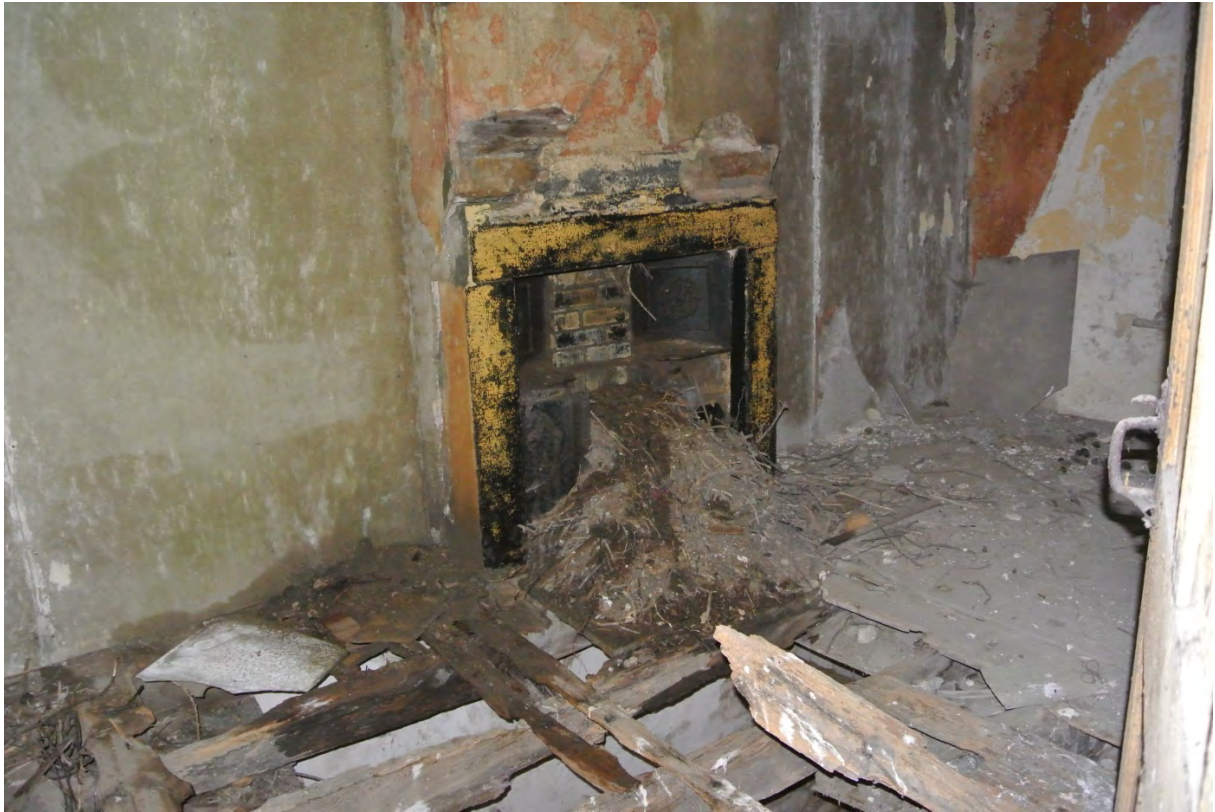
Internal view of East gable at first floor showing fireplace to be overhauled, fibre cement dry lining (ACM), rotten floor etc..

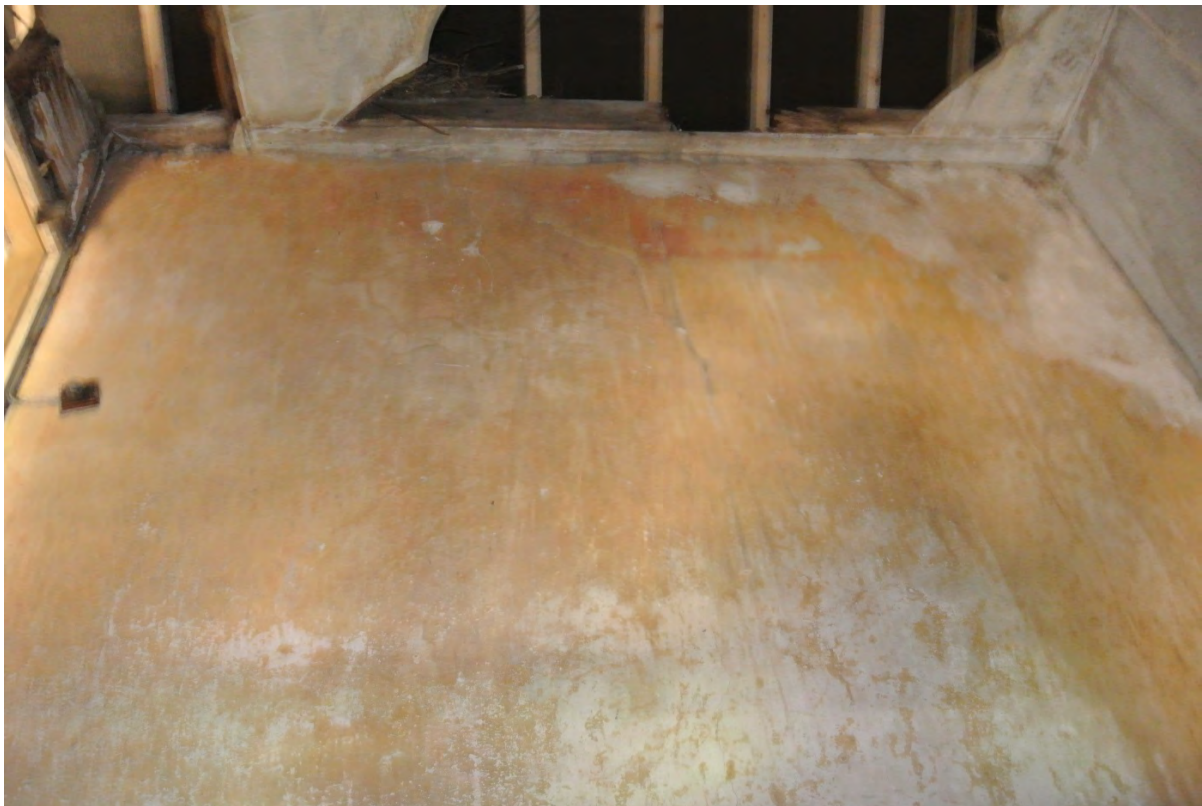
View of North wall in existing area 7 where new window to be formed for Bedroom 3. Fibre cement ceiling visible

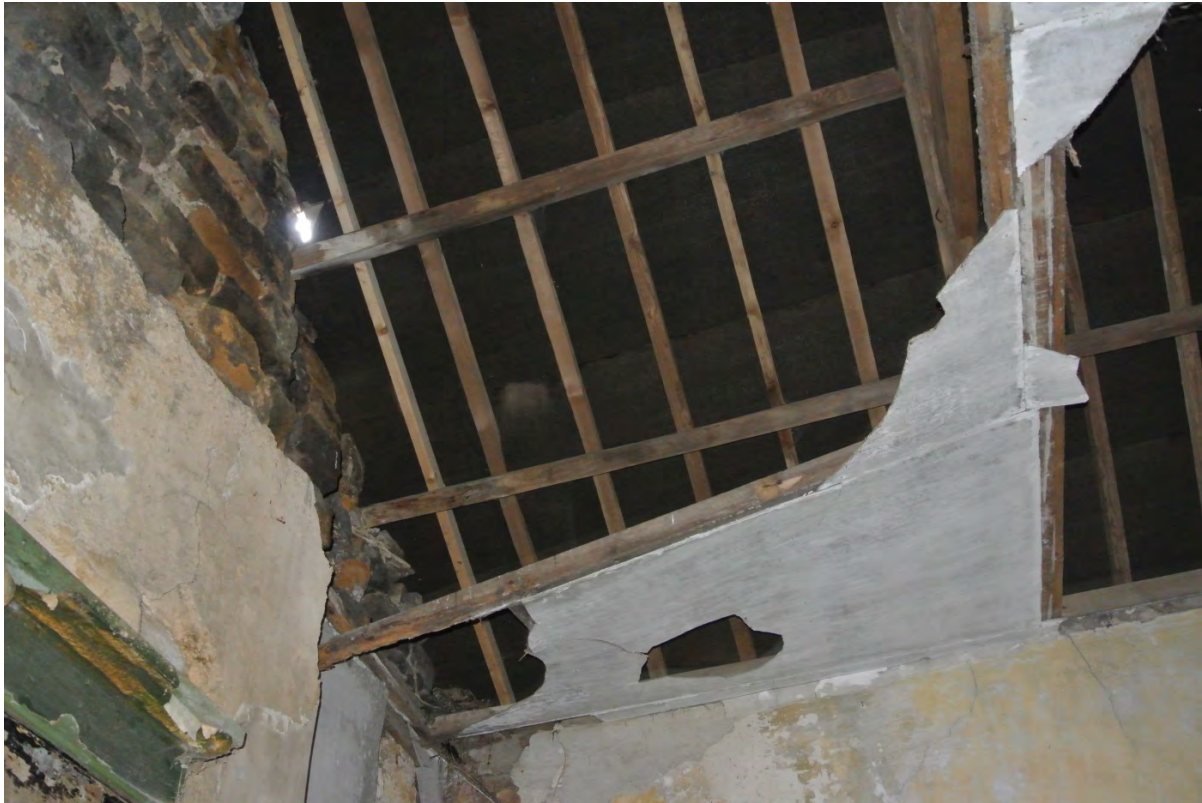
View of roof / fibre cement ceiling in existing area 6 where new rooflights to be installed.

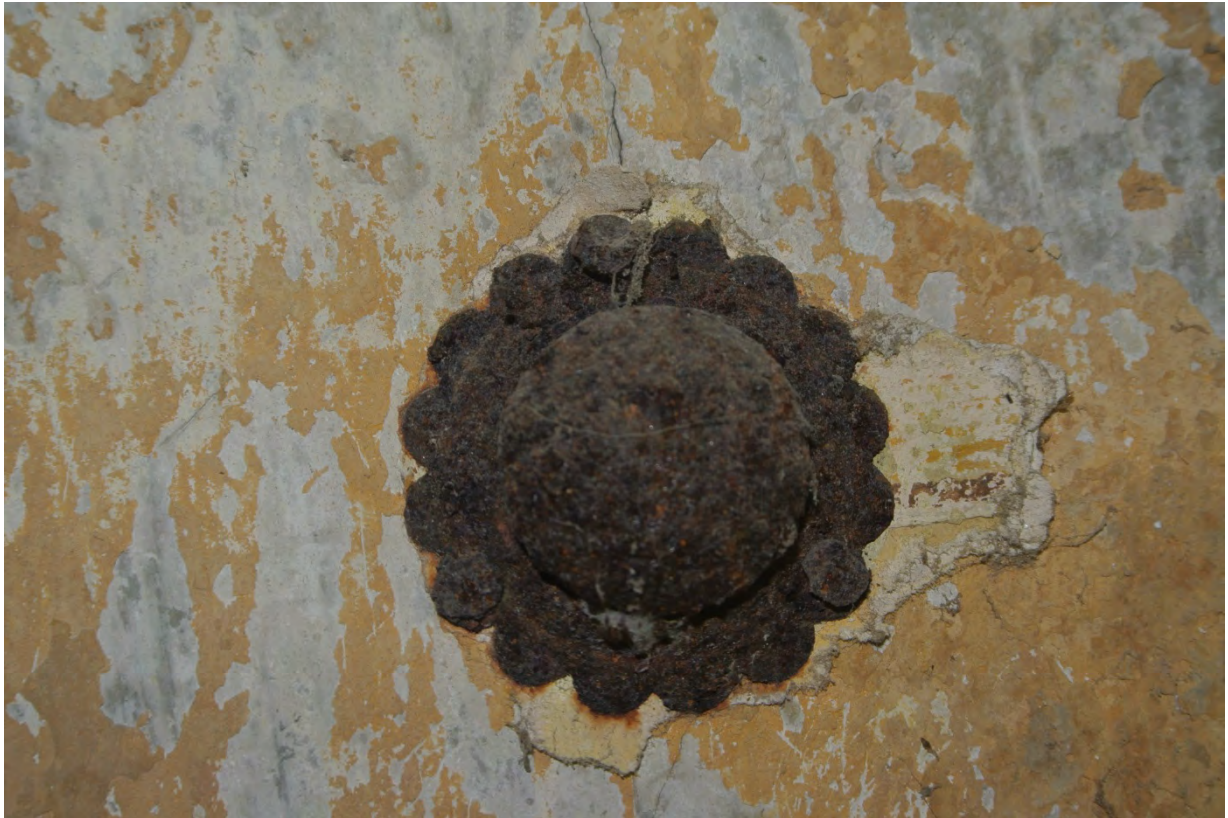
View of surface mounted “rosette” to be carefully removed and reused in refurbished building.

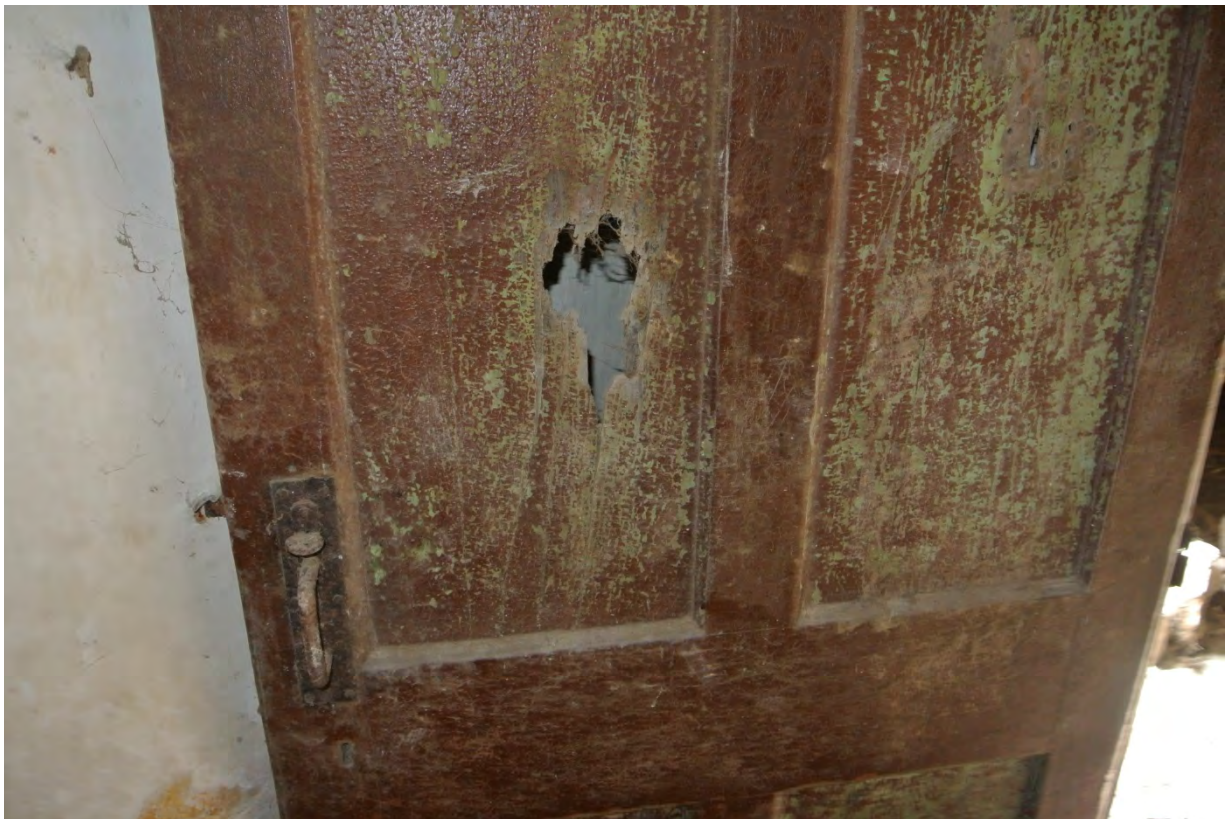
View of door to area 4 which is beyond repair
