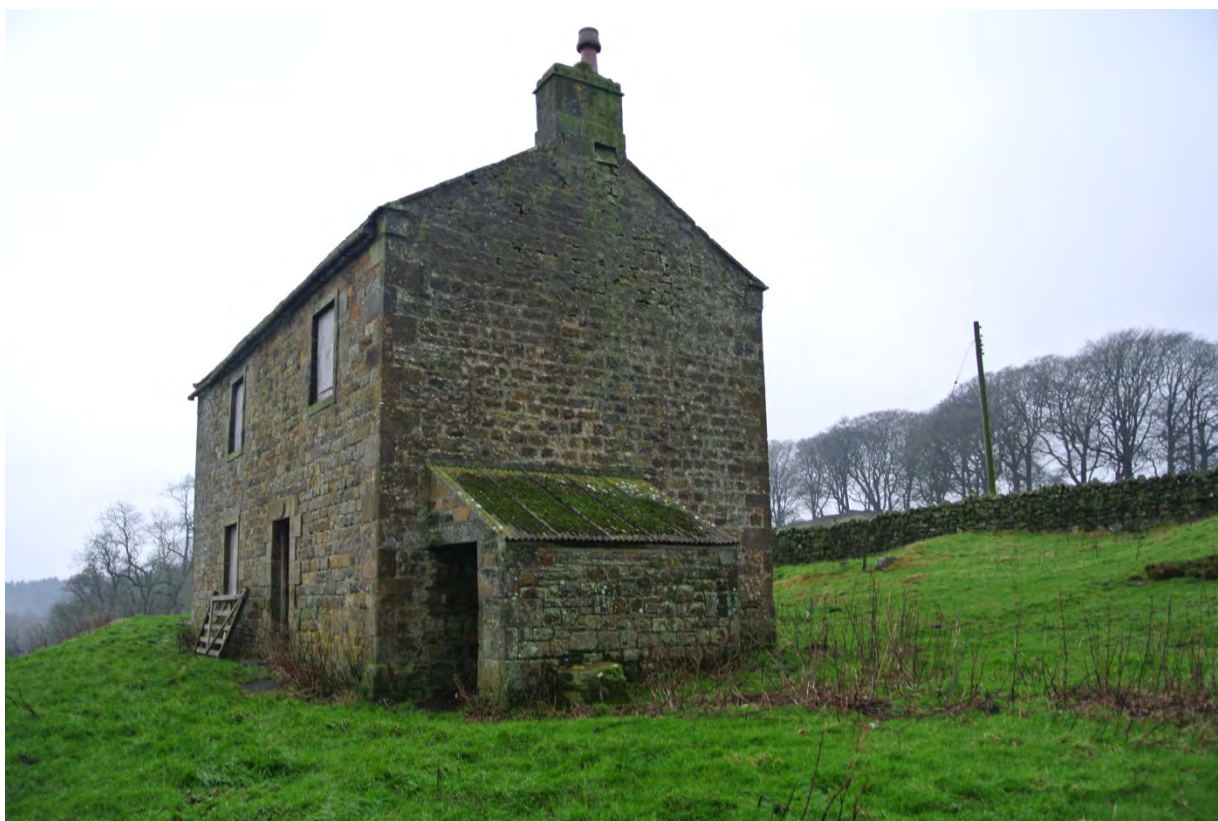
Existing South and East Elevations

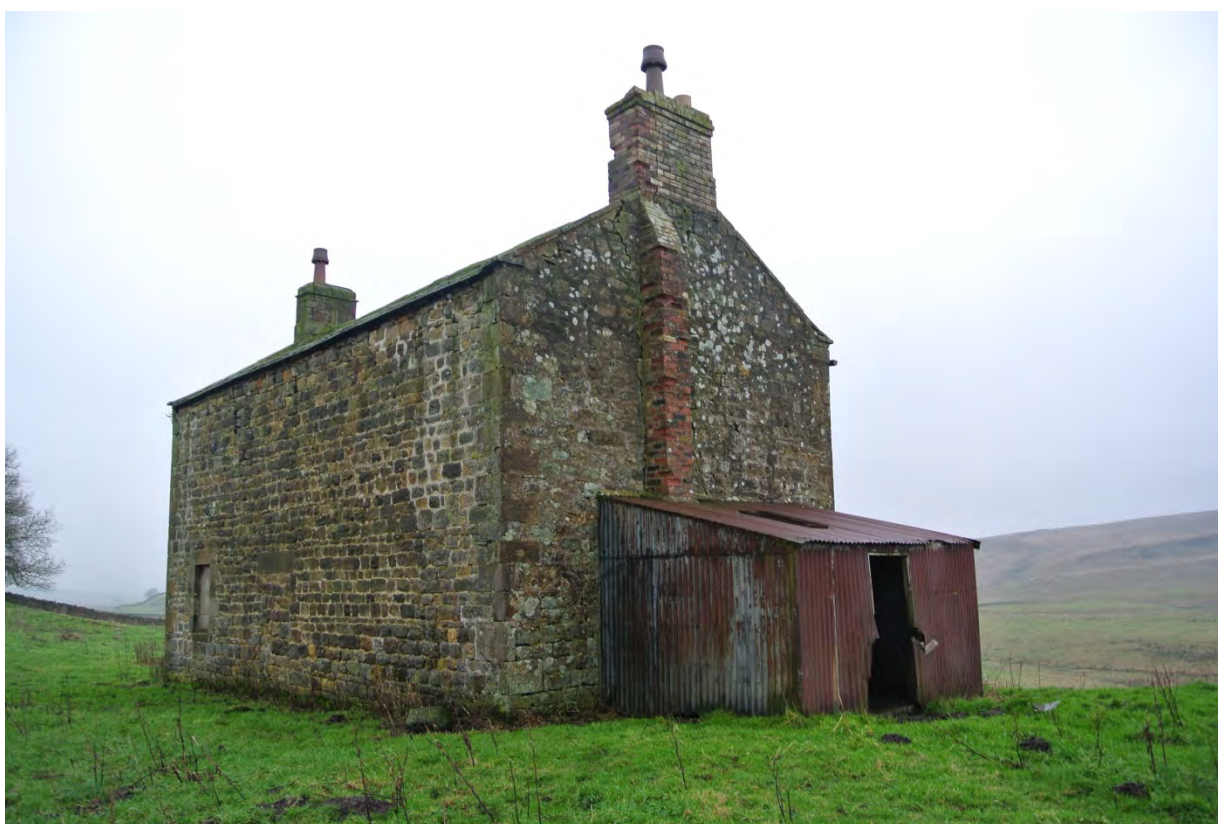
Existing North and West Elevations

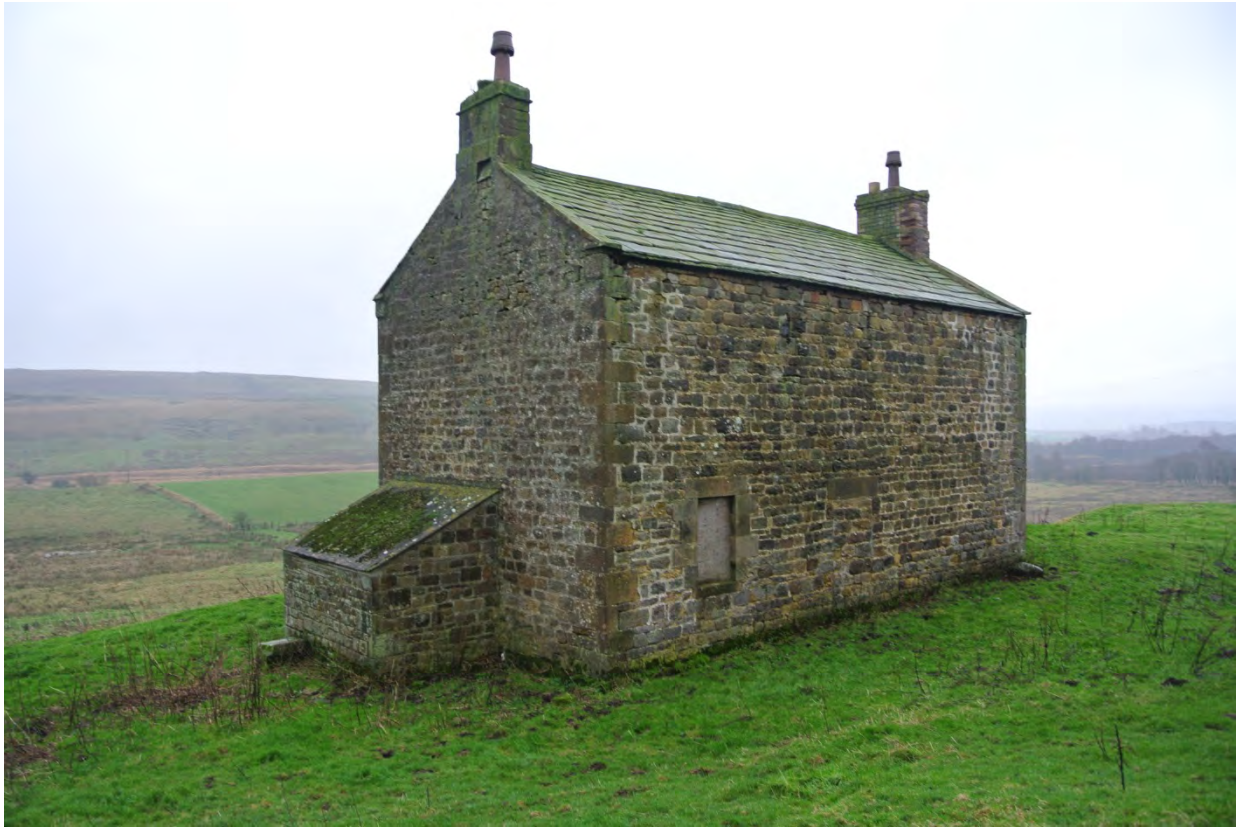
Existing East and North Elevations

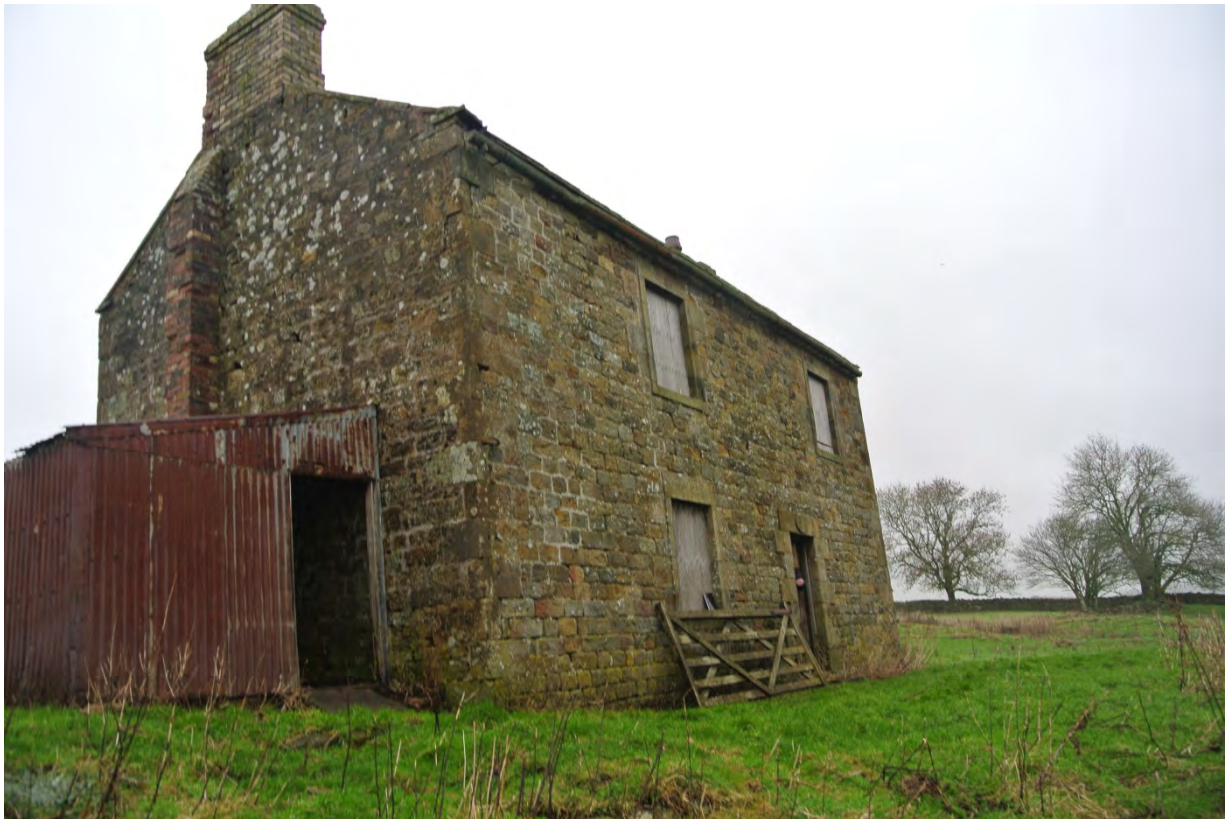
Existing South and West Elevations

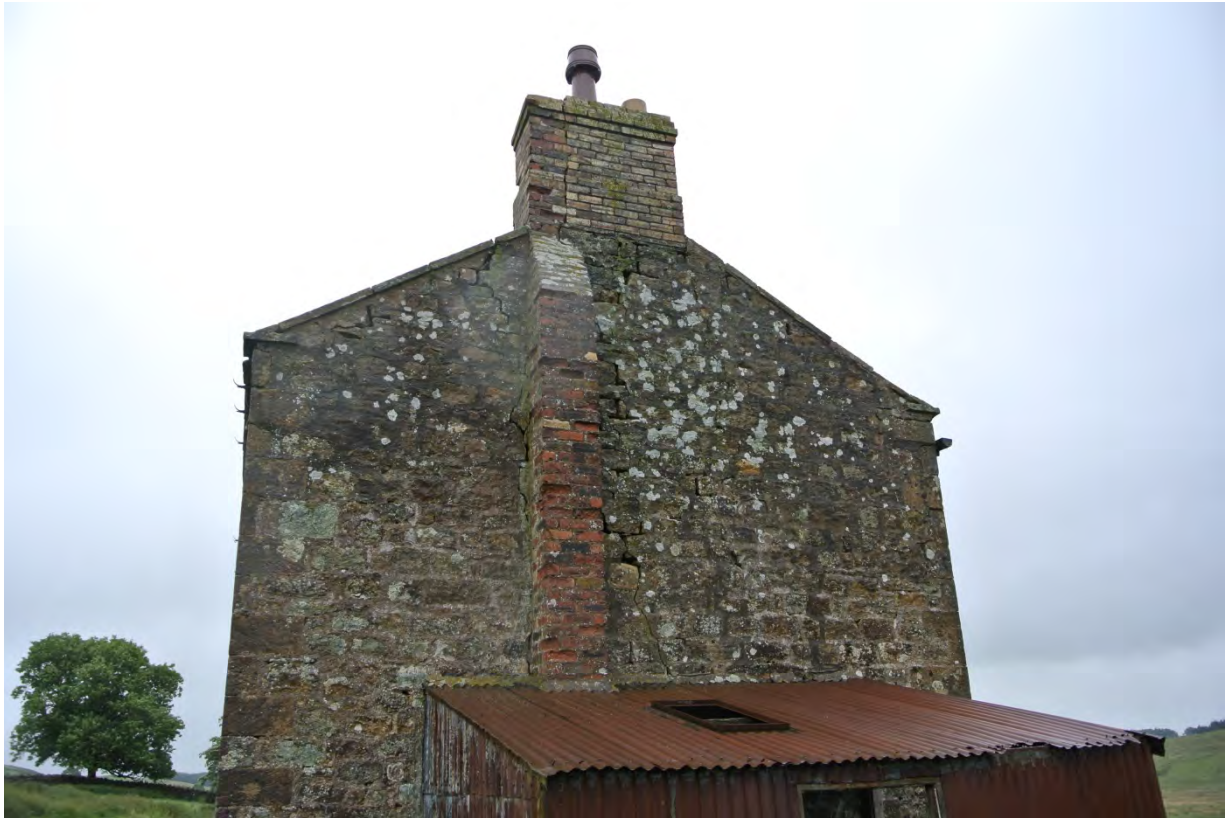
Existing West Elevation showing flue and stack to be removed.

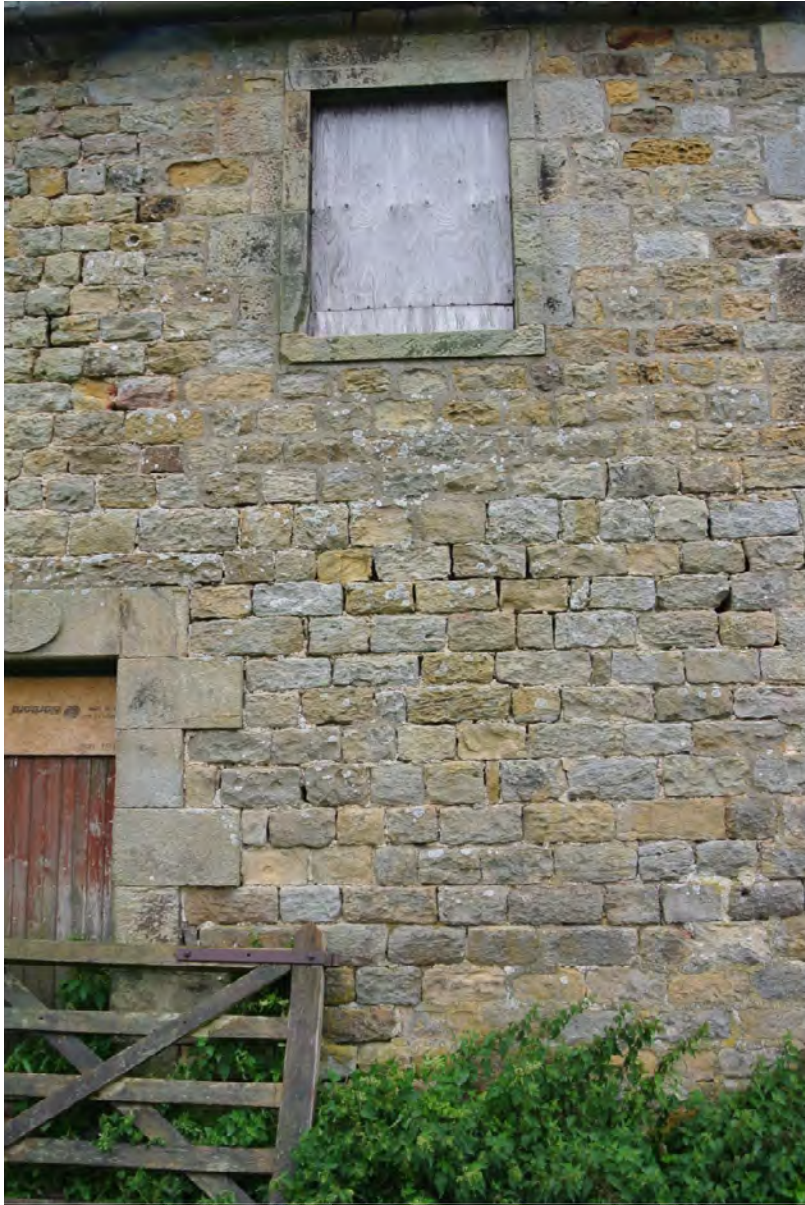
Part South Elevation showing location of new kitchen window

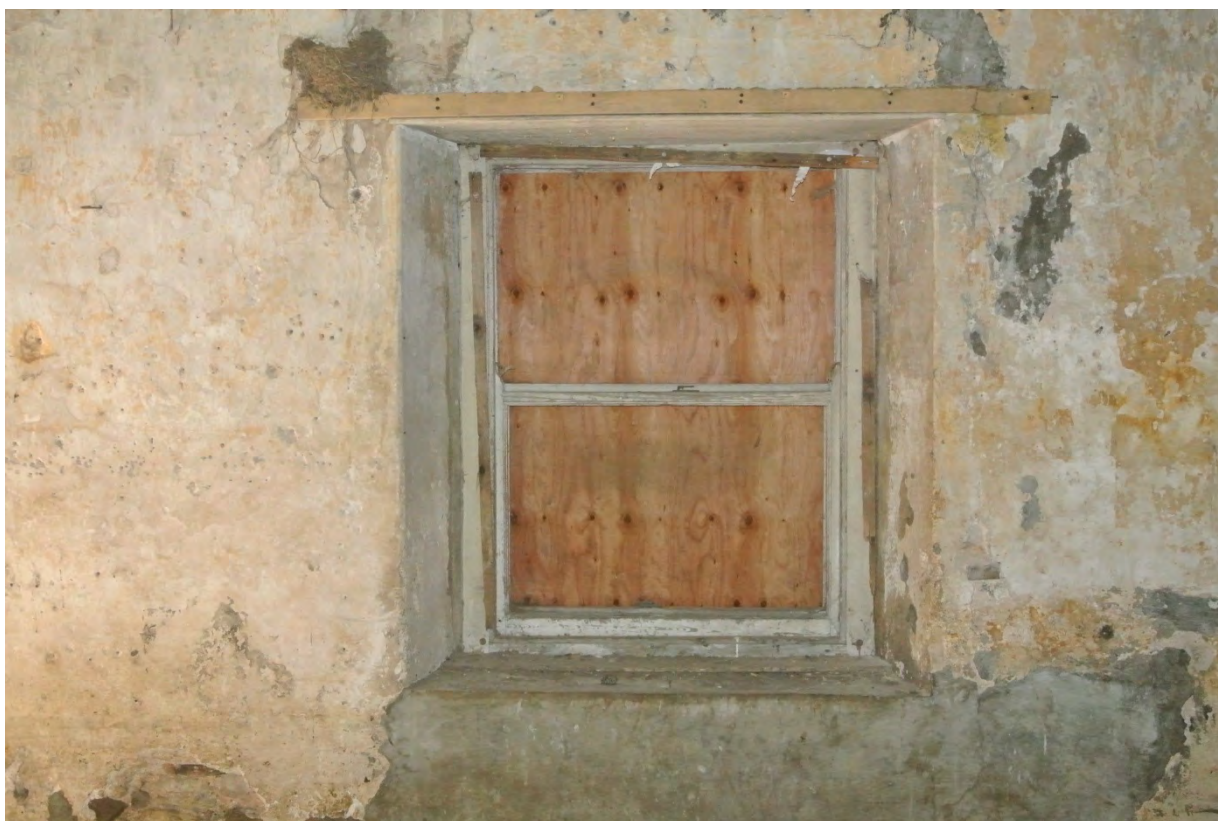
Existing sliding sash window to South elevation in Area 1

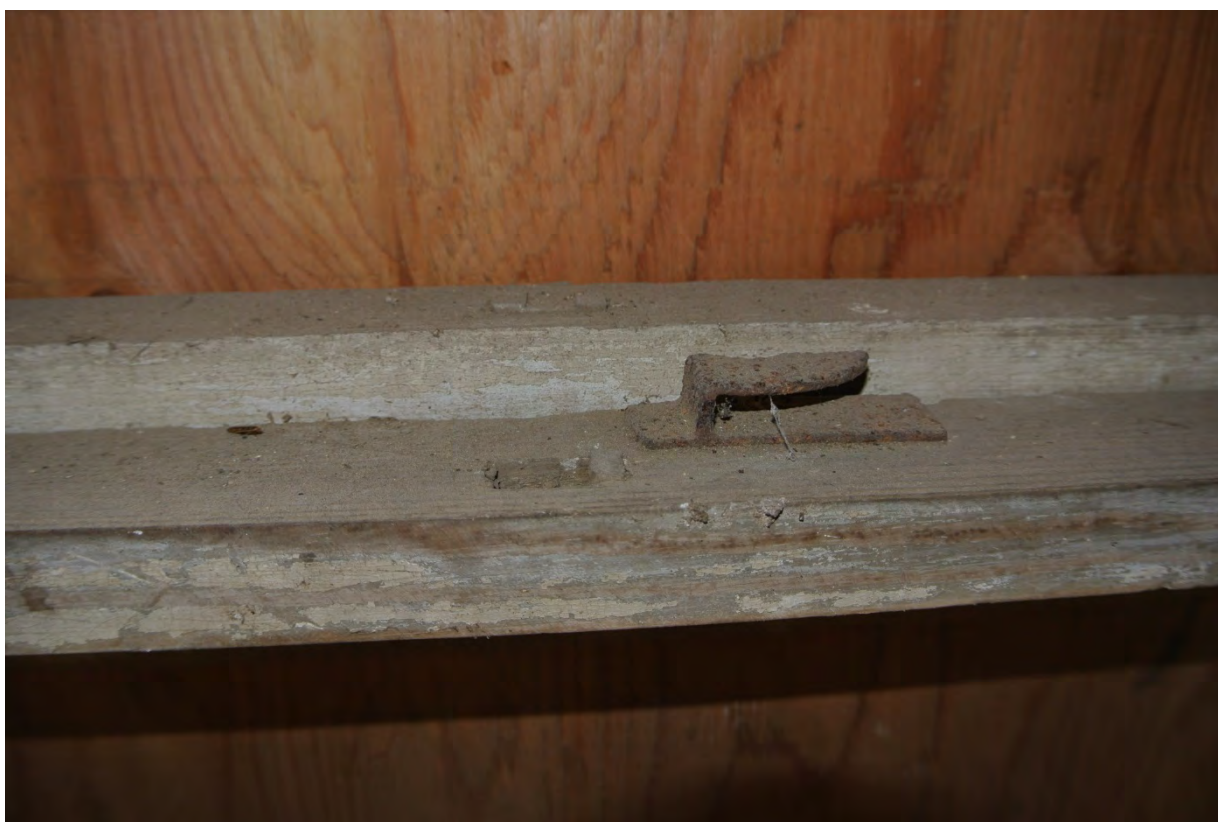
Detail of sliding sash window to South elevation in Area 1 showing mullion / glazing bar tenon hole

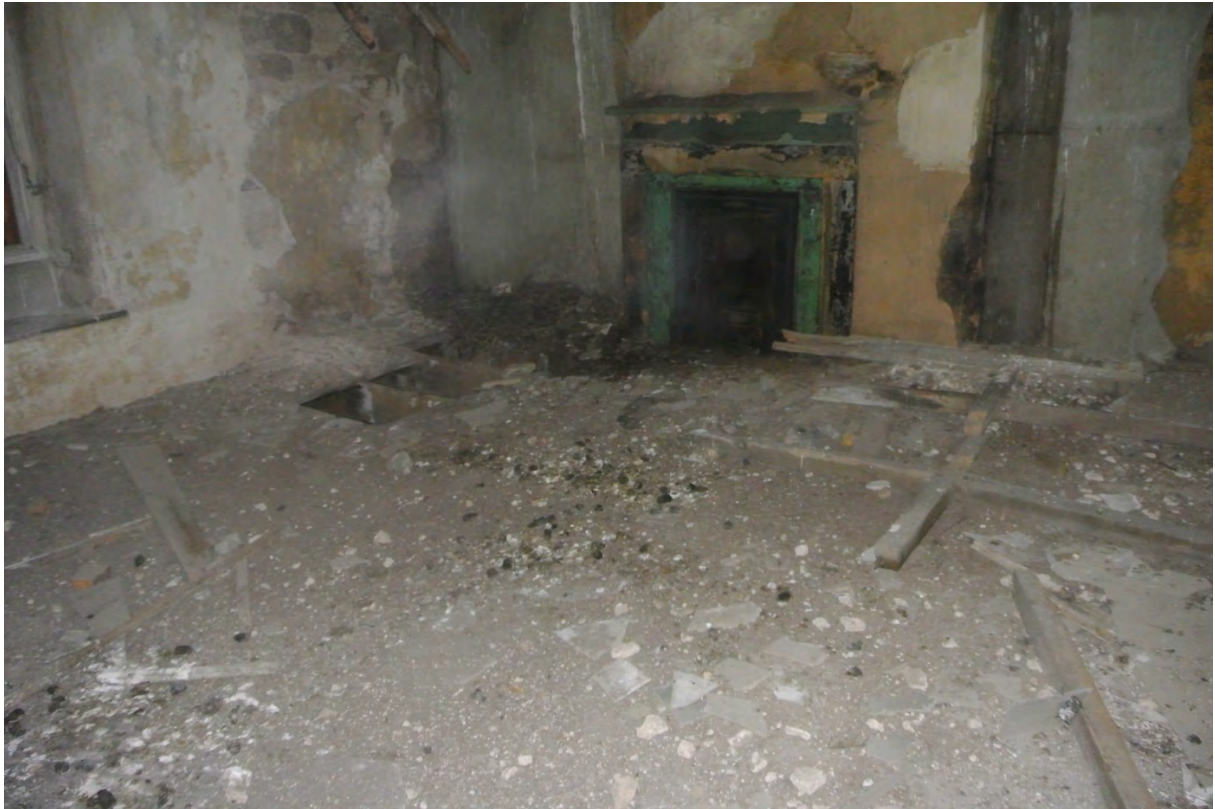
Internal view of West gable at first floor showing fireplace to be overhauled, fibre cement dry lining (ACM), rotten floor etc..

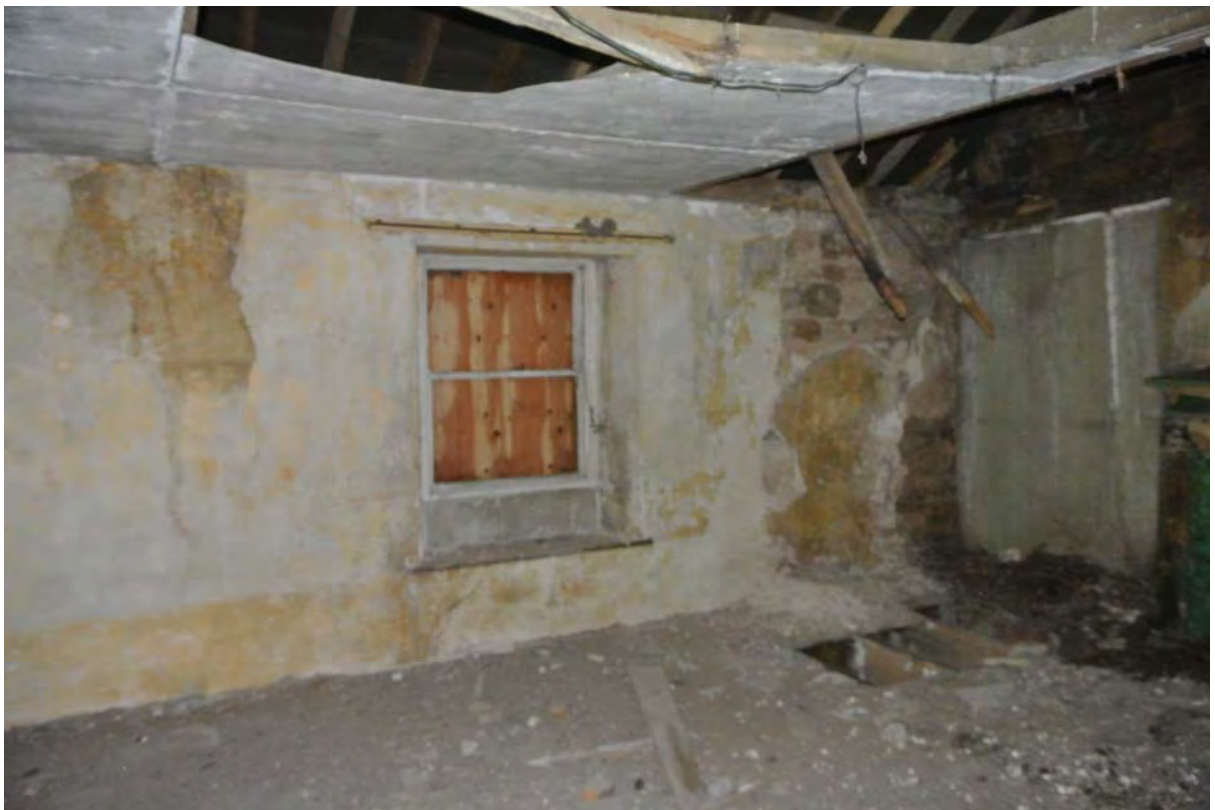
View of South wall in area 6 showing window and fibre cement dry lining / ceiling

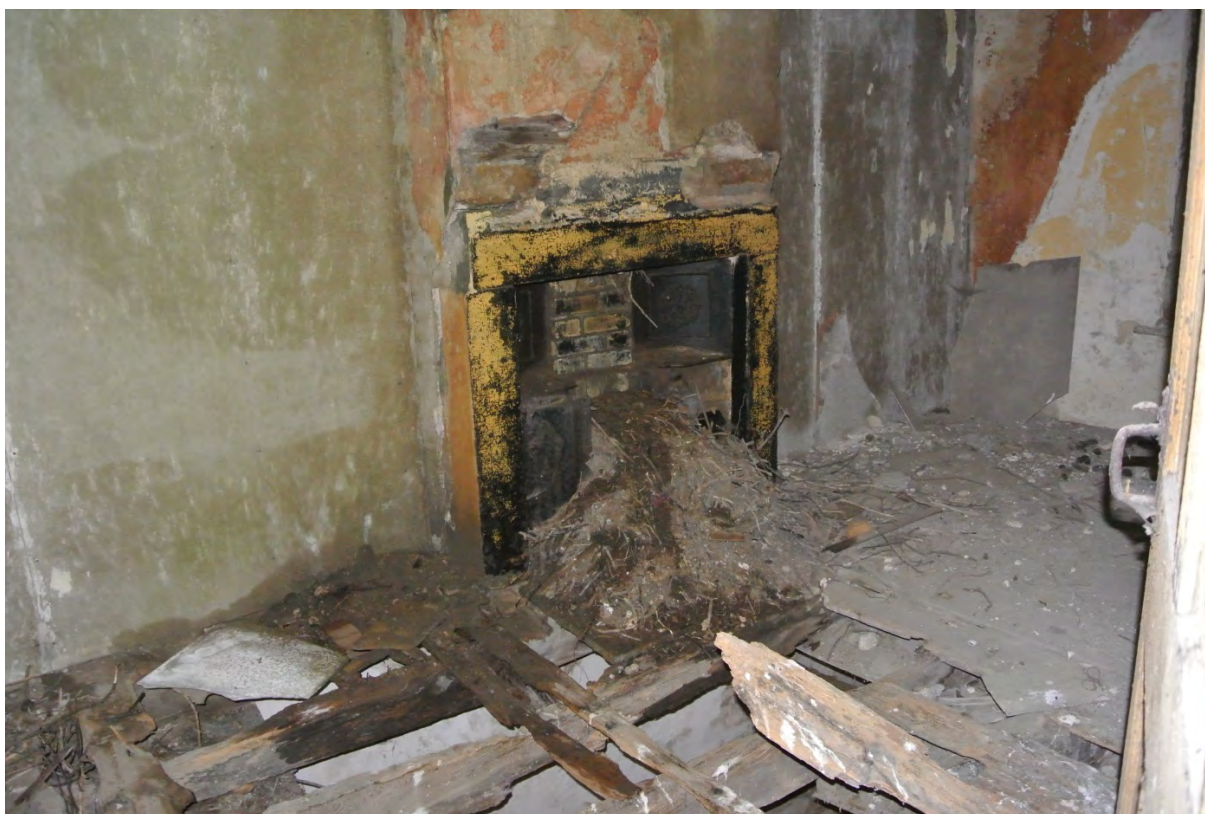
Internal view of East gable at first floor showing fireplace to be overhauled, fibre cement dry lining (ACM), rotten floor etc..

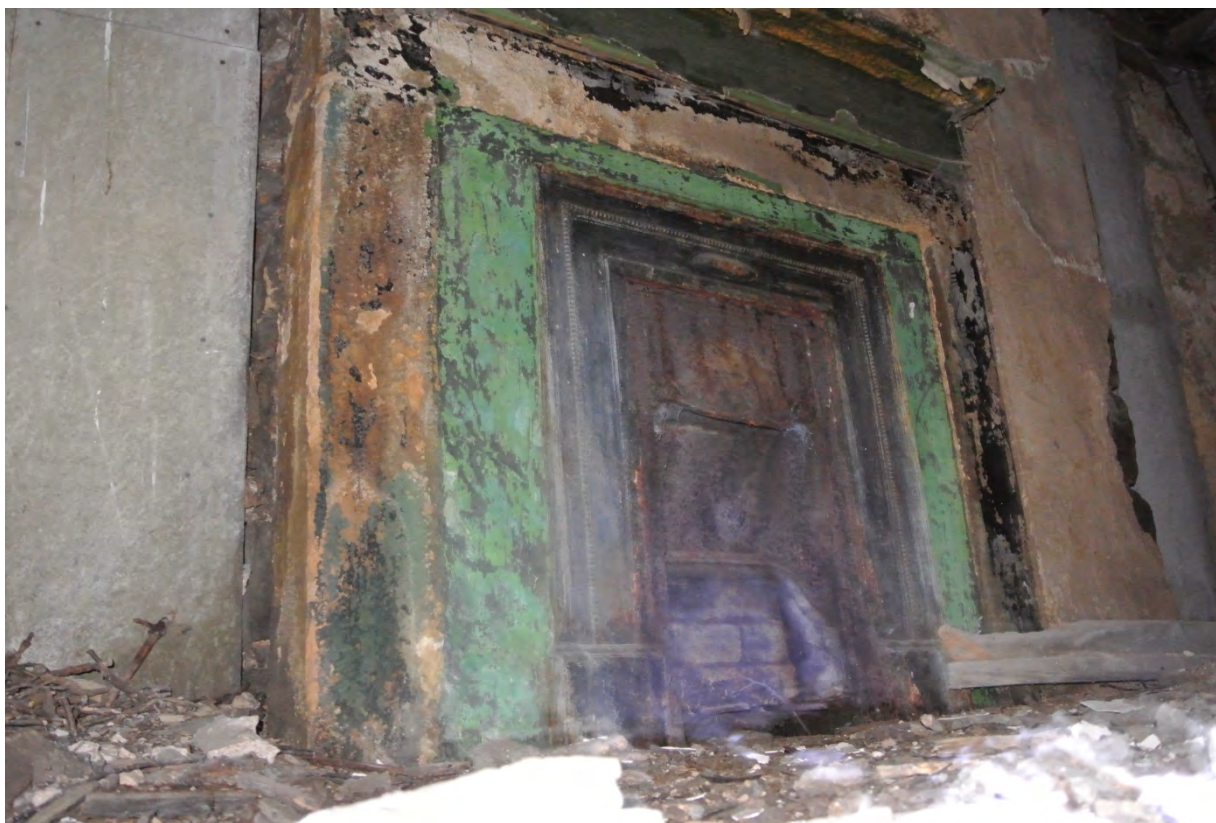
Detail of fireplace to West at first floor

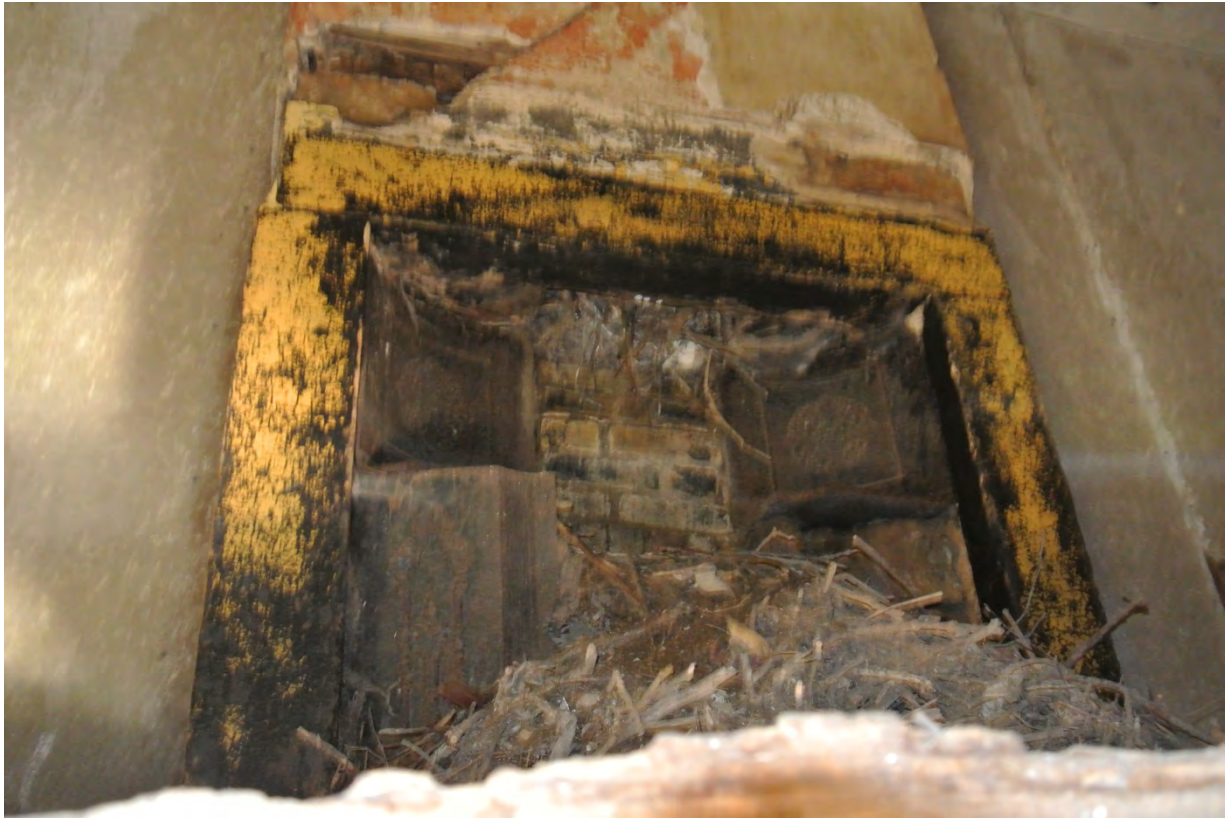
Detail of fireplace to East at first floor

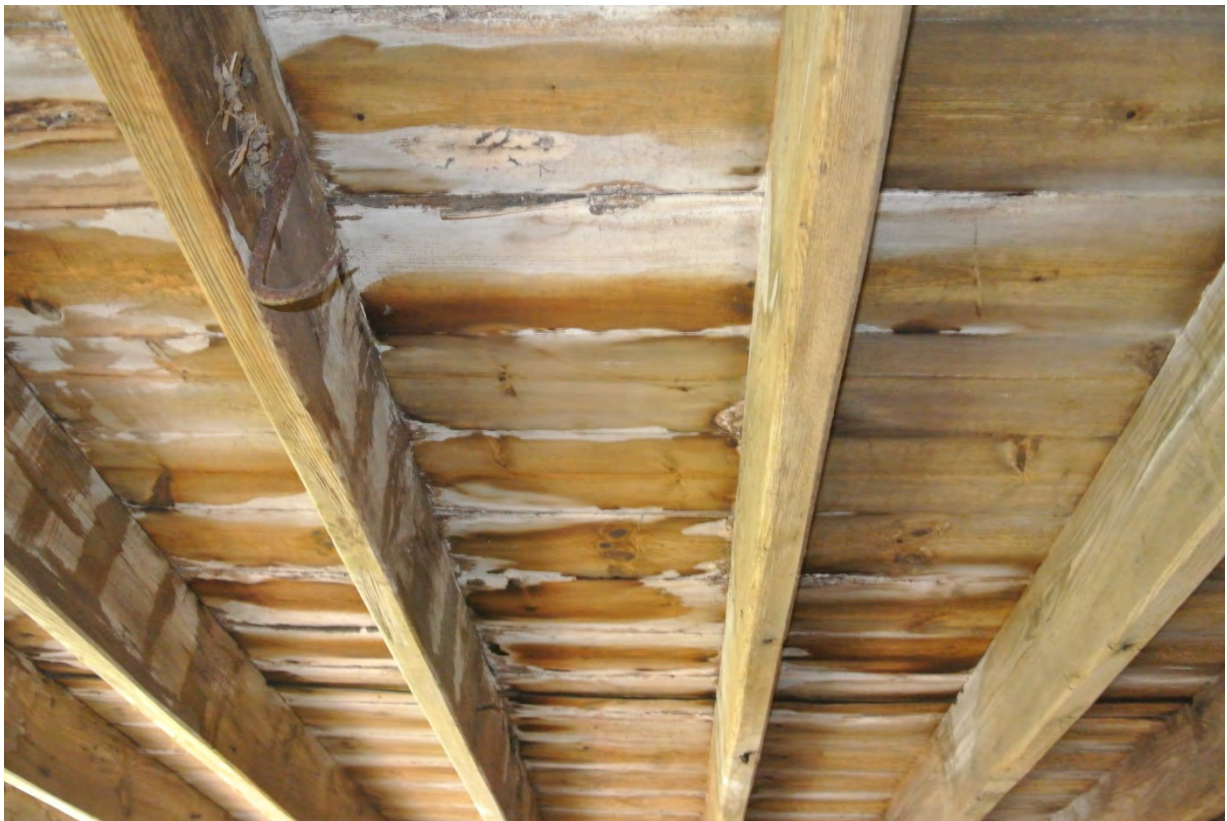
View of rotten floorboards in Area 2 and hooks to be reused

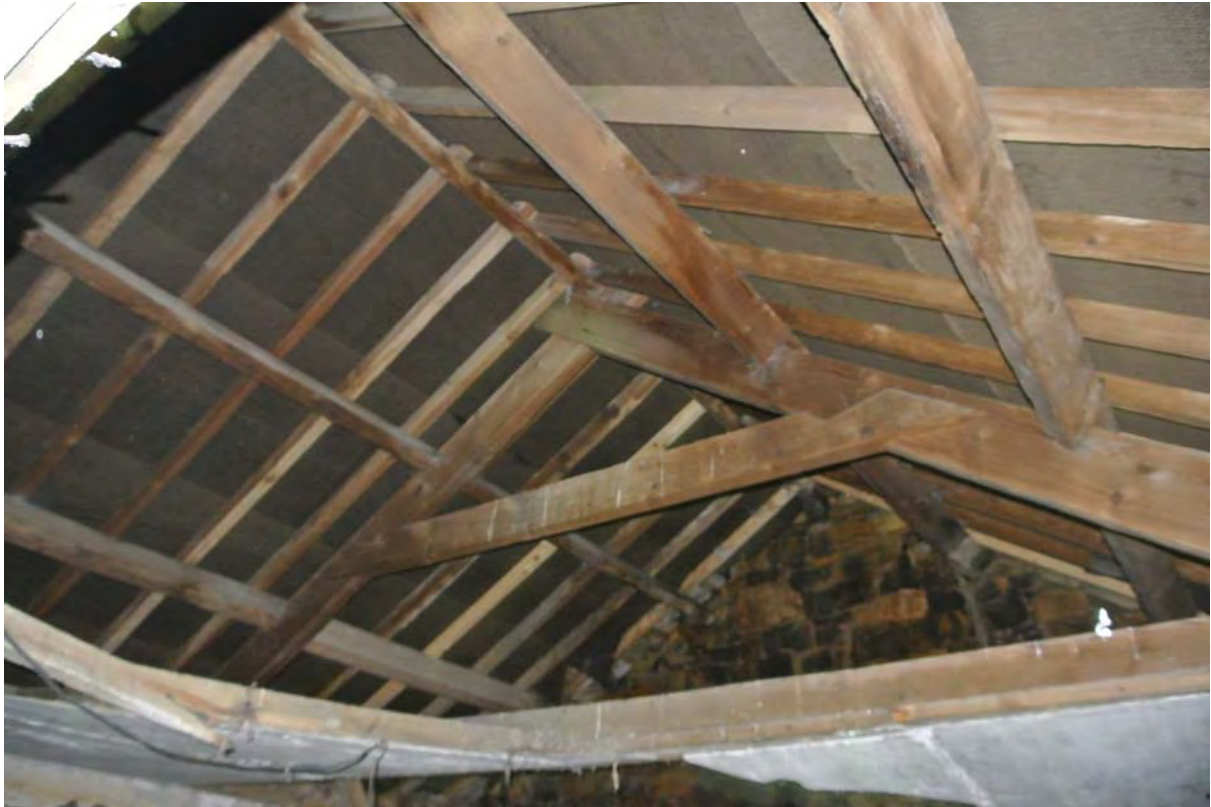
View of existing roof structure showing bitumen felt etc.

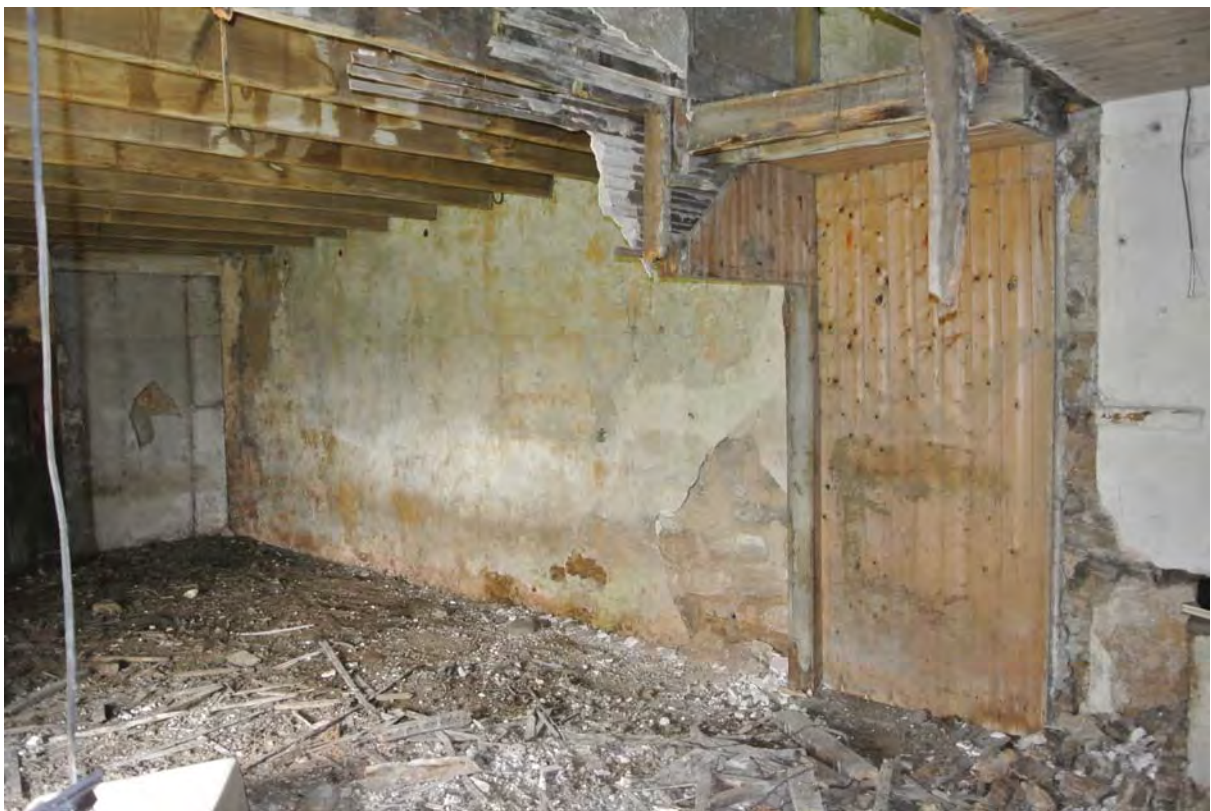
View of North wall at ground floor showing landing
