Claremont Joinery

7th. June 2020

Mr. Astles
1 The Square
Akeld
Wooler
Northumberland
NE71 6TA

During my recent visit to the above property I was requested to inspect the condition of the existing window frames. The following is a summary of my inspection.

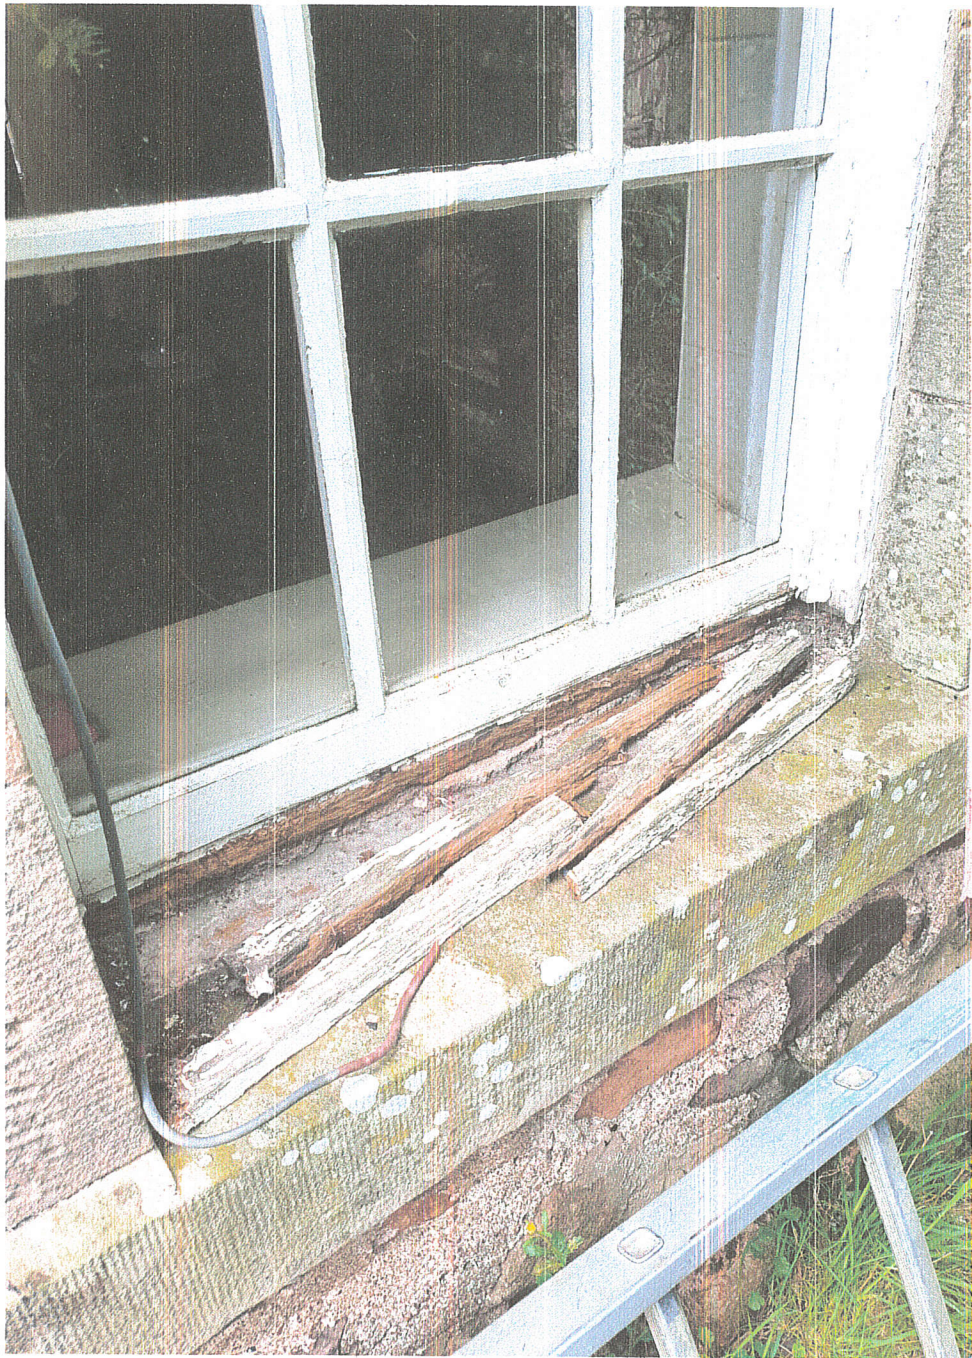
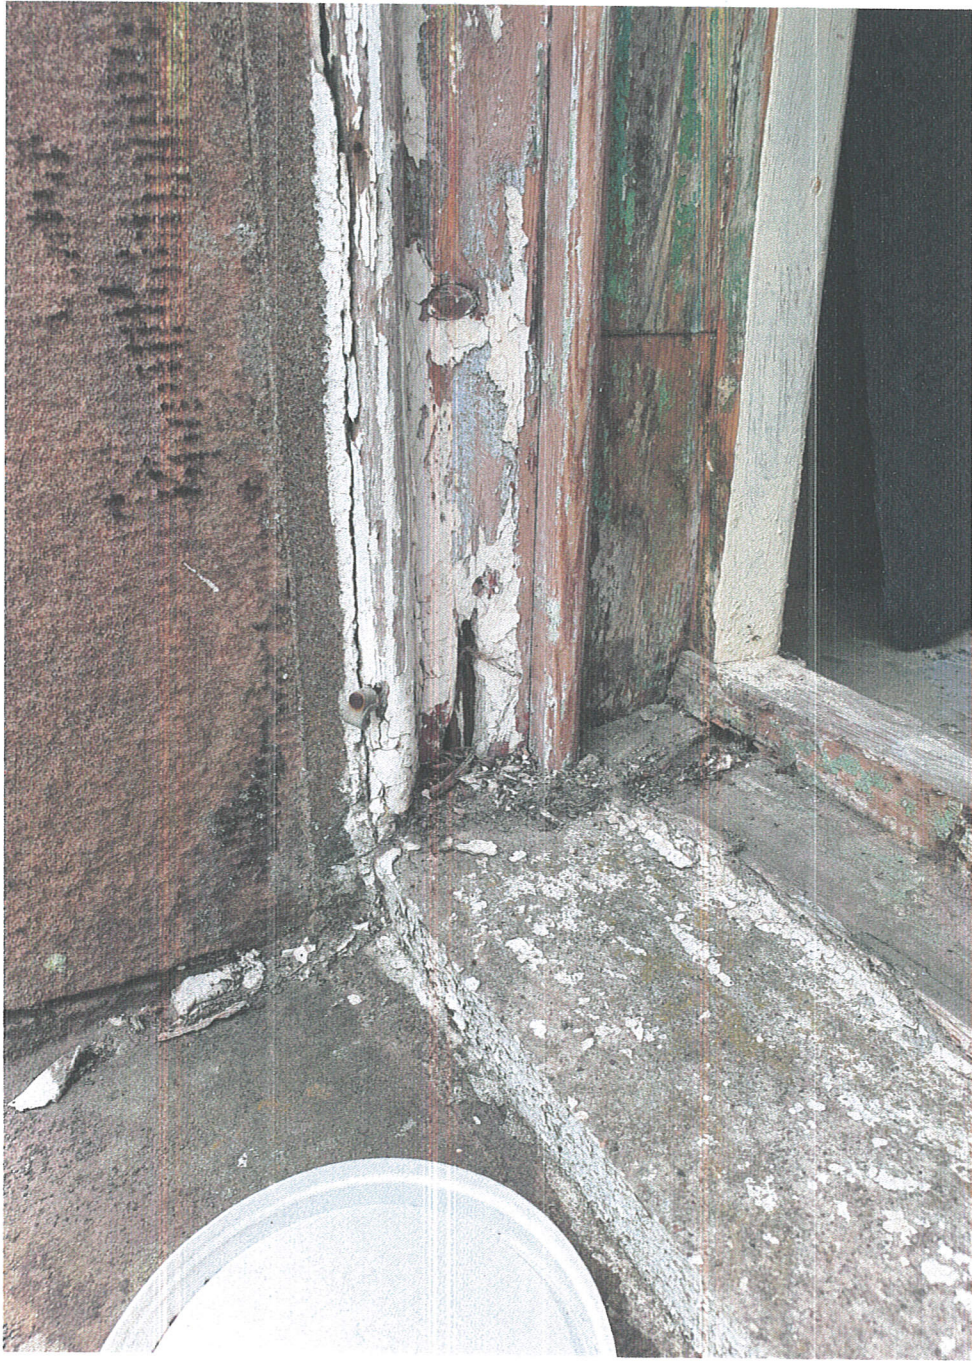
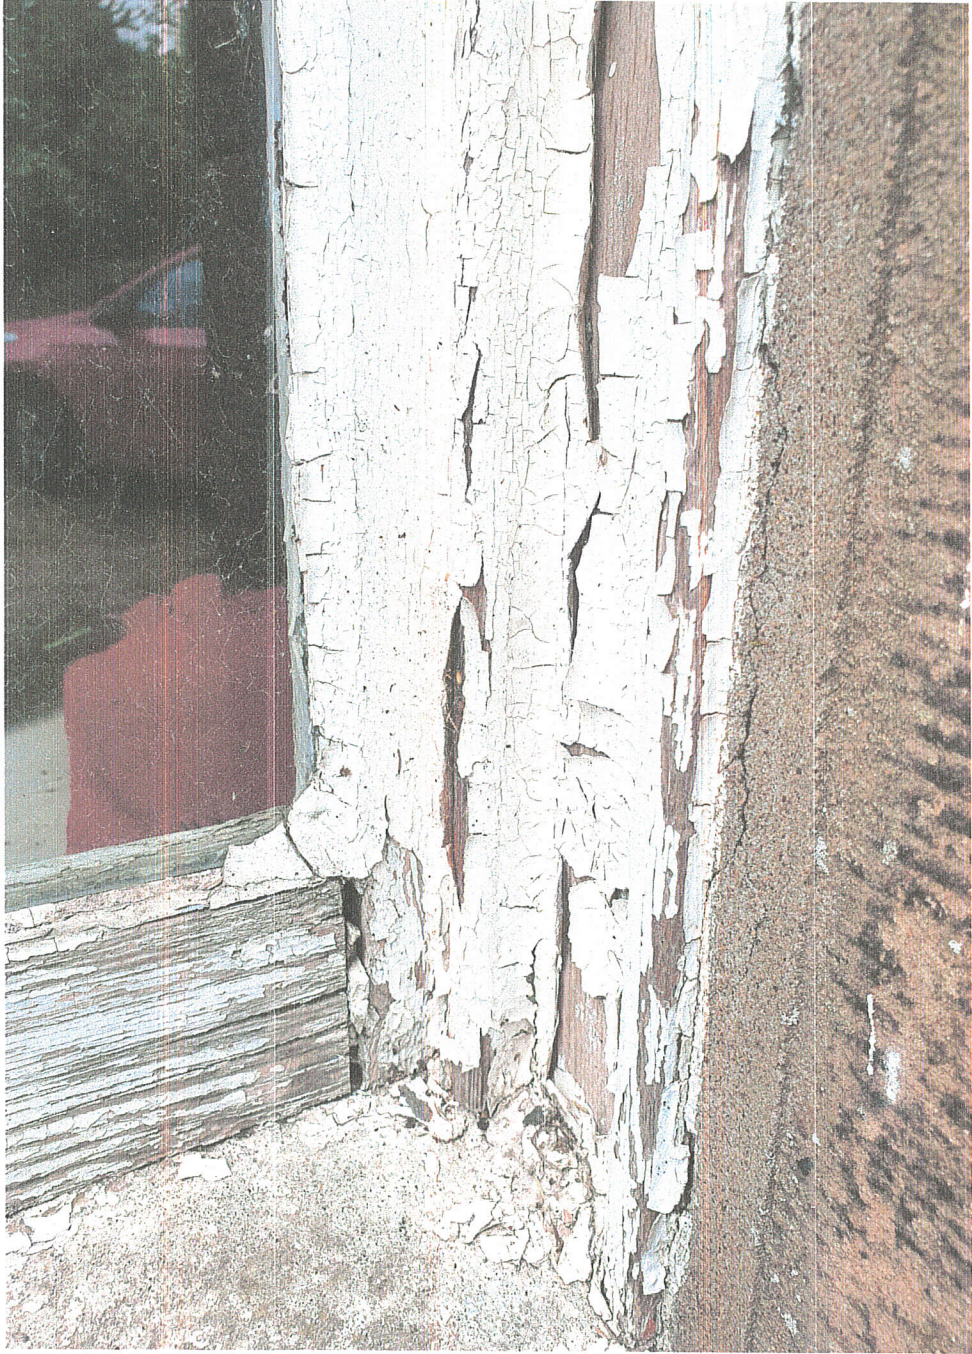
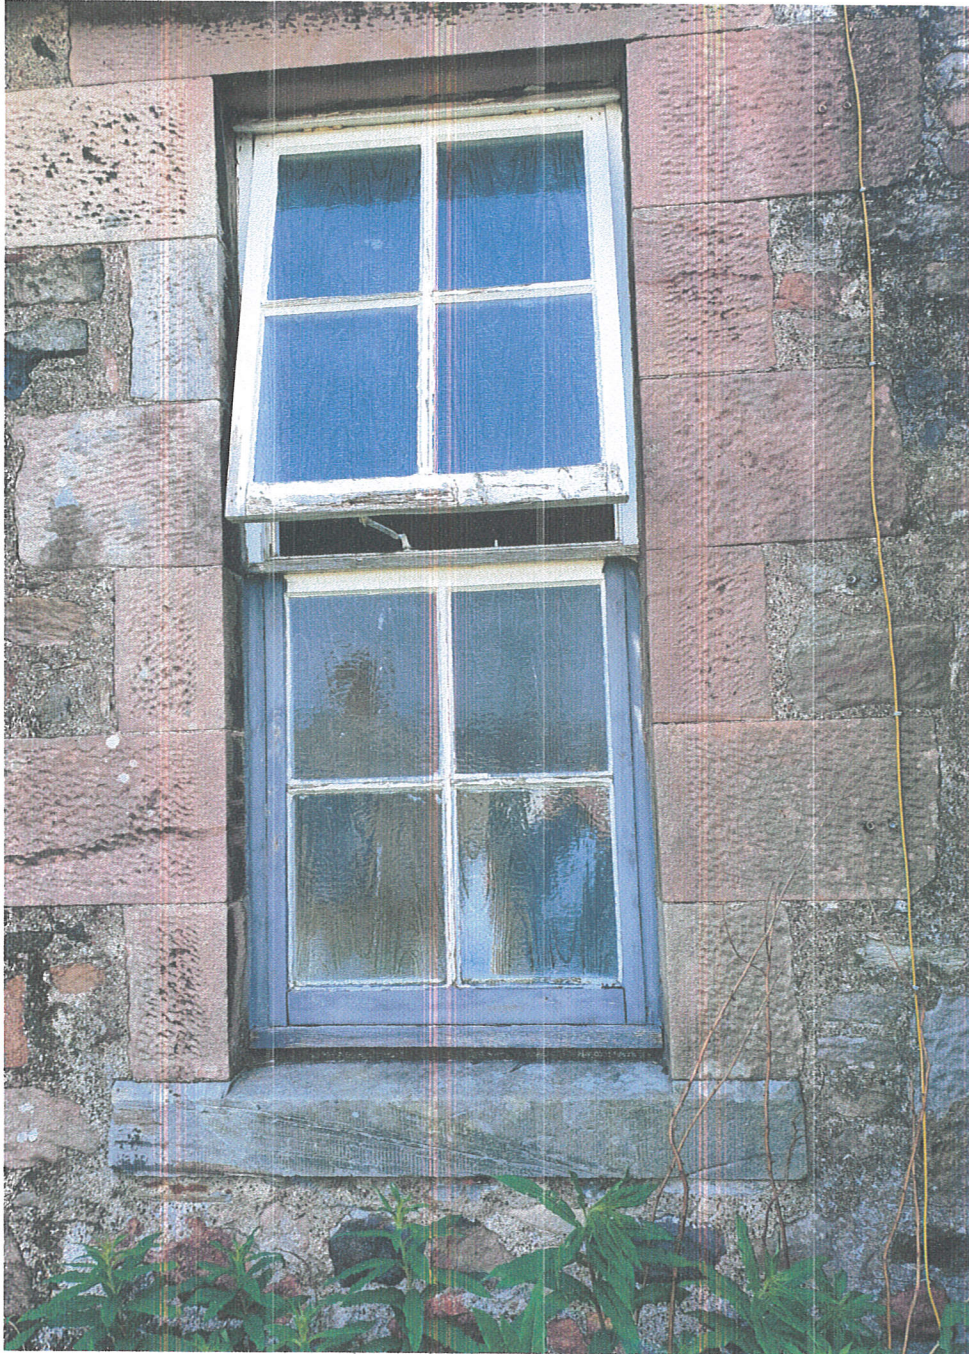
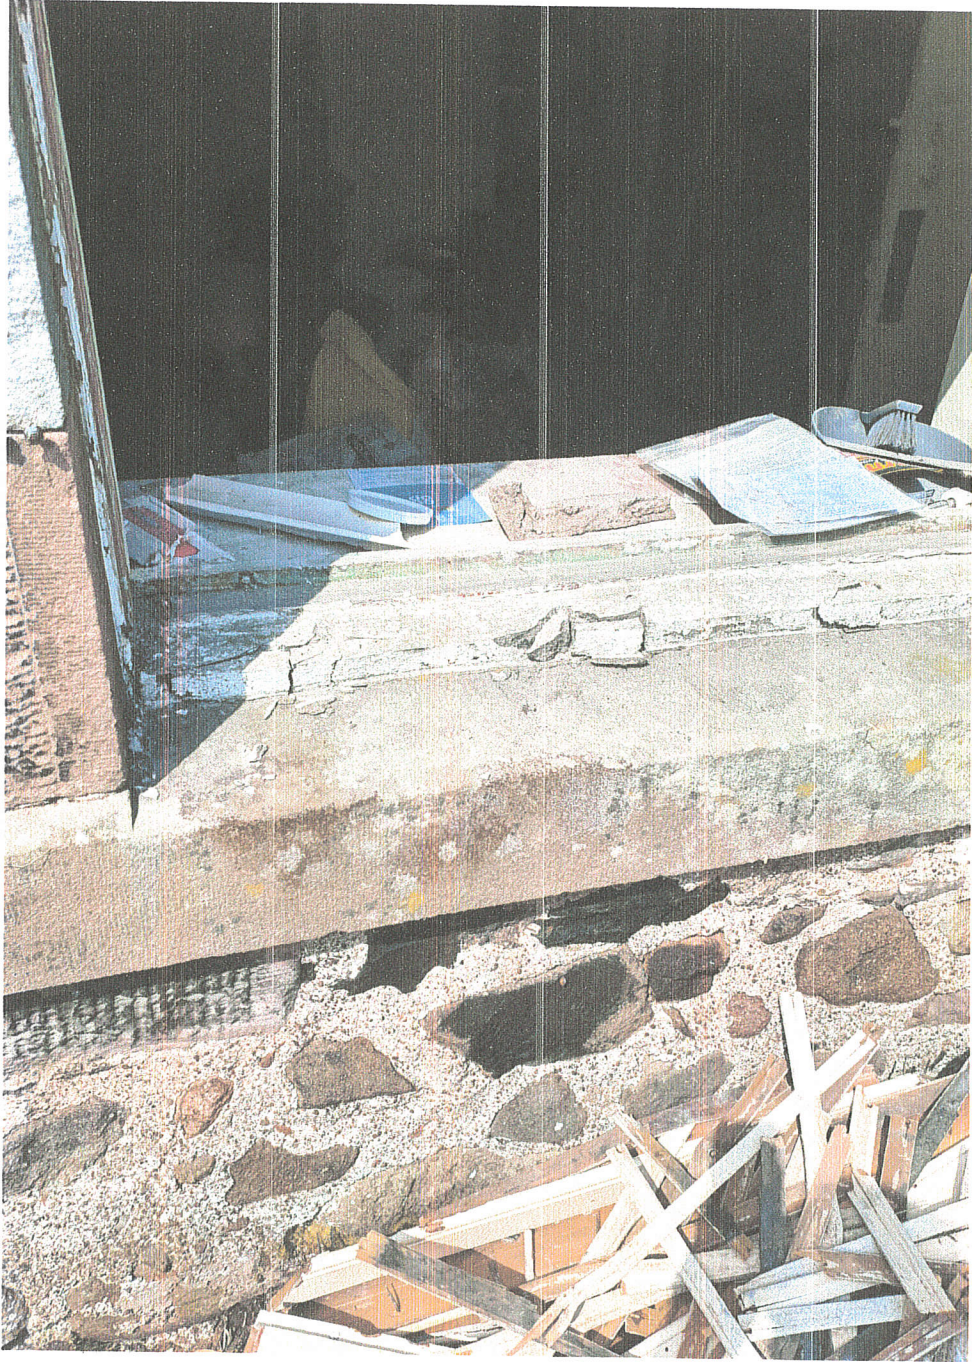
1. The sill sections to the 2no. windows on the east elevation had been removed & replaced with a concrete mix formed & painted to replicate the timber section. A section of one of these sills has broken & can be clearly see in the attached photograph. I've also attached photos of the following points.
2. The sill section of the window on the south elevation has totally rotted & become detached from the main body of the window.
3. In the case of the windows mentioned above, & the 2no. frames on the west elevation, decay was found to be prevalent not only in the sill sections but also in the pulley stiles & outer linings.
4. The bottom rails & stiles of the bottom sliding sashes are also suffering from decay with the mortice & tenon joints are starting to fail.
5. The original bathroom window has been replaced with a casement style window frame.

Taking into account the general condition & the highlighted issues with the existing window frames my recommendation would be to replace the frames with new windows manufactured to incorporate the style & features of the originals.
