project  
HIGHGREEN MANOR

drawing  
UNITS 3 AND 4: ROOF PLAN:  
PROPOSED  
With refurbishment notes

project nr	drawing nr	amendment
574	119	A

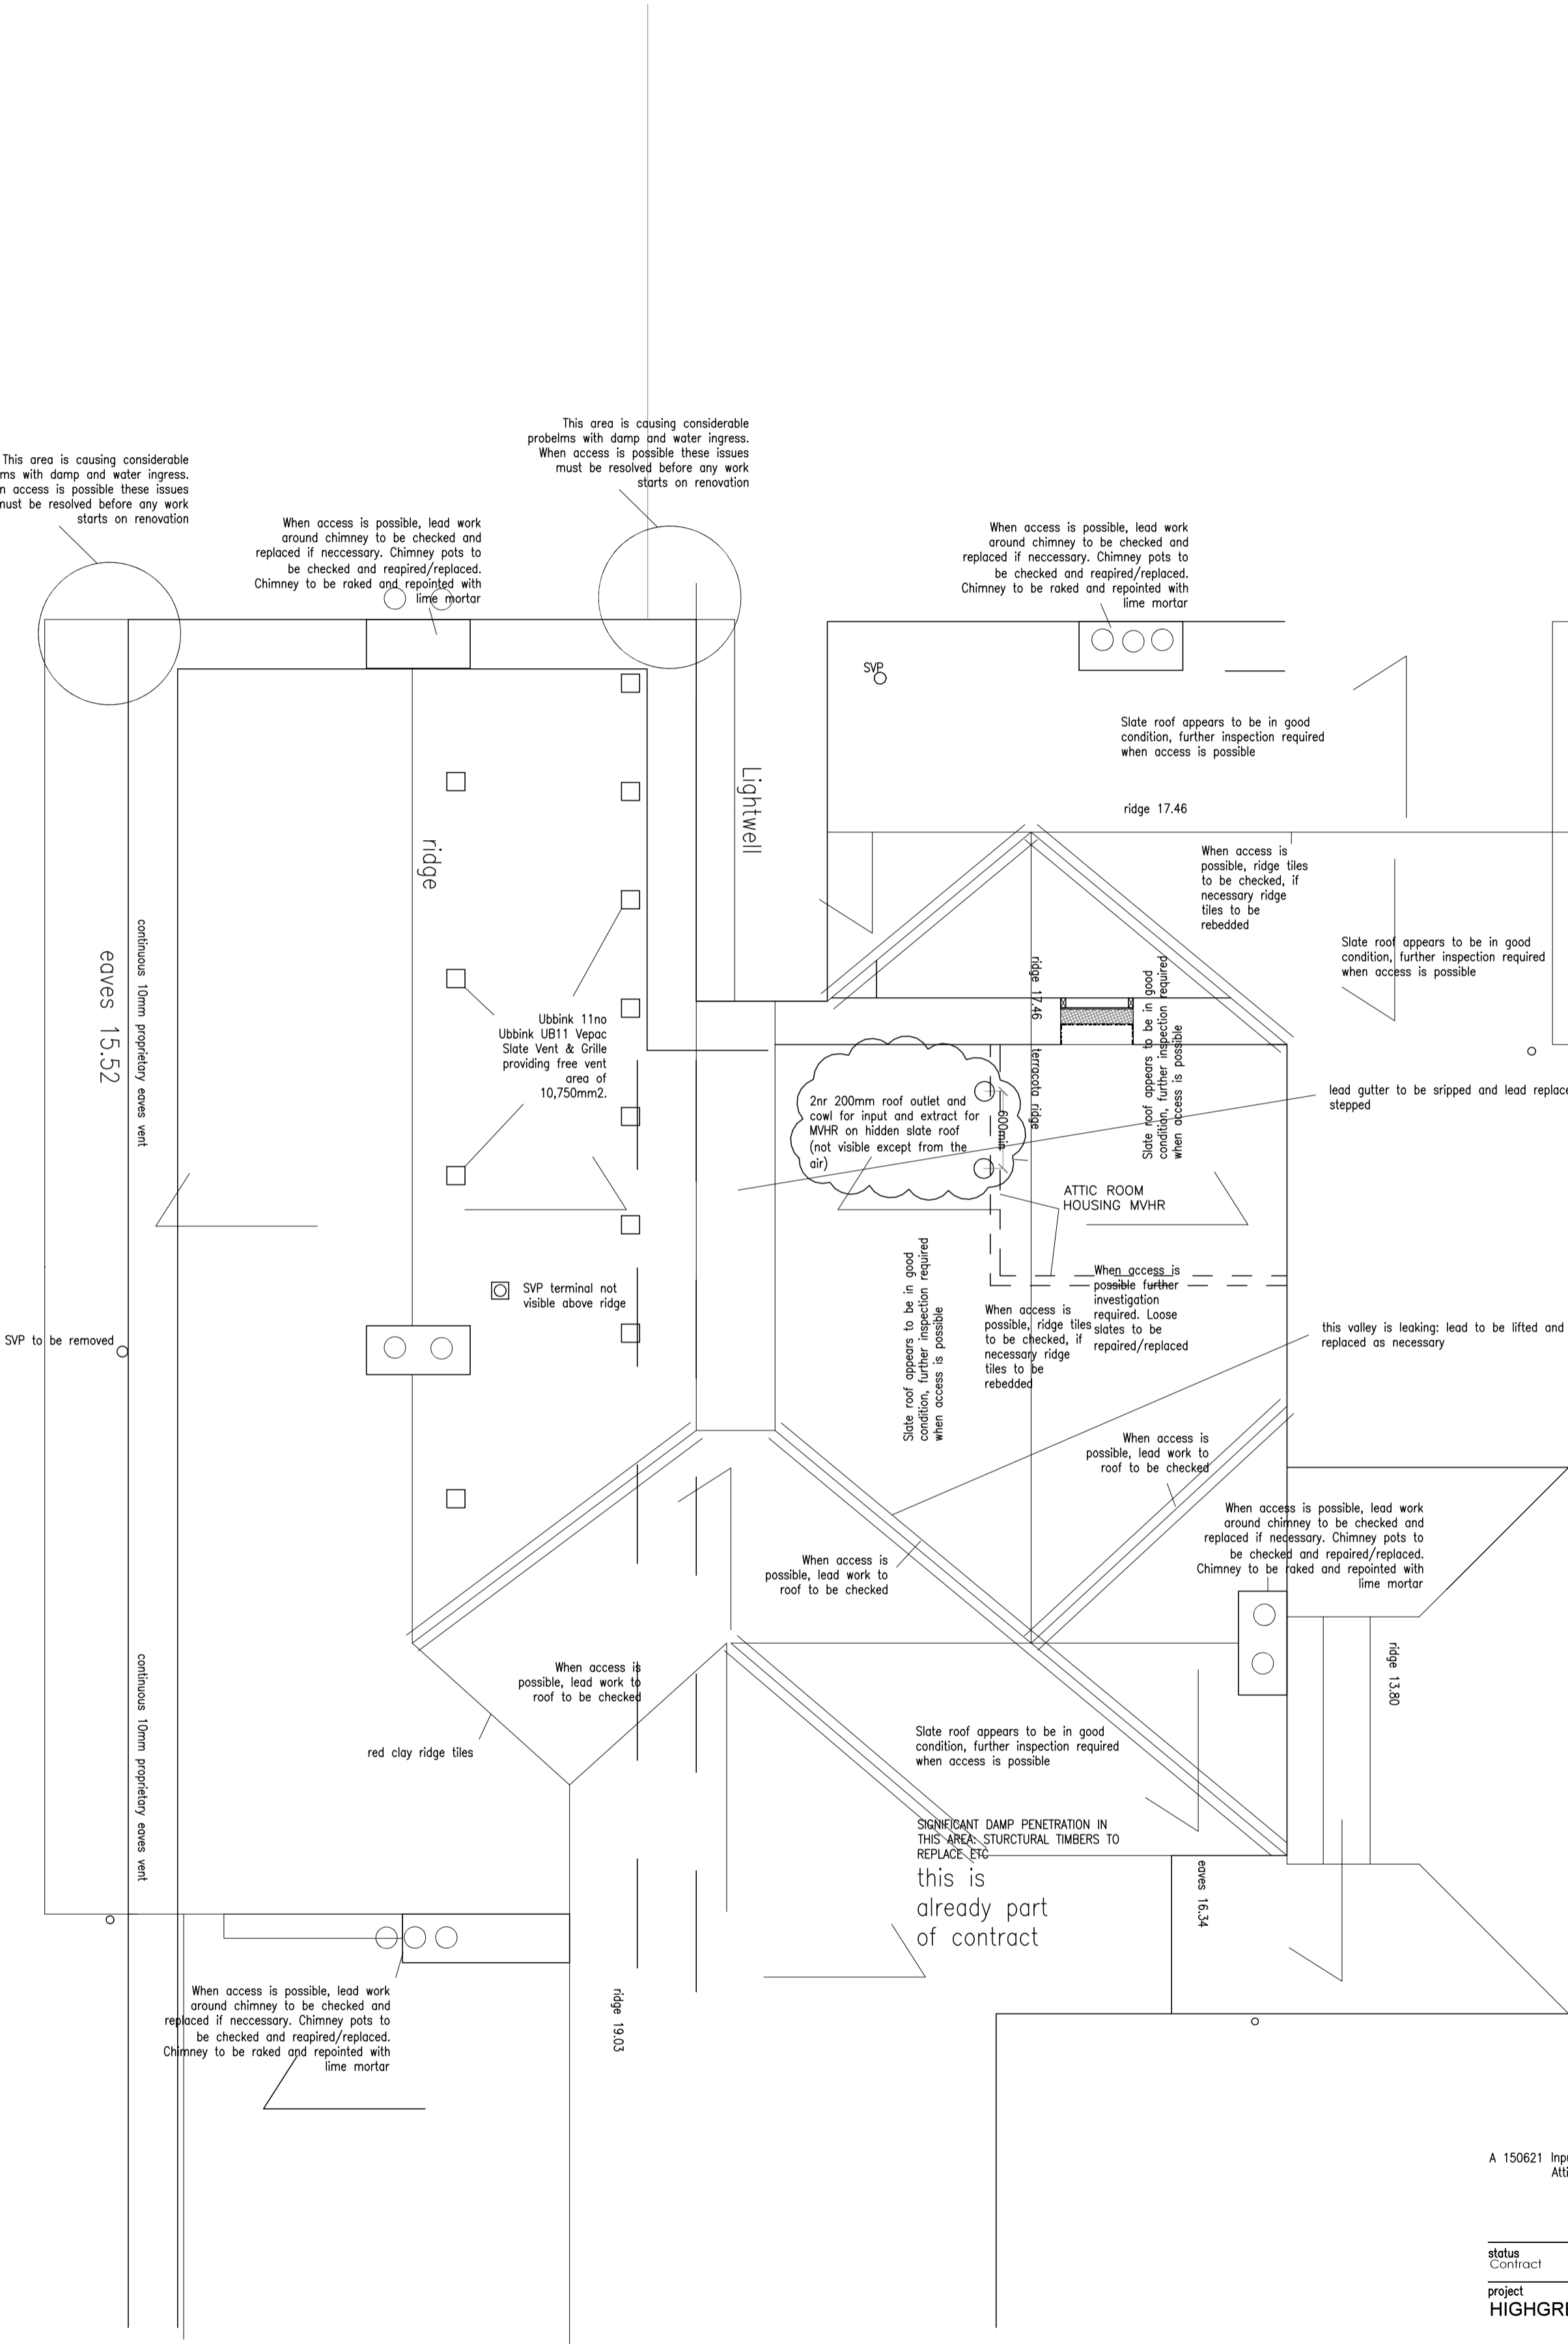
This area is causing considerable problems with damp and water ingress. When access is possible these issues must be resolved before any work starts on renovation

Slate roof appears to be in good condition, further inspection required when access is possible

this valley is leaking: lead to be lifted and timber under inspected and replaced as necessary

SIGNIFICANT DAMP PENETRATION IN THIS AREA. STURCTURAL TIMBERS TO REPLACE ETC

When access is possible, lead work around chimney to be checked and replaced if necessary. Chimney pots to be checked and repaired/replaced. Chimney to be raked and repointed with lime mortar

When access is possible, ridge tiles to be checked, if necessary ridge tiles to be rebedded

further investigation required. If necessary leadwork to be replaced

lead gutter to be stripped and lead replaced with shorter lengths, stepped

When access is possible, lead work to roof to be checked
