Design & Access Statement and Heritage Statement for Grade II Listed Redmire Bridge

Executive Summary.

This Design and Access and Heritage Statement has been prepared in order to demonstrate the requirement for strengthening works to be carried out to Redmire Bridge, a three span Grade II listed masonry arch structure carrying the single track C199 minor road over the Tarset Burn, and to accompany a Listed Building Consent Application deemed necessary for the works.

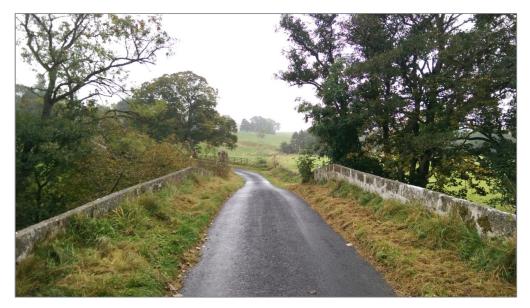
The carriageway over the bridge appeared to be in fair to poor condition. Verges to both sides of the road were overgrown with vegetation.

Photograph 1 – Poor surfacing and vegetation growth in verges looking southeast over bridge (16.10.2016)

Carriageway reconstruction will maintain the existing road width and include kerbs with hardened verges to prevent water ingress and to mitigate the risk of falling with the low parapet present.

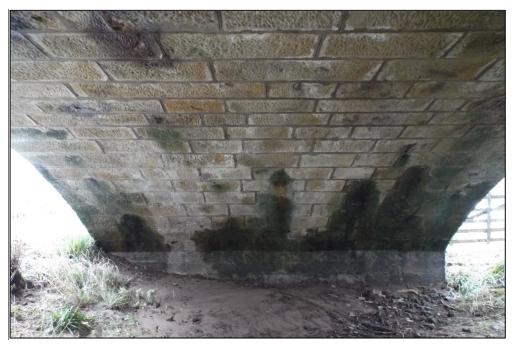
Photograph 2 – Dampness and staining to arch barrel masonry of north abutment

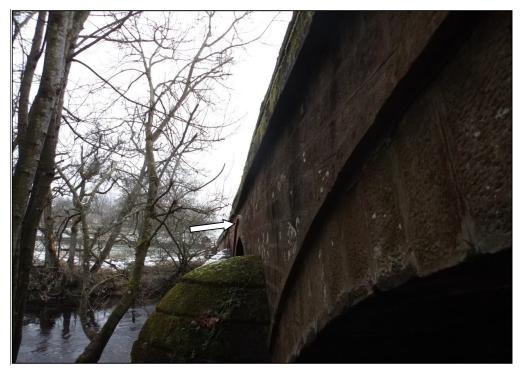
Photograph 3 – Bulging spandrel wall above west pier upstream elevation

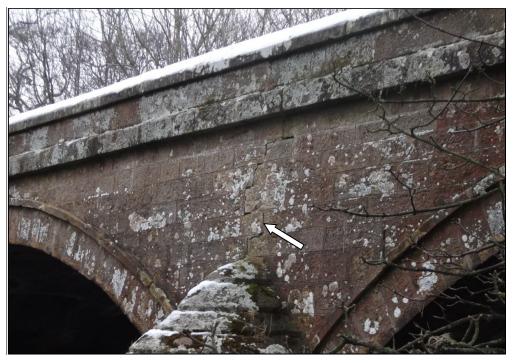
Photograph 4 – Crack above east pier to downstream elevation

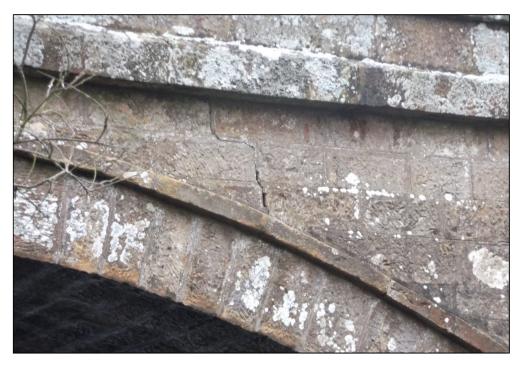
Photograph 5 – Crack in centre span spandrel to downstream elevation

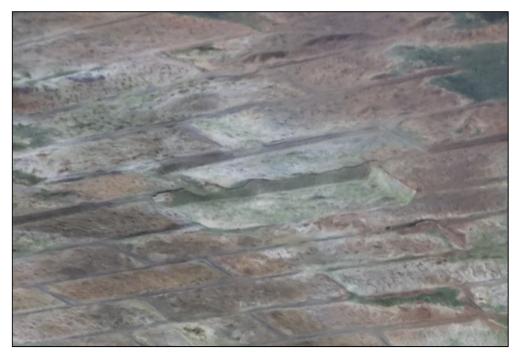
Photograph 6 – Displaced masonry block to south span arch crown

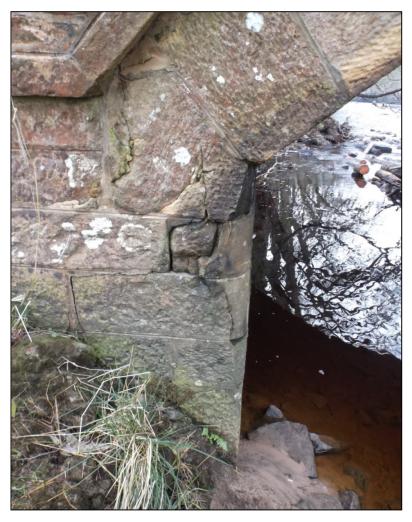
Photograph 7 – Masonry crushing at south abutment springing

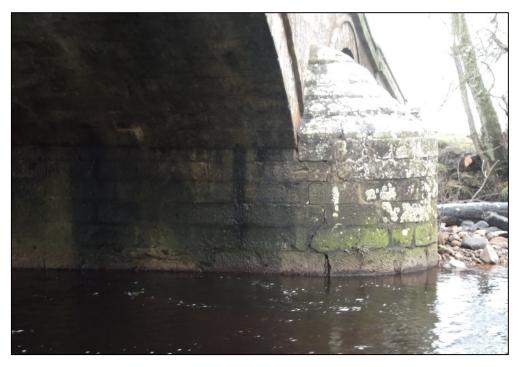
Photograph 8 – Crack and open joints to east pier downstream cutwater

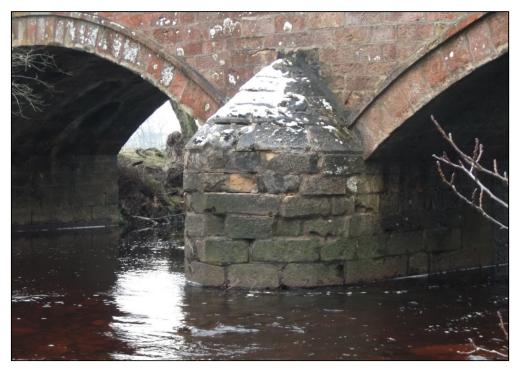
Photograph 9 – Open joints in east pier upstream cutwater, note evidence of recent spalling

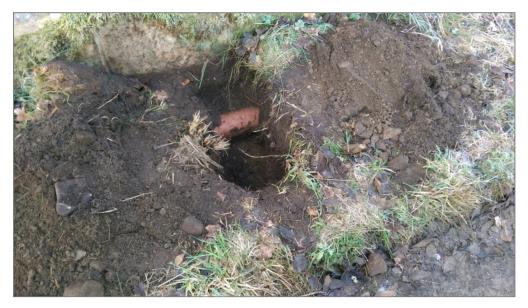
Photograph 10 – Downstream verge BT duct (05/12/2016).

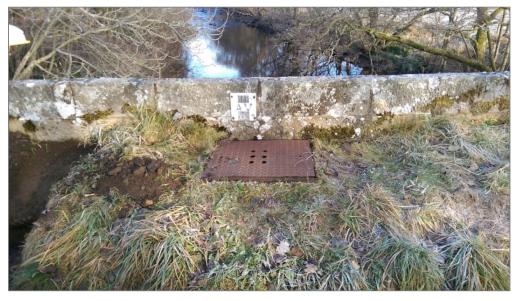
Photograph 11 – Abandoned water main cover to the Upstream verge (05/12/2016).
