NORTHUMBERLAND COUNTY COUNCIL

SWINDON KENNELS BRIDGE UNDERWATER INSPECTION REPORT MAY 2019

**REPORT TITLE: SWINDON KENNELS BRIDGE
INSPECTION REPORT – 31ST MAY 2019**

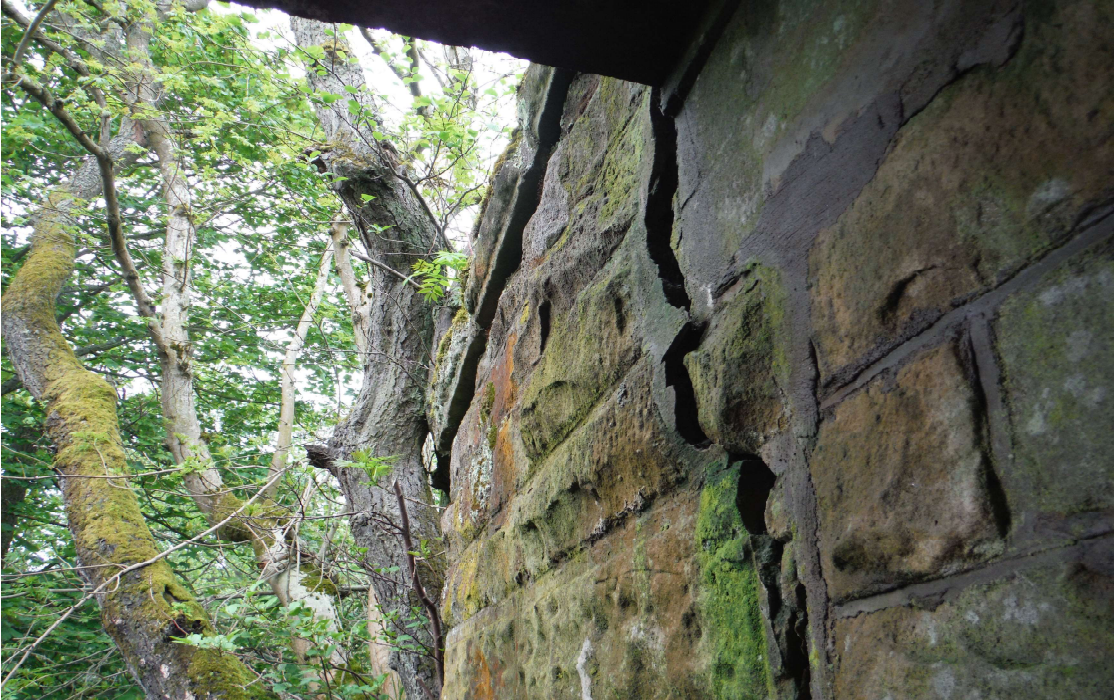
Photo 1

It was noted that two vertical cracks run beneath the deck of the bridge these measured 30mm at the top of the wall on the east end down to zero at the bed level.

It was also noted to have rotated out by approximately 30mm at the top.

The vertical crack at the west end of the abutment again runs the full height and measures 40mm at the widest point which is at the top, again the masonry was noted to have rotated 30mm at the top. The crack tapers from the top to the bottom. (See Photo 1,2)

Rotation at top of south abutment

The bridge was found to be in generally good condition.
No loss of mortar with the exception of the cracks which appear on the abutments.
The south side of the bridge which seems to have more rotation than the north should be monitored for further rotation.
The area of scour area on the west end of the north abutment should be monitored for further deterioration.

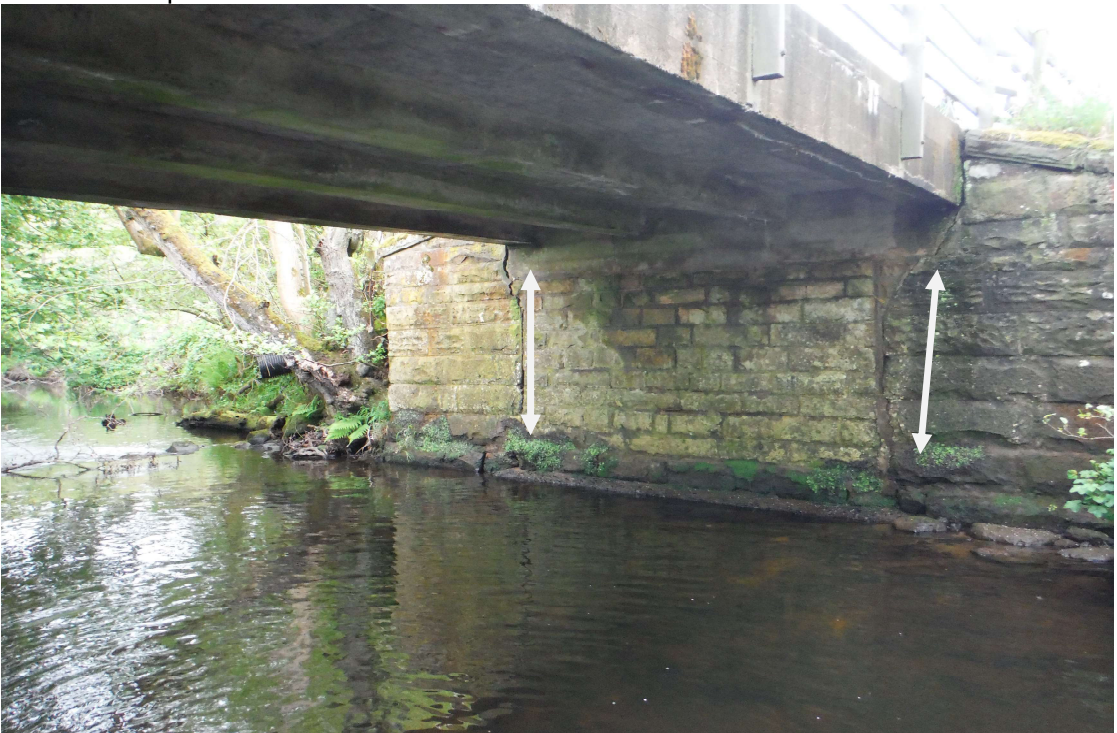
Both of the north and south abutment cracks have been re-pointed at some point and this has cracked due to the rotation.

Photo 2 South abutment, arrows show cracks.

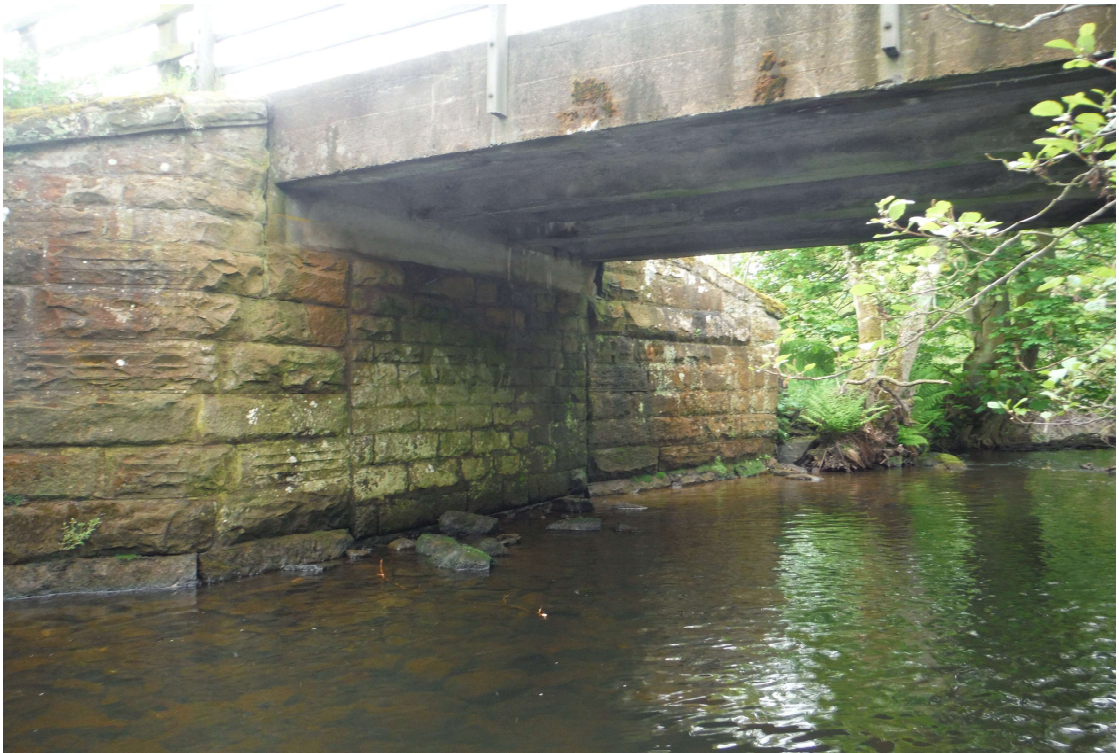
It was noted that two vertical cracks run beneath the deck of the bridge these measure; on the west end from the top of the wall to the bed at its widest it measures 20mm down to zero at the bed. The east end crack only runs from the top of the wall and measures 5mm wide at the widest point down to zero, it only measures 2.3m long. (See photo 3)

Photo 3 North abutment

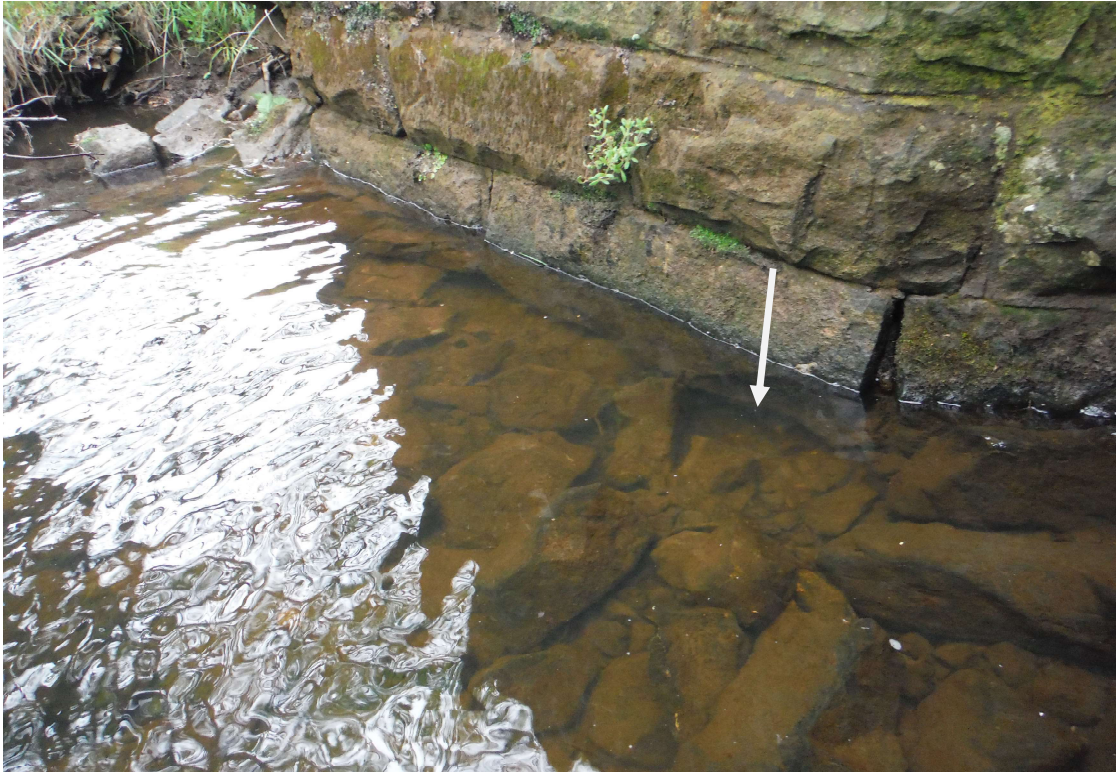
At the west end of the abutment a small area of scour was noted on the return corner this measures 1m long x 400mm deep at the deepest point and 40mm high at the highest point. (See photo 4) No other damage or defects were noted.

Photo 4 Scour area on west end of north abutment shown by arrow.

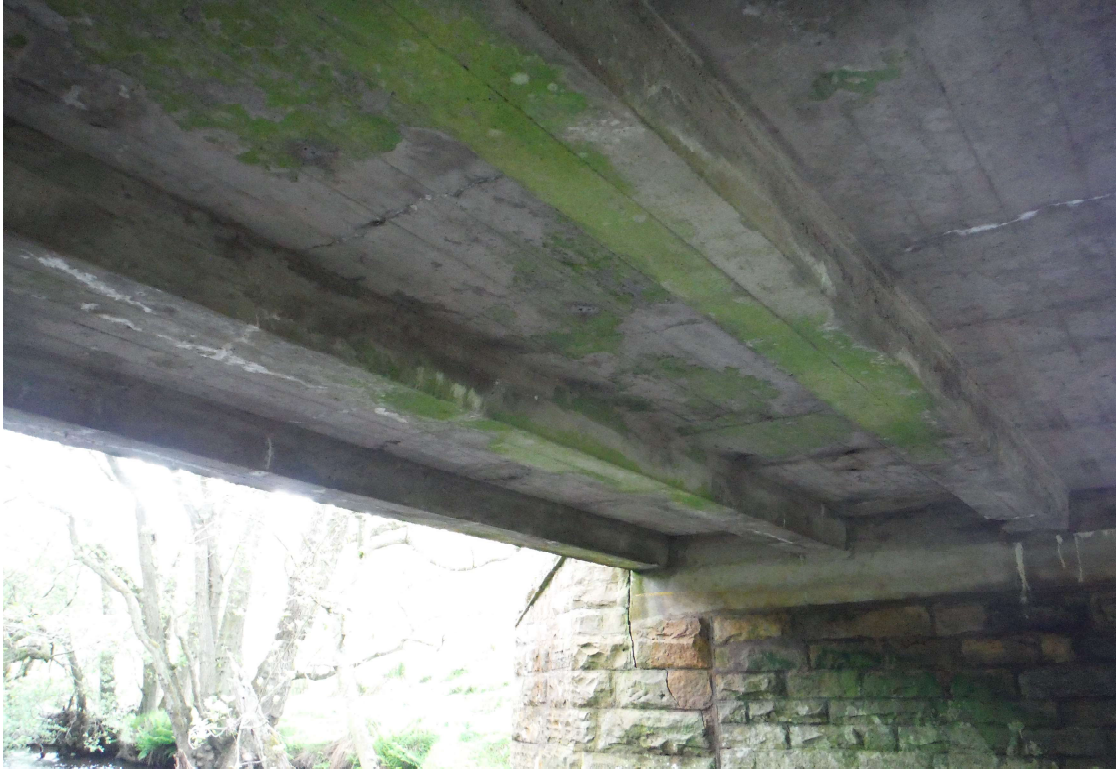
The deck was constructed of encased RSJ and a concrete deck it was noted to be free from defects and damage. (See photo 5)

Photo 5 Underside of deck.
