Swindon Kennels Bridge FEASIBILITY REPORT

1 Executive Summary

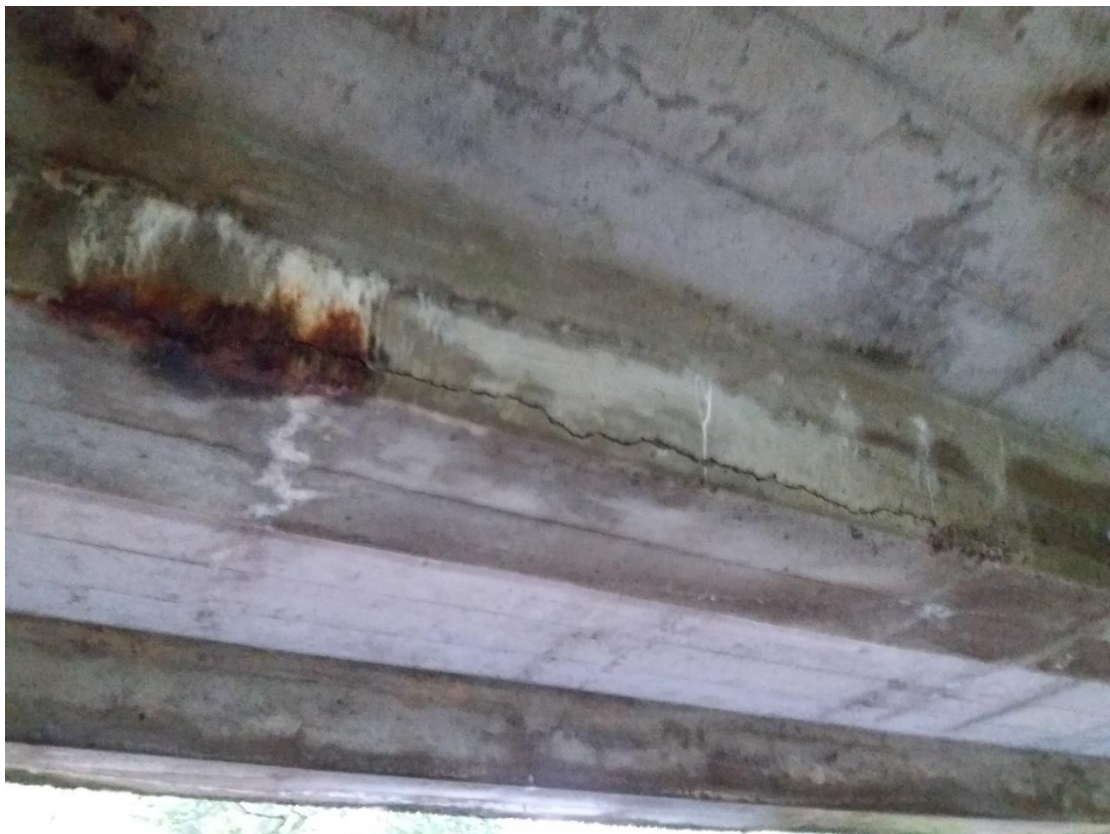
The structure is generally in a fair condition, however there is evidence of cracking to one of the deck downstand beams and settlement in the substructure which could have implications for the overall structural integrity of the structure:-

Figure 5 - View of longitudinal crack to downstand beam adjacent west elevation

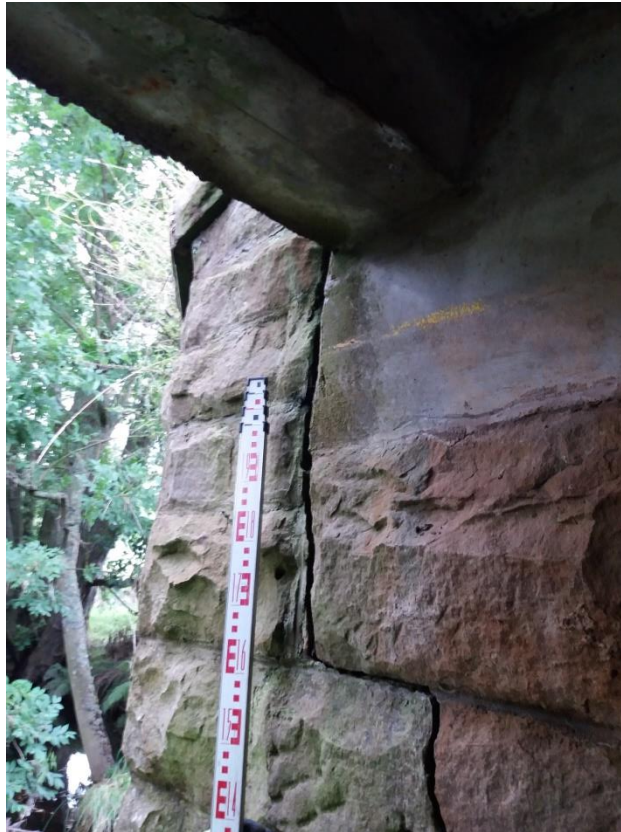
The north abutment was noted to have a small area of scour at the bed. It was noted that a vertical crack ran beneath the deck of the bridge at the west side measuring 20mm down to 0mm at the bed. At the east end a crack ran from the top of the wall for 2.3m and measured 5mm at the widest point down to 0mm. At the west end of the abutment a small area of scour was noted on the return corner.

Figure 6 - Vertical step fracture at north abutment

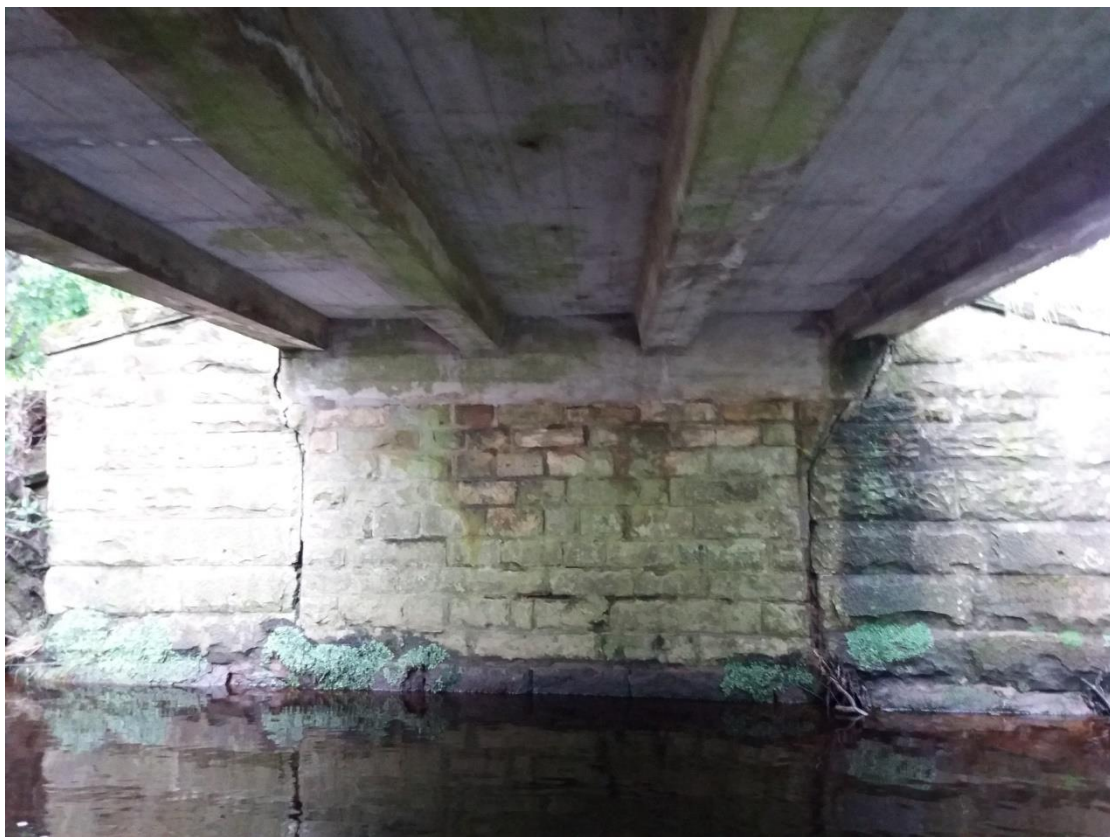
A diving inspection was undertaken in May 2019. The inspection and report found that the south abutment was free from damage and defects with no scour or undercutting to the base of the abutment. It was however noted that two vertical cracks ran beneath the deck of the bridge measuring 30mm at the top of the wall on the east end down to 0mm at the bed level. The vertical crack at the west end of the abutment was also found to run the full height and measured 40mm at the widest point at the top. The masonry was noted to have rotated 30mm at the top, with the crack tapering from the top to the bottom (*Figure 7*).

Differential settlement between the wing walls and abutments has been noted as far back of 1971 (on the bridge card) and has been noted throughout the duration of being in interim measures. During the interim measures period, a number of changes to the crack width measurements have been noted. This change in crack width indicates movement of the substructures. The poor SPT values for the strata to a depth of 10m below ground level could explain this movement if the foundations for the substructures were in this zone (which they are likely to be).

Figure 7 - Possible rotation of south wing walls
