Item no.	Location	Defect description	Photograph	Recommended Repair & Quantity	Repair Category & Spec ref	Tender Cost
1.0.0	ROOFS					
1.1.0	Cart Shed

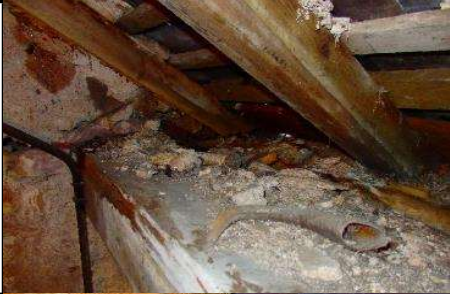
1.1.4	East side	There is rot to the top of the lintel/wall plate.

Once the roof is stripped inspect. Assume it can be retained but allow a timber treatment to the lintel.	2 Spec 3	
1.1.5	West side	There is a rotten rafter end and a rotten section of wall plate.

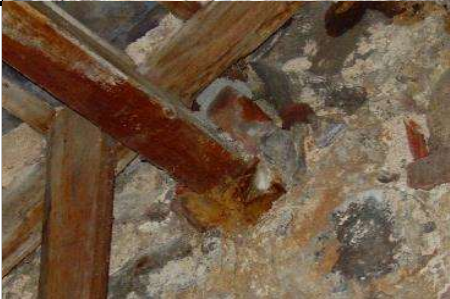
Cut out the section of rotten wall plate and insert a new section in. Cut out the rafter end up to the first purlin and renew with a new rafter from the purlin to the wallplate. (1no. 38x150mm wallplate section 400mm long & 1no. 65x80mm rafter)	2 Spec 2	
1.1.6	West side at the north	There is loose stonework around the purlin sockets.

Include for packing the void in the wall socket at the purlin ends with mortar and stone pinnings to secure the purlins. (2no areas)	2

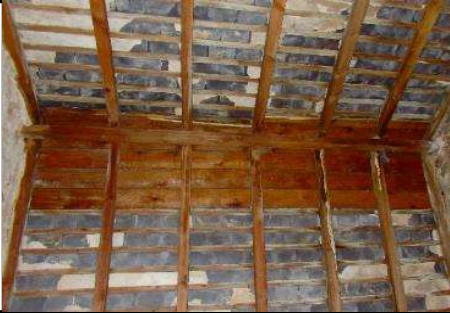
1.1.7	West side at the ridge.	There appears to be some rot to the ridge tops.

Inspect the rafter tops and treat.	2	
				(Allow a provisional sum for rafter renewal)	Spec 3

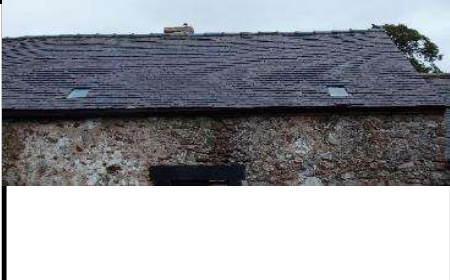
1.2.2	West face at the Stable	There are a number of slipped, missing & displaced slates, and recent storm damage.

Strip the slates and reslate the roof, rebedding the ridge and forming a mortar fillet at the roof abutment. (36m sq.)	1	Spec 1

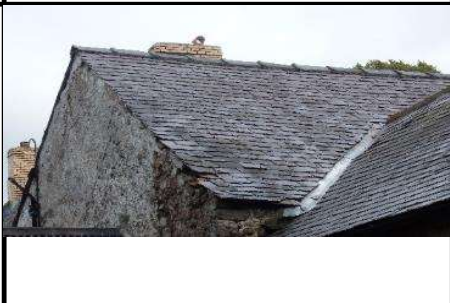
1.2.3	West face at the Granary	There are a number of broken, slipped, missing & displaced slates. There is damage to battens, and structure below especially arounds the valley gutters.

Strip the slates and reslate the roof, rebedding the ridge and forming a mortar fillet at the roof abutment. (36m sq.)	1	Spec 1
				(Allow a provisional sum for additional roofing slates)

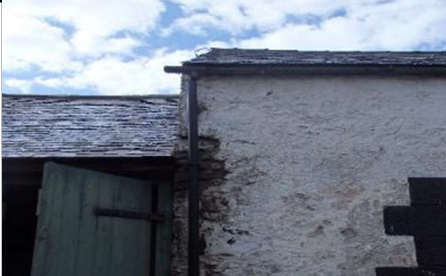
2.2.0		Stable/Granary				
2.2.1	East face	The existing cast iron guttering is corroded.

Renew the corroded components with new cast iron. (Allow 16.5m of deep flow guttering, with 2no stop ends and 1no. outlet)	1 Spec 5

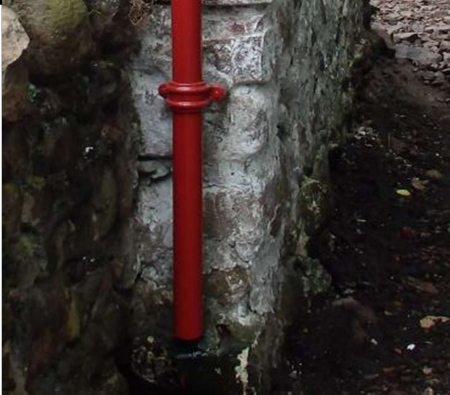
2.3.0	Store					
2.3.1	East roof	The downcomer discharges directly on to the ground at the wall base, and is missing a outlet shoe.

Install an outlet shoe new gully with underground drainage to a soakaway. (Include for an outlet shoe. Allow for the installation of a 200mm sq, gully with cast iron grill. Assume the installation of 9m of underground drainage with a 1m sq. stone filled soakaway)	1 Spec 6

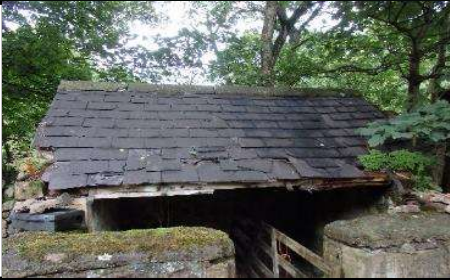
<p>Remove the fascia. Install a new deep flow cast gutter and short section of downpipe.</p> <p>(Allow 16m of guttering, with 2no stop end, 1no outlet and a short section of downcomer to discharge to the gutter at the west of the store.)</p>	3	Spec 5
2.6.0		Pig sty				
2.6.1	South roof	The gutter is missing.

<p>Install a new gutter with downcomer to the west.</p> <p>(Allow 3.5m of guttering, with 2no stop end, 1no outlet and a 90 deg. Corner. Include for a new section of 1.3m downpipe with an outlet shoe.)</p>	1	Spec 5
					sub total

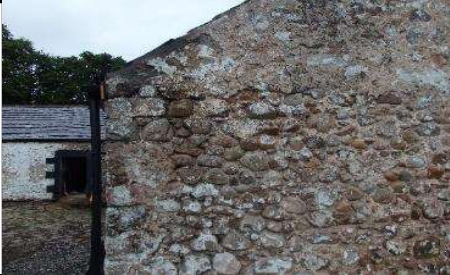
3.1.4		At the west end there is an area of stonework with loose and missing mortar.

Rack out the mortar and repoint. (3m sq.)	2 Spec 7	
3.1.5		The mortar to the lower portion of the wall is loose and friable.

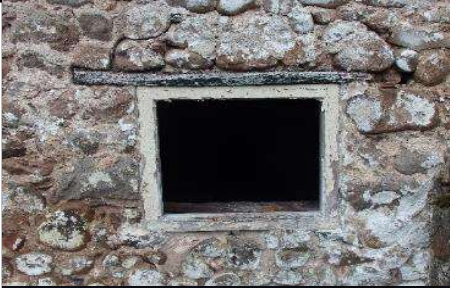
Rake out the loose mortar and patch repoint. (Assume a rate of 80% over an area of 20m sq.)	3 Spec 7	
3.1.6		The timber lintel over the opening is rotten.

Carefully prop the stonework and remove the lintel. Renew with a new oak lintel and make good the surrounding stonework. (75x150mm laid flat and 1250mm long.)	1 Spec 9	
3.1.7	West wall	There is a vertical crack towards the corner.

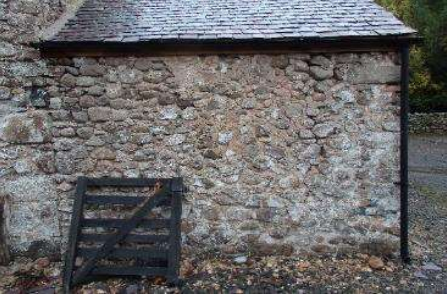
3.1.8		The mortar is loose and friable.

Rake out the loose mortar and patch repoint. (Assume a rate of 80% over an area of 7.5m sq.)	1 Spec 7	
3.1.9	Internal walls	There is plaster render internally which is loose and friable in places.		Brush off loose material and clear the debris.	3	
3.1.10	South internal wall	There is deflection to the timber lintels with displacement of the stonework above.

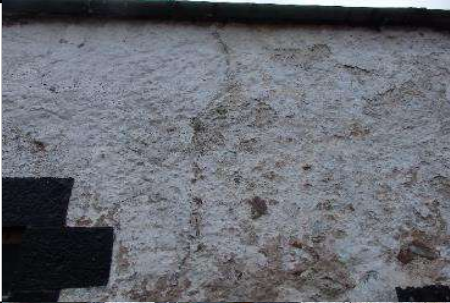
3.2.0		Stable/Granary				
3.2.1	East wall	There is a crack at high level in the centre of the wall.

Repoint the crack and monitor. (1500mm long)	2 Spec 7	
3.2.2		There are open joints along the foundation stones to the south.

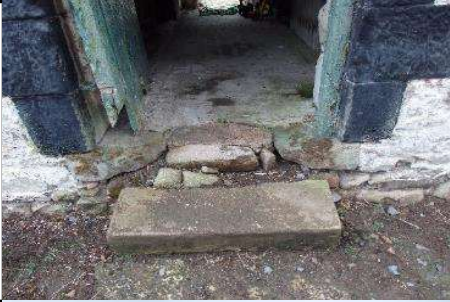
3.2.5		The step to the stable has decayed and is pieces, and is a potential trip hazard.

Install a new stone step. (Dressed stone step to match the existing stonework 150x200mm and 1250mm long)	3	
3.2.6	South Wall	There are a number of open joints.

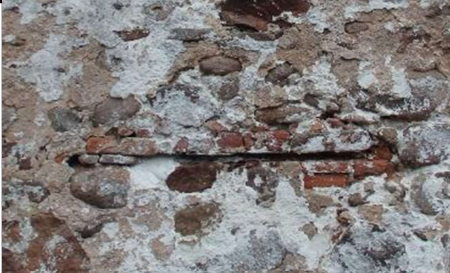
3.2.9		There is a rotten timber built into the wall with a crack above.

Hack out the timber and piece in with stonework, and repoint the crack. (1200x100mm area.)	1 Spec 8	
3.2.10		There is loose stonework in the door jambs.

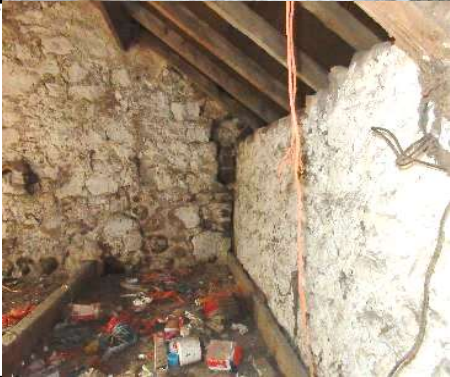
3.2.17	Internal cross wall	There are cracks at the junction of the east and west external walls..

Include for pinning the walls from the outside to secure the cross wall. (Assume 8no 10mm stainless steel treaded bars drilled through the external stones into the cross wall and bedded in resin, install at 600mm vertical centres.)	2 Spec 10	
3.2.18				(Allow for an additional 25m sq. of repointing to be directed on site.)	Spec 7	
3.3.0	Store					
3.3.1	East wall	There are open joints and gaps to the foundation stones.

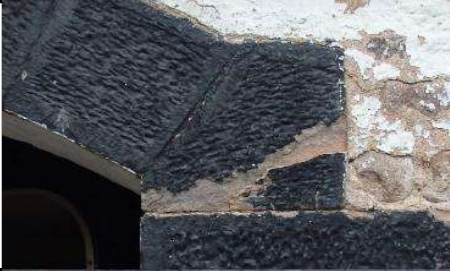
3.4.6		There is a crack to the springing point stone to the arched opening.

Carry out a resin repair the cracked stone.	3 Spec 14	
3.4.7		The limewash finish to the wall between the doorways is flaking and loose.

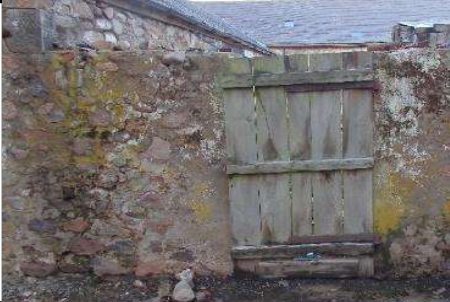
3.5.4	West wall at the north end	There is a small area of loose, cracked, friable and missing mortar to the stonework joints.

Rake out the mortar and repoint (1m sq.)	2 Spec 7	
3.5.5		There is loose masonry to the wall head.

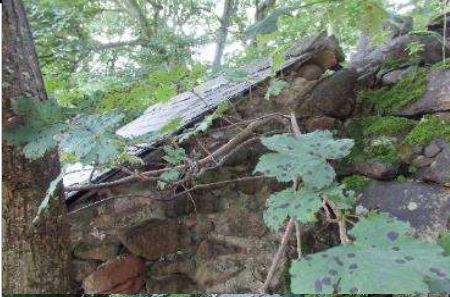
3.6.6	East wall	There is missing stones at the verge.

Piece in with new stonework. (1200x300mm)	1	
3.6.7		There perimeter wall is missing a capping which has fallen.

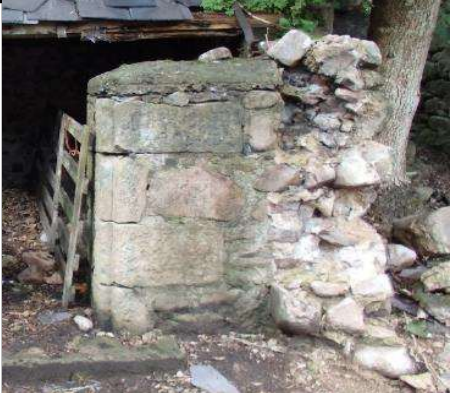
<p>3.6.9</p>		<p>The end portion of the perimeter wall is missing</p>

<p>Consider rebuilding the wall and include a gate post. (1200mm high and 750mm long, with a stone gate post at the end.)</p>	<p>2 Spec 13</p>	
<p>3.6.10</p>	<p>South wall</p>	<p>There are gaps below the capping and some open joints.</p>	 	<p>Rake out loose and open joints and repoint the gaps</p>	<p>2 Spec 7</p>	
<p>3.6.11</p>	<p>West wall</p>	<p>There is a gap to the northern end of the wall.</p>

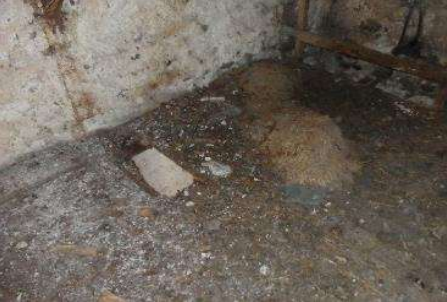
4.2.3		There is evidence of water damage to the floor beams.

Inspect the beams for rot, and allow a timber treatment.	1 Spec 3	
4.2.4		One of the timber floor beams is rotten.

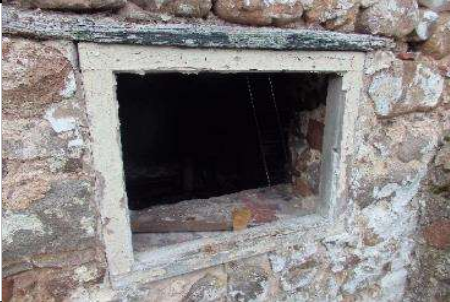
5.1.4		There are missing glazing bars to the window.

Remove the glass and install new glazing bars then reglaze securing the glass with linseed putty.	2 Spec 18	
5.1.5		The paintwork is flaking on the window.	see above	Rub down the timber to remove loose paint and redecorate internally and externally.	2 Spec 15	
5.2.0	Stable/Granary					
5.2.1	Granary door on east wall.	The boards to the bottom portion of the door are warped and rotten.

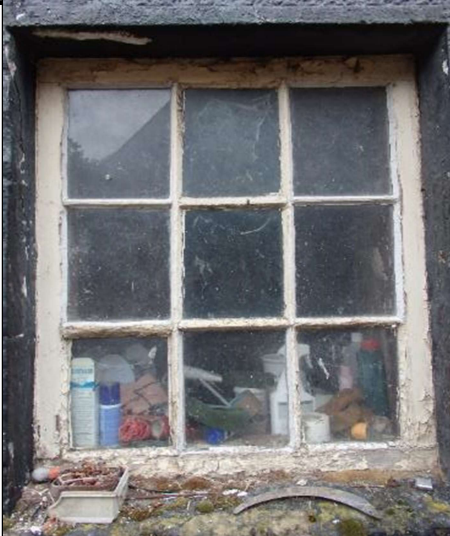
Rub down the timber to remove loose paint and redecorate internally and externally.	2 Spec 15	
5.2.4	Stable - northern window on the east elevation	The paintwork is flaking on the window and the putty is crumbling and missing.

Rub down the timber to remove loose paint and redecorate internally and externally. Include for reglazing the window with linseed putty. (Include a provisional sum for repairs to the glazing bars.)	2 Spec 15

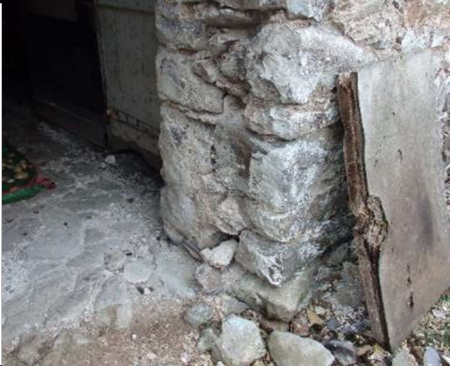
5.2.10	Stable door on the west elevation	One side of the frame is missing, and the other side is rotten at the base.

Cut out the rotten section of door frame and splice in a new section of timber. Include for a new frame leg. (Allow for a 80x100x400mm long splice, and a 80x100mm frame.)	1 Spec 18	
5.2.11		The door is rotten and decayed.

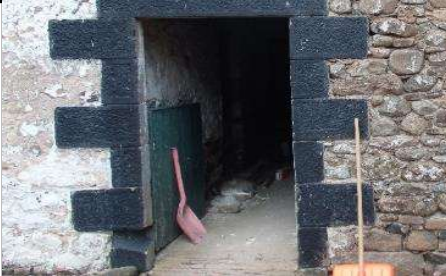
5.4.0		Rear Range				
5.4.1	Door to the south elevation at the east.	The upper section of the door is missing.

Install a new door and ironmongery (Provide a new accoya timber ledged and braced batten door and include for decoration)	3 Spec 19 & 15	
5.4.2		The boards to the lower section are rotten and the hinges are corroded.
