DESIGN, ACCESS & HERITAGE STATEMENT

The repair of the existing farm building at Carrowbrough Farm.

By: Doonan Architects Ltd.
On behalf of: George Benson

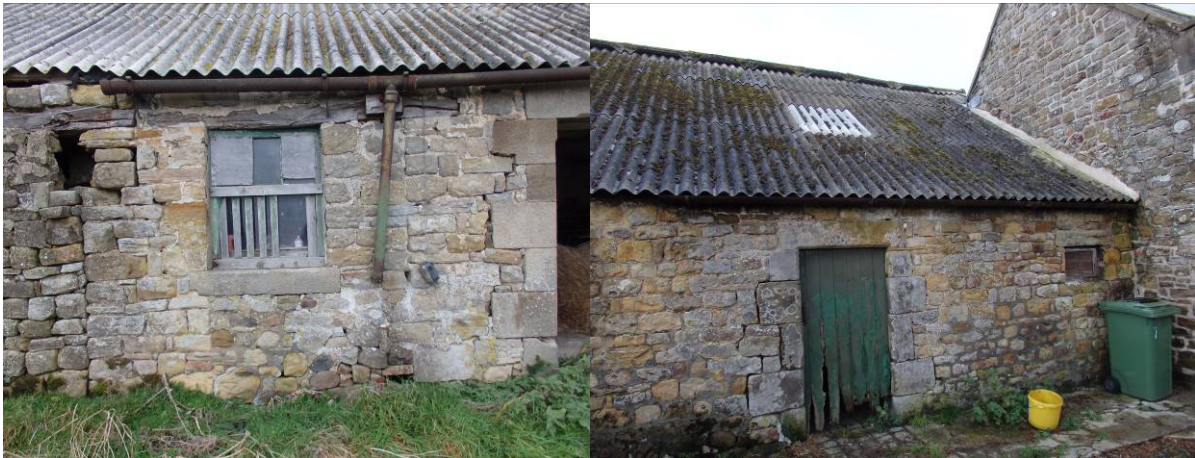
There are only remnants left of the original cast guttering and down pipes. The lack of guttering has prevented the effective removal of rainwater from the roof. This has allowed water to run down the face of the stonework that has washed out and caused decay of the mortar, which in turn has led to the displacement and structural deterioration of the walls. In addition, the water has been allowed to discharge into the ground at the base of the walls, causing softening of the ground and displacement of the walls.

Southern elevation: Note the corroded and ineffective rainwater goods, the masonry panels of differing condition. Northern Elevation. Note the lack of guttering, and the poor condition of the door.

In order to have efficient rainwater removal from the roofs new deep flow cast gutter with cast guttering is proposed. To ensure the water is removed from the bases of the walls the downcomers will discharge into a new gulley with underground pipework to a soakaway to the south. To the northern elevation which faces Hadrian's Wall the pipe can be installed and covered by extending a concrete

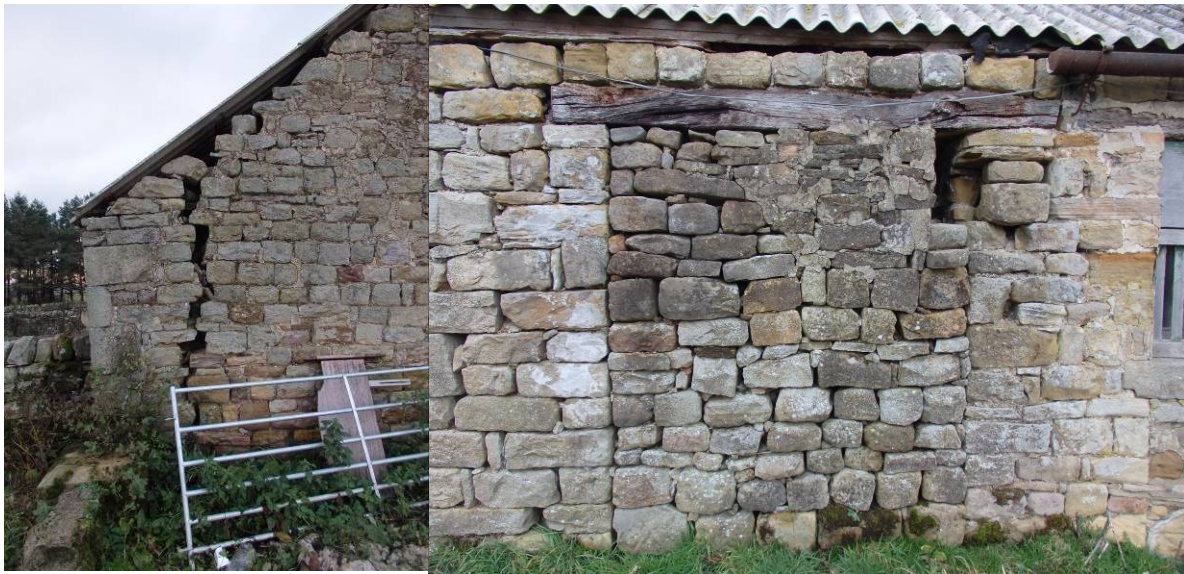
The east wall also has loose friable and cracked mortar. There are cracks at both the northern and southern ends of this wall. The northern end can be stitched while the southern will require rebuilding. There is a section to the north which has numerous cracks that will also require rebuilding.

Eastern elevation: Note large crack indicating movement on the southern wall.

Southern elevation: Note the panels of masonry with washed out and missing mortar joints, and missing stone.

The southern wall consists of a number of piers that are connected with larger timber eaves beams/lintels, some of which are rotten. Beneath these the former openings have been blocked up with stone. This has left the wall as a series of unconnected panels that have been prone to displacement and movement as a result washed out joints and the wetting of the ground causing movement in the wall. A programme of renewing the timbers, rebuilding some of the panels, repointing and deep tamping will be required, together with tying the panels to the piers to ensure the wall is acting together will improve its structural integrity.

However, at Carrowbrough the walls will require more intervention to ensure they remain stable. There are a number of areas that have been subject to cracking. In order to reduce the amount of rebuilding it is proposed stainless steel stitches are introduced within the joints to reinforce these areas. This is a common technique which allows the masonry to remain in place rather than be rebuilt to improve the structural integrity of a cracked wall. However there are areas that have moved to such an extent that rebuilding is the only course of action, this is particularly to the east and southern elevations.

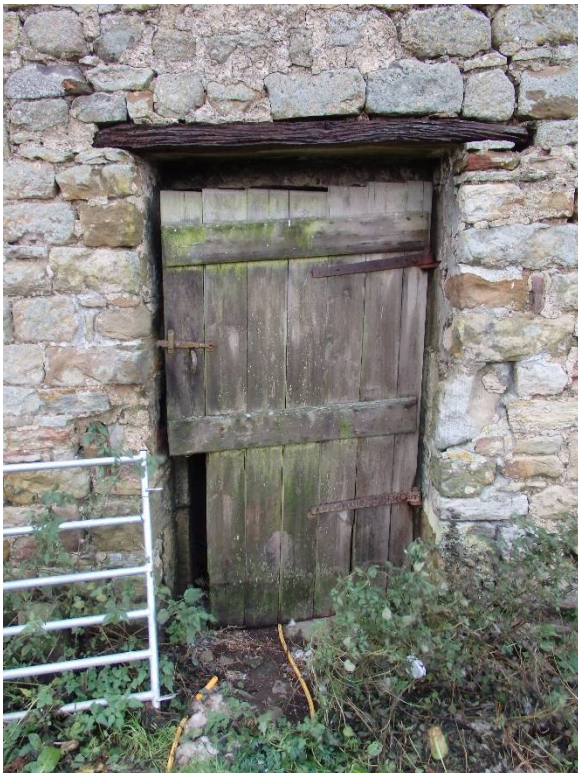
Given the water penetration into the walls and lack of protection from the rain offered by guttering the windows and doors are generally in a very poor state with rotten timbers, missing and broken glass and vents, and have been subject to numerous patch repairs over the years. As they are in such poor condition they are beyond feasible repair and therefore it is proposed these are renewed on a 'like for like' basis. They will follow the existing fenestration patterns of the traditional barn venting windows. The glass will be single glazed and secured with putty. The doors will be vertical boarded ledge and braced doors to match those existing doors. Whilst new doors are proposed, existing ironmongery will be stripped from the rotten doors and reused where possible. It is proposed Accoya timber is used in the fabrication of the new windows and doors as this treated timber has significant protection from rot.

East elevation: Note displaced boards and poor condition of the door.

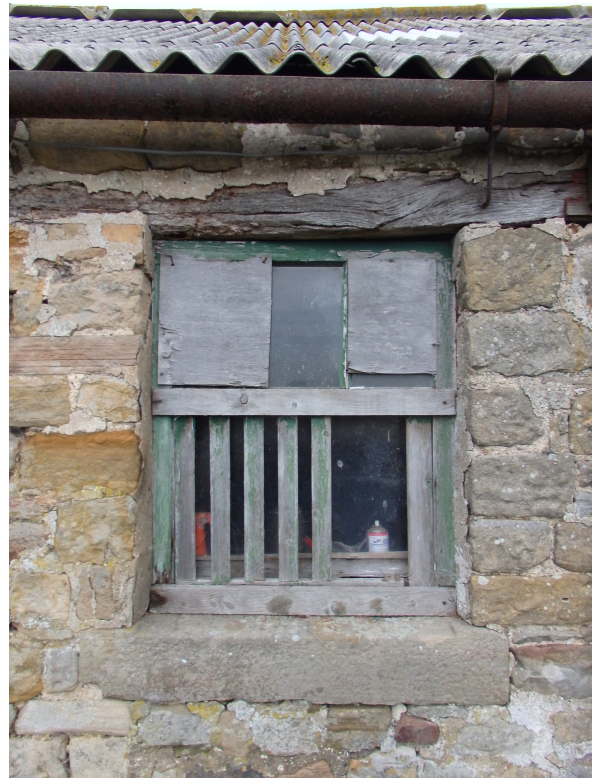
Southern Elevation. Note repairs to the traditional venting window with low level ventilation slats, partially missing.
