C - REPAIR WORKS

Note: For tender purposes assume the below areas and quantities. These will be confirmed and agreed on site. They will be re-measured upon completion of the works. The figures here will be used to extrapolate rates for each operation and these will be applied to any additional/omission works instructed during the contract. Sizes of timber are nominal and need to be checked on site in order for the new/replacement timbers to match the existing.

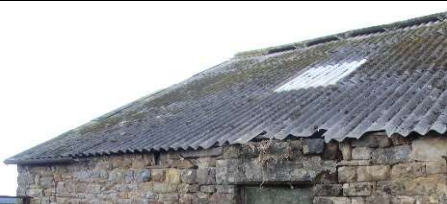
Item no.	Location	Defect description	Photograph	Recommended Repair & Quantity	Repair Category & Spec ref	Cost (Doonan Estimate)
1.0 ROOFS						
1.1	North Face	There is a build up of moss on the asbestos sheeting. The sheets are broken over the east window. In addition the verge is missing.

Remove the corrugated asbestos sheet and replace with a slate roof covering to match the existing farmhouse (73m sq. with 2no. rooflights)	2 Spec 1

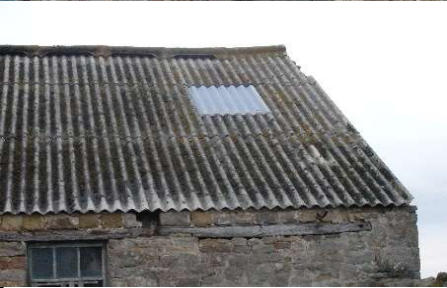
1.2	South Face	The verge at the west end is broken and the verge cover piece is missing at the east end.

Remove the corrugated asbestos sheet and replace with a slate roof covering to match the existing farmhouse (77m sq. with 2no. rooflights)	2 Spec 1

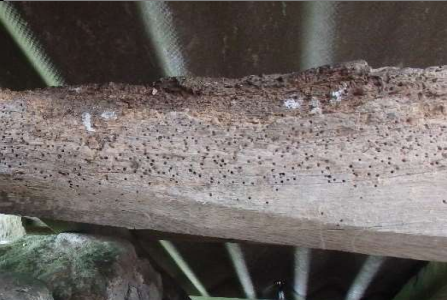
Include a provisional sum to chock and level the rafters to accommodate the slating battens.		£3,500.00
1.4	Structure	The roof timbers generally appear sound. There is evidence of woodworm although it can not be determined whether this is active or not.

Include for inspection of the timbers once the roof has been stripped. Allow for treatment of the timbers with a suitable insecticide.	1 Spec 10

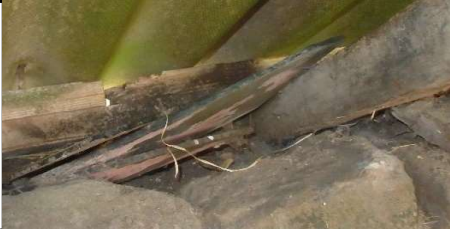
1.5	North Structure	A length of the lower timber batten below the roof sheeting is rotten.

Remove the rotten section and renew the batten. (Allow 50x80mm timber, and approximately 5m long)	2 Spec 2	
1.6		The bearing and fixing of a purlin is poor, as the purlin is short.

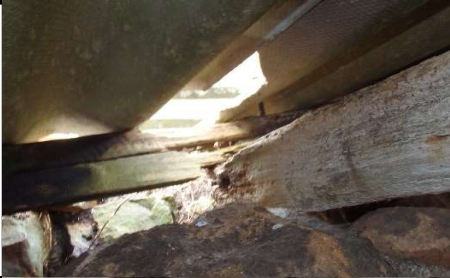
Install a new purlin alongside the existing. (Allow for the installation of a 100x100mm sw purlin)	1 Spec 2	
1.7		The rafter end is rotten and not bearing on to the wall head.

Cut out the area of rot and install a new rafter along side the remaining timber spanning from the wall to the first purlin. (Allow 100x65mm rafter 1.5m long)	2 Spec 2	
1.8	South Structure	The rafter has suffered from decay with a worn section of limited depth.

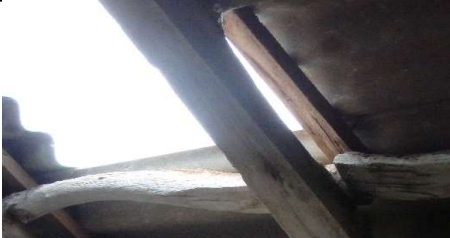
1.9		A high rafter adjacent to rooflight is decay and appears in poor condition.

Install a new rafter along side the remaining timber spanning from the wall purlin to purlin. (Allow 100x65mm rafter 1.5m long)	2 Spec 2	
1.10		The wall plate is missing at the west end eaves and the rafters are not supported.

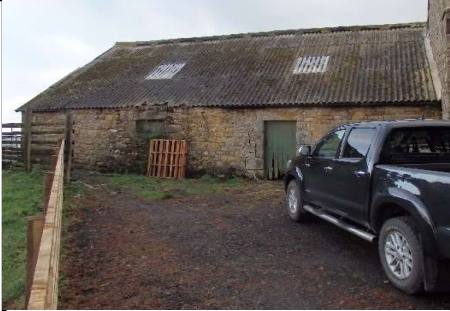
2.0 Rainwater Goods						
2.1	North elevation	50% of the guttering is missing and the remainder is corroded. There is no down comer

<p>Remove the remaining guttering. Renew with cast guttering fixed with spiked brackets. Include a new cast down comer</p> <p>(Allow a length of 13.5m of deep flow guttering with 2no. stop ends, 1 outlet, spiked gutter brackets 1no. 2.3m downpipe with outlet shoe.)</p>	<p>1</p> <p>Spec 3</p>

2.2			see above	<p>Install a new gully with pipe running along the edge of the concrete step to discharge into the grassed area. Cover the pipe in a concrete to extend the step.</p> <p>Allow for 1m of pipework bedded in concrete to extend the existing concrete step.</p>	<p>1</p> <p>Spec 4</p>

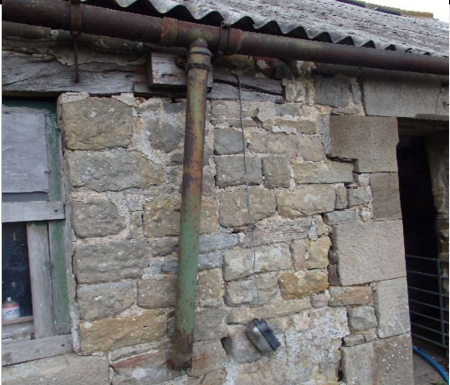
2.3	South elevation	There are only remnants of the guttering and down pipes remaining, which are corroded.

<p>Remove the remaining guttering. Renew completely with cast guttering fixed with spiked brackets. Include a new cast down comer</p> <p>(Allow a length of 13.5m of deep flow guttering with 2no. stop ends, 1 outlet, spiked gutter brackets 1no. 2.3m downpipe with outlet shoe.)</p>	<p>1</p> <p>Spec 3</p>

2.4		There is no gully for the down comer.	see above	<p>Install a new gully with underground drainage pipe running into the garden to a new soakaway.</p> <p>(Allow for the installation of a 200mm sq., gully with cast iron grill. Assume the installation of 15m of underground drainage to a 2m sq. soakaway)</p>	<p>1</p> <p>Spec 4</p>	
					sub total

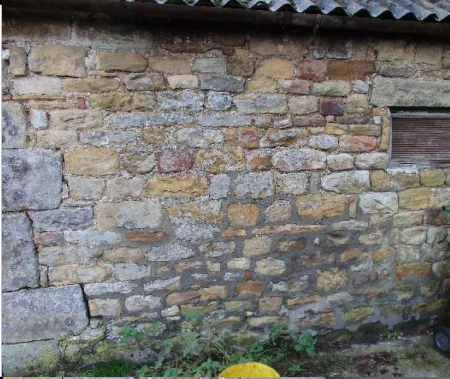
3.0		WALLS				
3.1	North Wall	The mortar to the stonework joints is soft and friable and there are patches of more recent cement pointing.

Rack out the loose mortar, carefully hack out the cement and repoint. (26m sq.)	2 Spec 5	
3.2		There are displaced stones to the east of the doorway.

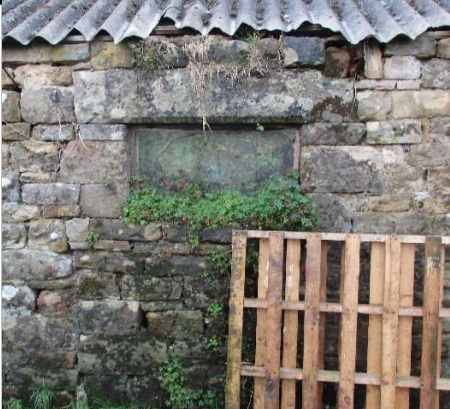
Carefully remove the stone and rebed. (0.3m sq.)	1 Spec 7	
3.3		There are washed out joints with vegetation growth around the eastern window.

Remove the vegetation, rake out the mortar. Deep tamp the stonework and repoint. (5m sq.)	2 Spec 6

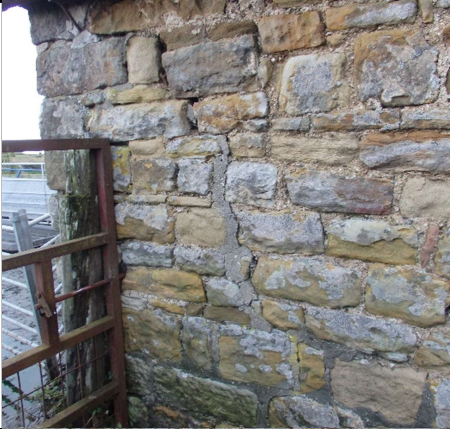
3.4		There is a crack at the eastern corner.

Install helifix stainless steel helifix bars across the crack, bedded in resin and repoint. (Allow 5no. stainless steel helifix bars 900mm long at 300mm vertical centres bedded in resin.)	2 Spec 8	
3.5	West Wall	The mortar to the wall is loose, friable and washed out.

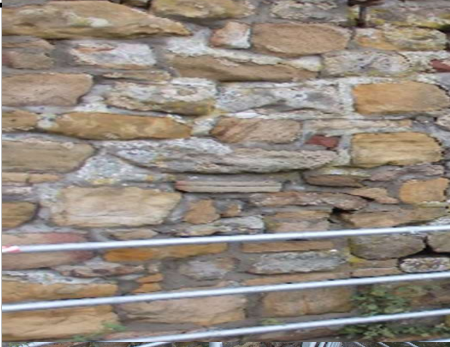
Rake out the loose mortar and repoint. (30m sq.)	1 Spec 5	
3.6		There are two cracks to the northern side of the elevation.

Install helifix stainless steel helifix bars across the crack, bedded in resin and repoint. (Allow 10no. stainless steel helifix bars 1200mm long at 300mm vertical centres bedded in resin.)	1 Spec 8

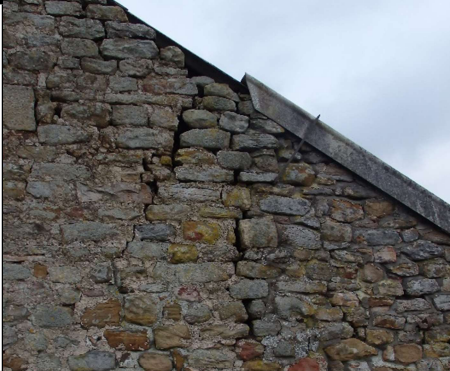
3.7		The stonework has displaced at the cracks and is not tied into the surrounding masonry.

Carefully take down the stonework and rebuild to the full thickness of the wall introducing stainless steel bed reinforcement to secure the rebuilt masonry with the existing masonry. (Allow 3.5m sq.)	1 Spec 7	
3.8		There are loose stones to the head of the walls and at the apex above the upper opening.

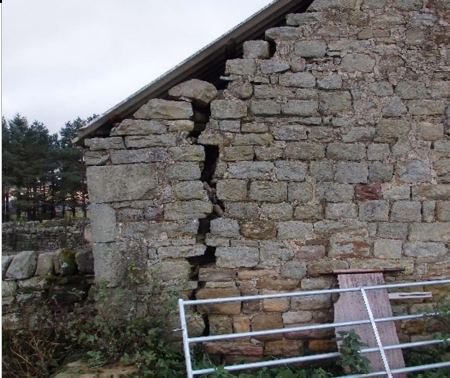
Carefully take down the top 400mm of wall and the masonry above the opening at the apex. Rebuild to wall head. (Allow 11.5m)	1 Spec 7	
3.9		There is a crack at the southern elevation, which is falling away.

Carefully take down the stonework to ground level and rebuild to the full thickness of the wall introducing stainless steel bed reinforcement and stainless steel ties to secure the rebuilt masonry with the existing masonry. (Allow 3.5m sq.)	1 Spec 7

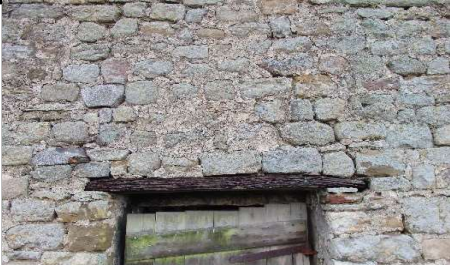
3.10		There is decay and the timber lintel over the ground floor door is rotten.

Cut back the existing rotten timber by 200mm and install a new oak lintel with lead capping. (Assume a 100x200mm oak lintel 1.5m long. Include for rebuilding the stonework above 1m sq.)	Spec 9 & 7

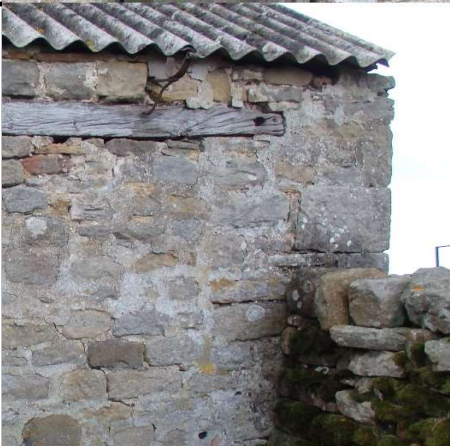
3.11	South Wall 1st Pier	There is displacement to the pier with cracks to the corner. The mortar is cracked in places and there is missing stone at the end of the timber lintel.

Carefully take down the stonework to ground level and rebuild to the full thickness of the wall introducing stainless steel bed reinforcement and stainless steel ties to secure the rebuilt masonry with the existing masonry. (Allow 2.5m sq.)	1 Spec 7

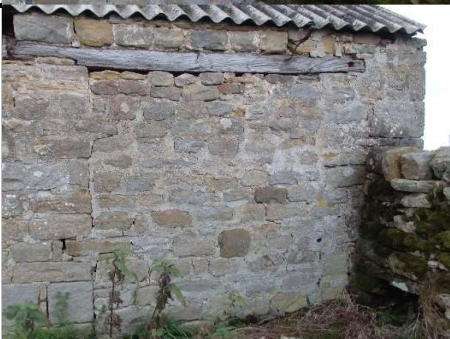
3.12	1st Panel	There is a bulge at the base. The mortar is smeared over the stones, and is cracked.

Carefully take down the stonework to ground level and rebuild to the full thickness of the wall introducing stainless steel bed reinforcement and stainless steel ties to secure the rebuilt masonry with the existing masonry. (Allow 4.5m sq.)	1 Spec 7

3.13		There is some decay to the timber lintel.	see above	Inspect the existing timber. Re-use if sound and treat. Include for the installation of a lead capping and rebuilding the masonry above.	1 Spec 10 & 7	
3.14				Include a provisional sum for the supply of a new timber lintel if the lintel above is found to be in a poor condition (Allow 150x125mm 2.5m long)		£300.00
3.15	2nd Pier	There is a crack to the base with washed out joints to the surrounding stonework.

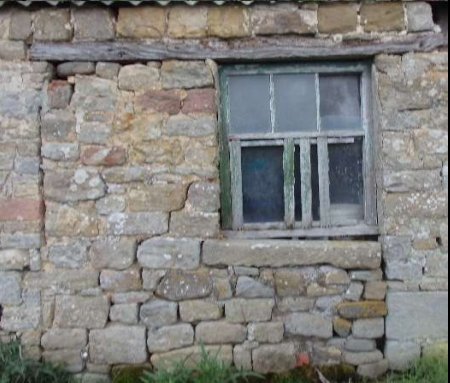
Repoint around the crack. (1.0msq.)	1 Spec 5	
3.16	2nd Panel	There is a bulge at the base and the whole panel is leaning outward and is not tied into the existing piers.

Carefully take down the stonework to ground level and rebuild to the full thickness of the wall introducing stainless steel bed reinforcement and stainless steel ties to secure the rebuilt masonry with the existing masonry. (Allow 4.5m sq.)	1 Spec 7

3.17		There is some decay to the timber lintel.	see above	Inspect the existing timber. Re-use if sound and treat. Include for the installation of a lead capping and rebuilding the masonry above.	1 Spec 10 & 7	
3.18				Include a provisional sum for the supply of a new timber lintel if the lintel above is found to be in a poor condition (Allow 150x125mm 2.5m long)		£300.00
3.19	3rd Pier	There is a crack at the base and washed out joints

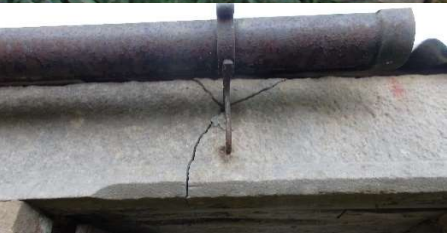
Carefully take out the loose stones and rebed the stones. (1m sq.)	1 Spec 5	
3.20		The lintel over the door opening is cracked.

Carefully take out the lintel. Include for pinning and refixing the lintel. (Allow for installing 2 no. 10mm stainless steel pins bedded in resin to secure the lintel.)	1 Spec 11

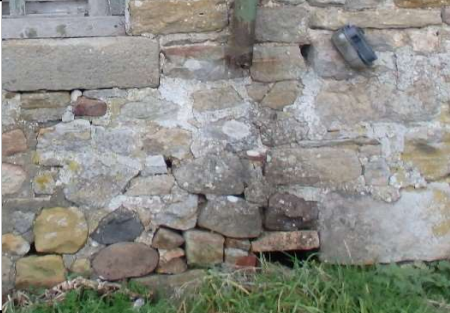
3.24		There are displaced stones to the base of the wall.

Rebed the stones (500mm x500mm)	1 Spec 7	
3.25		There is rot and decay to the timber lintel.	see 3.23 above	Renew with a new oak lintel. (New oak lintel 200x150mm and 2.4m long.)	1 Spec 9 & 7	
3.26	5th Pier	There is friable, cracked and washed out mortar joints.

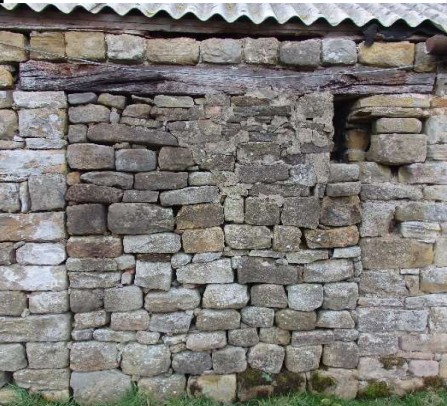
3.27		There are missing and displaced stones to the head of the pier	see above	Rebuild the section of loose and missing masonry. (Allow for rebuilding the top 200mm of the pier)	1 Spec 7	
3.28	4th Panel	There is little or no mortar in the stonework.

Deep tamp and fully repoint the panel of masonry (2.5m sq.)	1 Spec 5 & 6	
3.29		There is a section of missing stonework to the top of the panel.

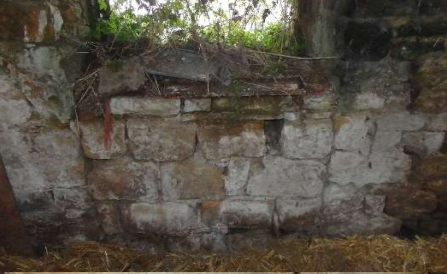
3.35				(Allow for an additional. rebuilding masonry as directed on site.)	Spec 7	£2,000.00
	Internal walls	Note: Defects to the internal walls have not been noted below where the walls are to be rebuilt to the full thickness as this is detailed above to the external walls.				
3.36	North Wall	There is vegetation growth above and below the eastern window, with friable mortar joints.

Remove the vegetation, rake out the mortar and repoint. (Allow for 1.5m sq.)	2 Spec 5	
3.37		The inner timber lintel at the eastern opening is rotten.

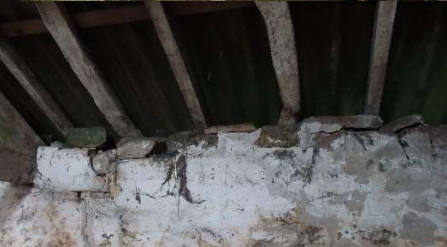
Carefully take down the masonry above the lintel and renew the lintel with a new oak lintel. (Allow for a oak lintel 90mm x 300mm and 1.95m long.)	1 Spec 9 & 10	
3.38		There are anumber of loose stones to the wall head.

Rebed the stones to ensure they are secure. (Allow for 12m)	3 Spec 7

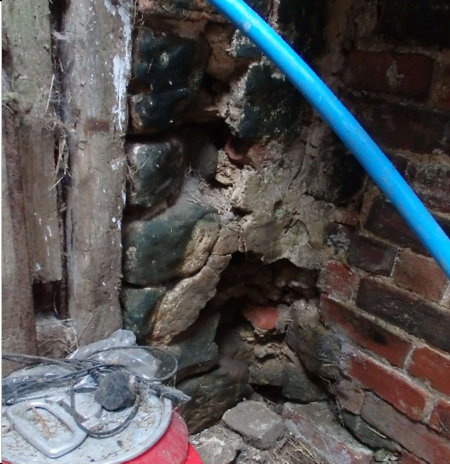
3.42	Cross Wall	There is a section of missing masonry at low level at the eastern end.

Piece in new stonework (Allow 400mmx400mm)	3 Spec 7	
					sub total	
4.0.0	FLOORS					
4.1.0	Cart Shed					
4.1	Floor	The floor is a concrete floor appears in reasonable condition although it is covered in debris.

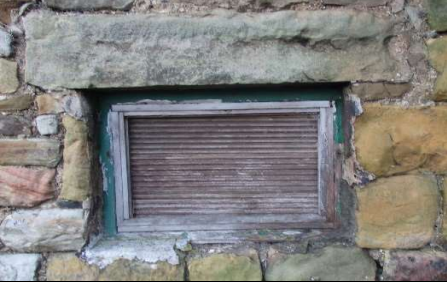
5.0 WINDOWS/DOORS/JOINERY					
5.1	North elevation west window	The window has been boarded up and the paint is flaking.

Rub down the timber to remove loose paint and redecorate externally.	2 Spec 12
5.2			see above	Consider opening up the window and installing glass to the existing frame. (Allow 600x375mm safety glass.)	3 Spec 13
5.3	North elevation door	The boards to the door are rotten and in poor condition.

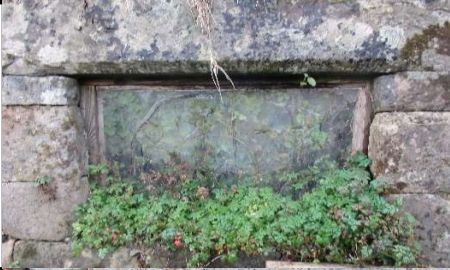
5.4	North elevation east window	The eastern window is rotten, there is vegetation growth, the glazing is plastic and there is no paint on the timber.

Renew the window. (Provide a new window with safety glass including new vertical glazing bars. Include for decoration).	1 Spec 15	
5.5	West elevation lower door	The door is in poor condition and has twisted.

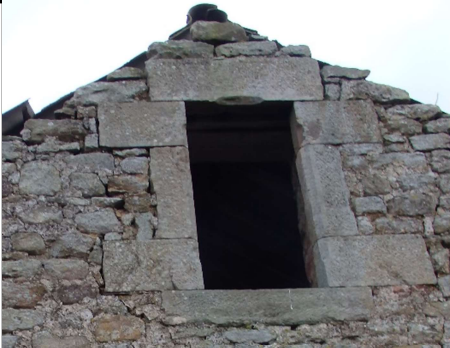
Strip off the existing ironmongery, and reuse on a new timber door. (Provide a new accoya timber ledged and braced batten door 1100mm x 1900mm and include for decoration)	2 Spec 14	
5.6	West elevation upper door	The door is missing.

Install a new door. (Provide a new accoya timber ledged and braced batten door include for decoration)	2 Spec 14

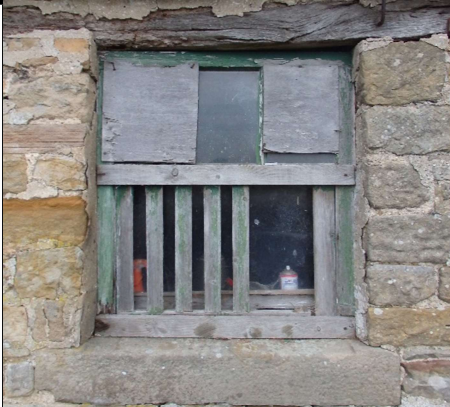
5.9	South elevation east window	The window is rotten with broken and missing panes

Install a new window. (Provide a new accoya window to match the existing (860mmx1070mm include for decoration)	2 Spec 15	
5.10		The internal remnants of kennels, timber stabling are ram shacked but are generally sound.
