Our Ref: 19152 BTB SMW

Date: 30th September 2019

CARRAWBROUGH FARM

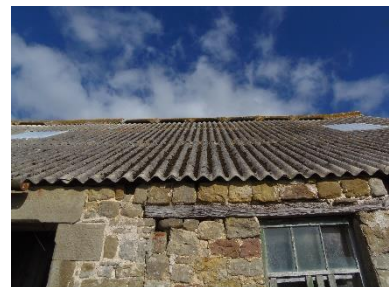
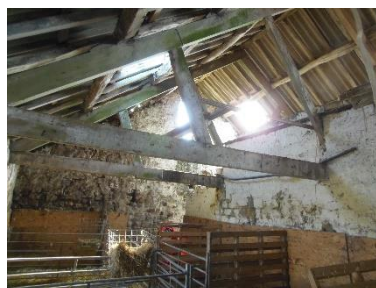
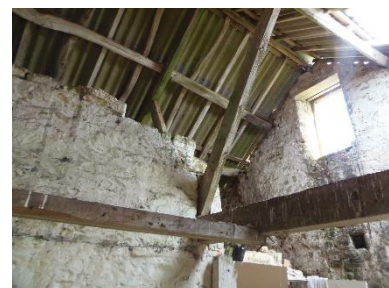
It is apparent that the roof covering is not original, and we understand that you recommend replacing the asbestos cement sheeting with slate to match what is believed to be the original covering. The roof trusses, purlins and common rafters internally appear to be in reasonable condition and recently upgraded, though further checks will be required for rot during any repair works, particularly to purlin ends

which have skew-cut bearings of limited thickness, over the trusses. Rainwater good to the eaves of the roof are virtually non-existent and should be replaced, particularly as it is likely that the issues apparent to the building walls are likely to be related largely to water ingress.

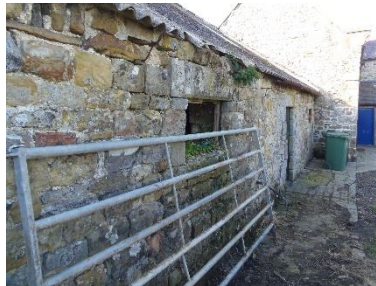
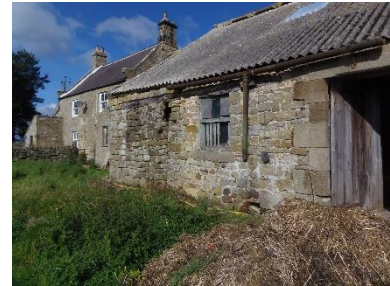
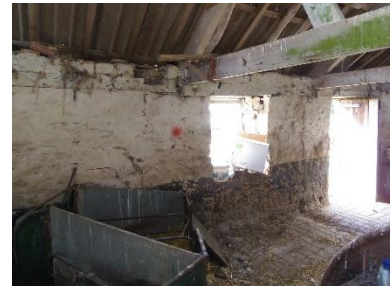
In addition to restoring the above-ground drainage, we also noted some formed channels in the barn floor, leading to openings in the walls to allow for hosing-down the floor internally. The outlets from these should also be picked up externally with gullies and we suggest that a new underground drainage system, leading to a soakaway in the fields to the rear, will be required.

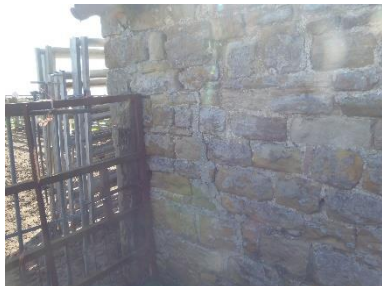
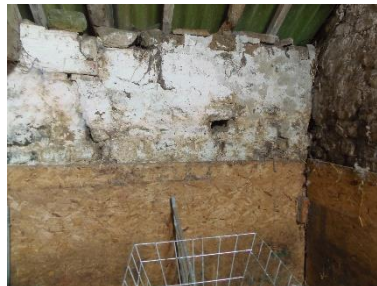
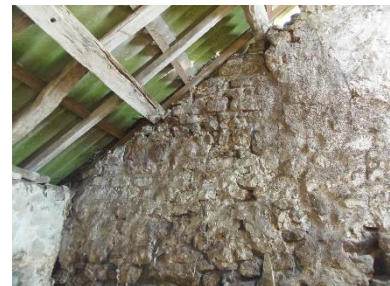
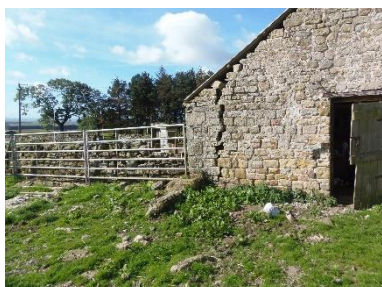
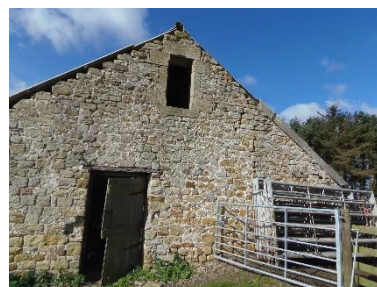
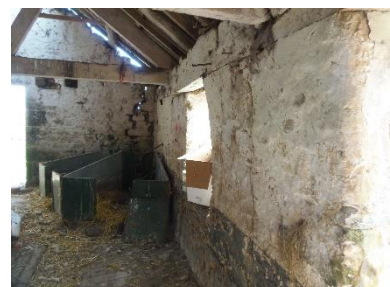
There are a number of cracks to the walls to the northern side and the eastern gable and you have sensibly proposed repairs to the cracks along with rebuilding of a significant part of the central and southern sections of the gable wall.

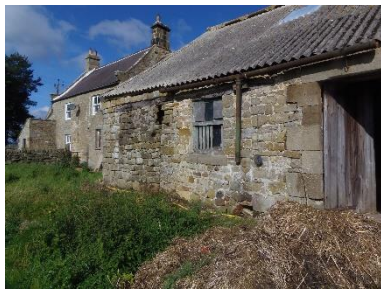
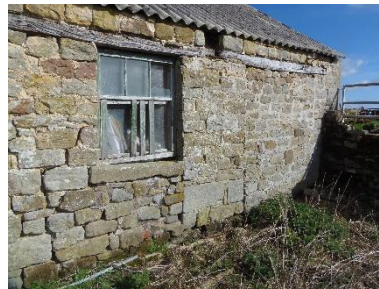
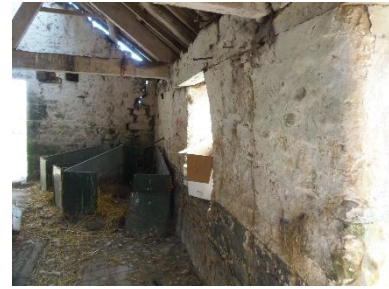
The southern elevation appears to have had quite a history. It appears that this used to comprise a number of stone piers, with timber lintels over 4 openings along the wall, 2 to each side of the central doorway. Gradually, over the years, these openings have been filled in with further random stone masonry. The western end of this wall appears to be reasonably stable, but the eastern half has a significant lean and bulge outwards. It appears that the infill panels, and perhaps the piers too in this

area, have very limited if any, foundations. We recommend that the roof is propped and this section of wall to the eastern end is taken down and rebuilt on a new strip footing, either of concrete or river boulders, if available. In terms of appearance, you may choose to inset the infill masonry panels slightly to express the history of building alterations. Infill panels will need to be adequately tied into the adjoining piers throughout this elevation. Through ties may also be required in places to maintain the integrity of the wall and prevent further bulging. Currently there are simple butt joints. Work is required to replace/ restore pointing throughout the building. There is also a central internal wall in the barn. This is in reasonable condition but may need some consolidation to the head of the wall where it appears to support the roof trusses.
