DESIGN, ACCESS & HERITAGE STATEMENT

The repair of the existing farm building at Sewingshields Farm.

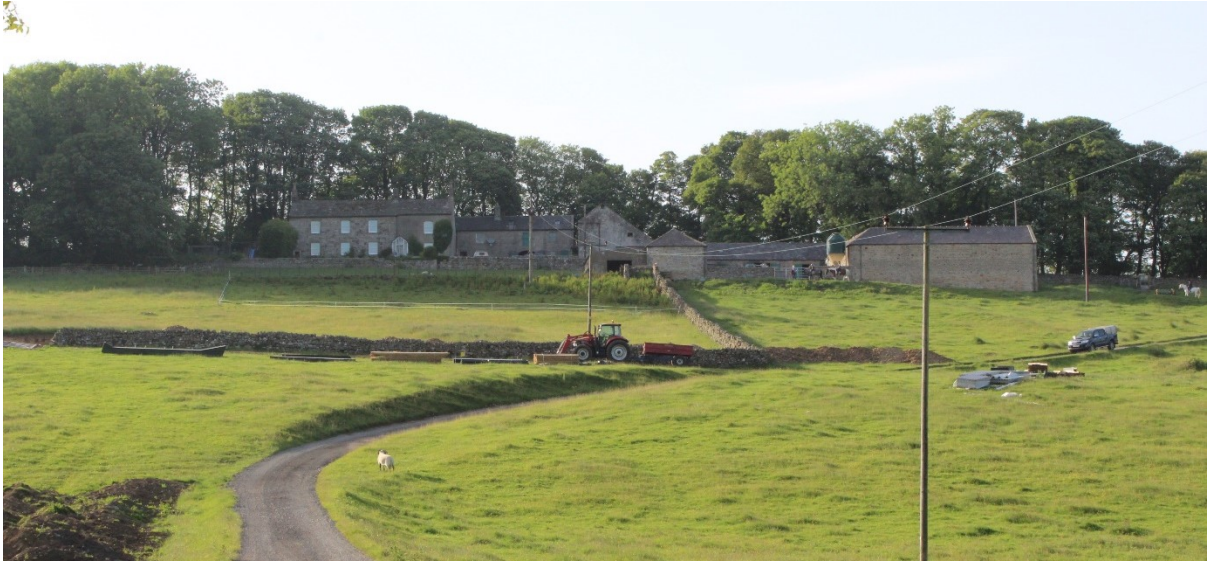
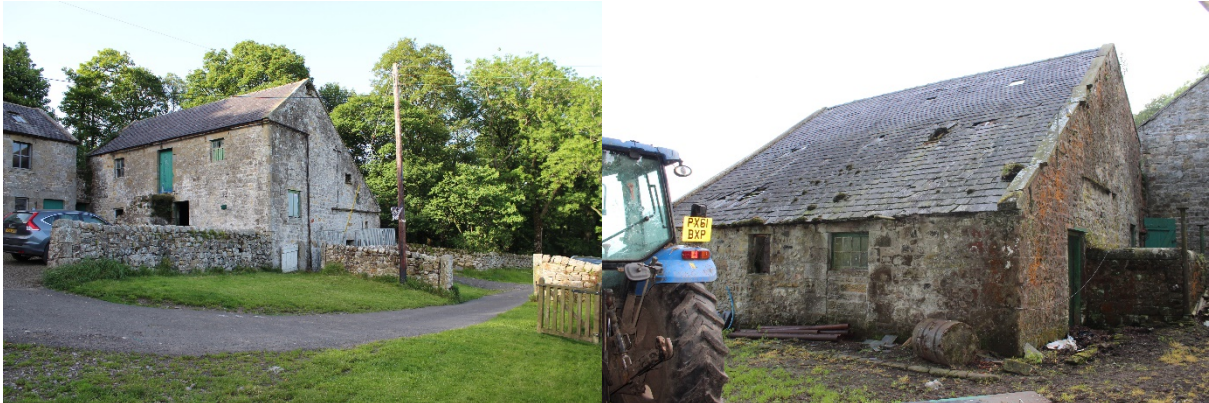
By: Doonan Architects Ltd.
On behalf of: Mr Murray

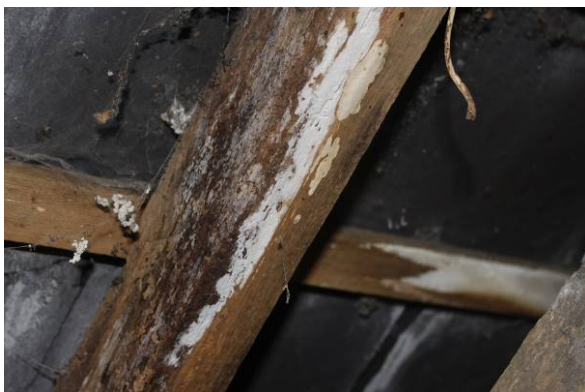
Store Roof. Note decay to one of the rafters.

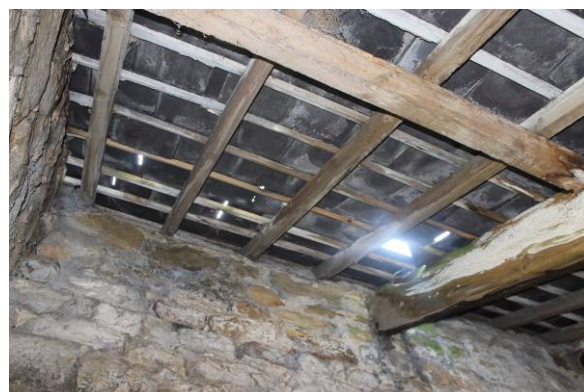
Kennel Roof. Note the missing and slipped slates, and decay to the purlin and principle rafter.

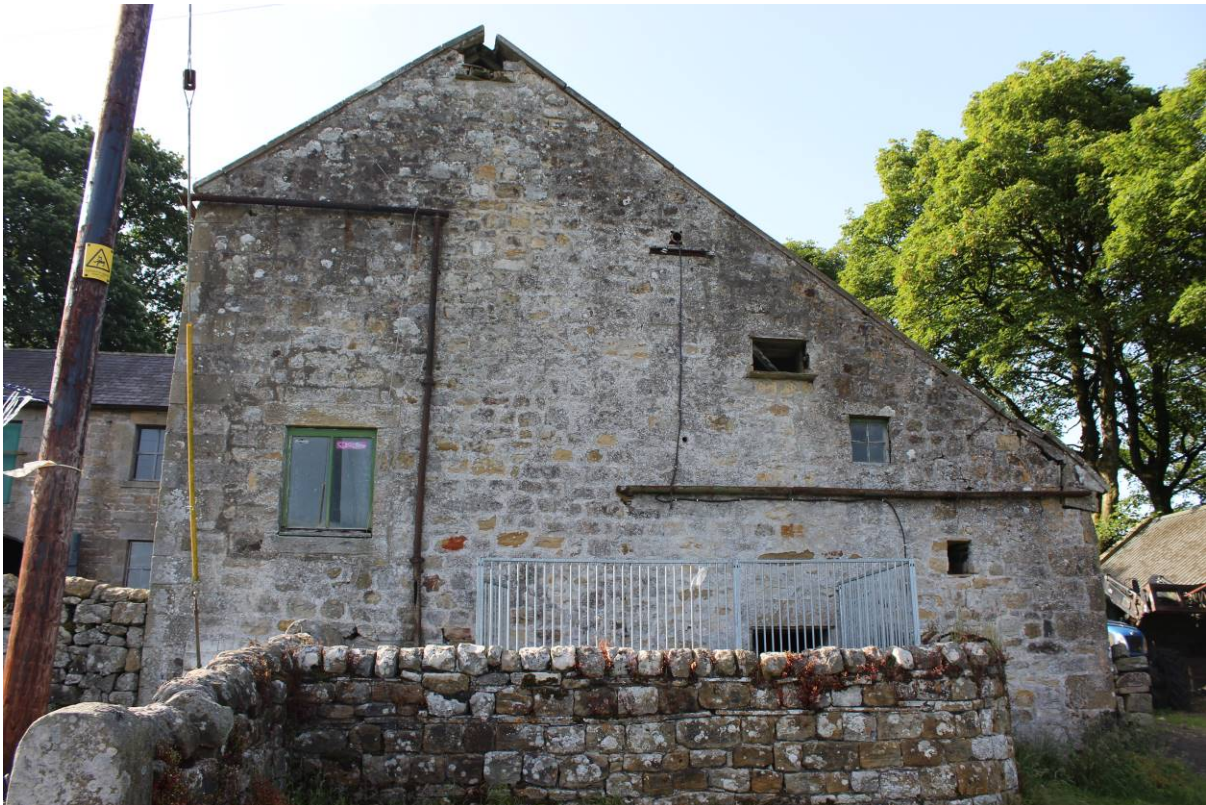
Southern Gable Wall. Note the missing stonework to the apex, the rainwater goods, and the displacement of the east kneeler and surrounding stonework.

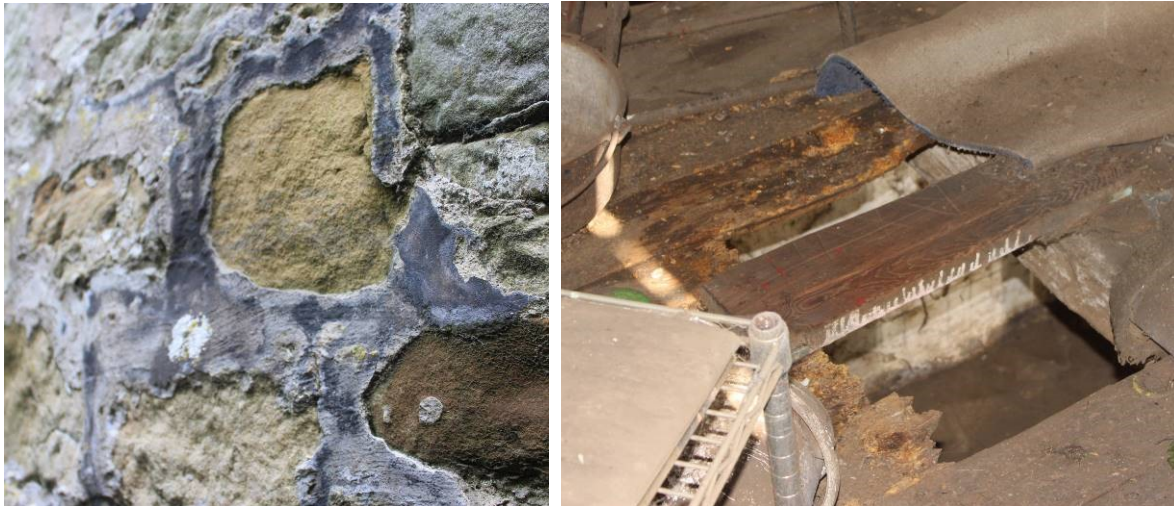
Northern Gable wall. Note the protruding cement based mortar. Granary Floor: Note the decay to the floor boards.

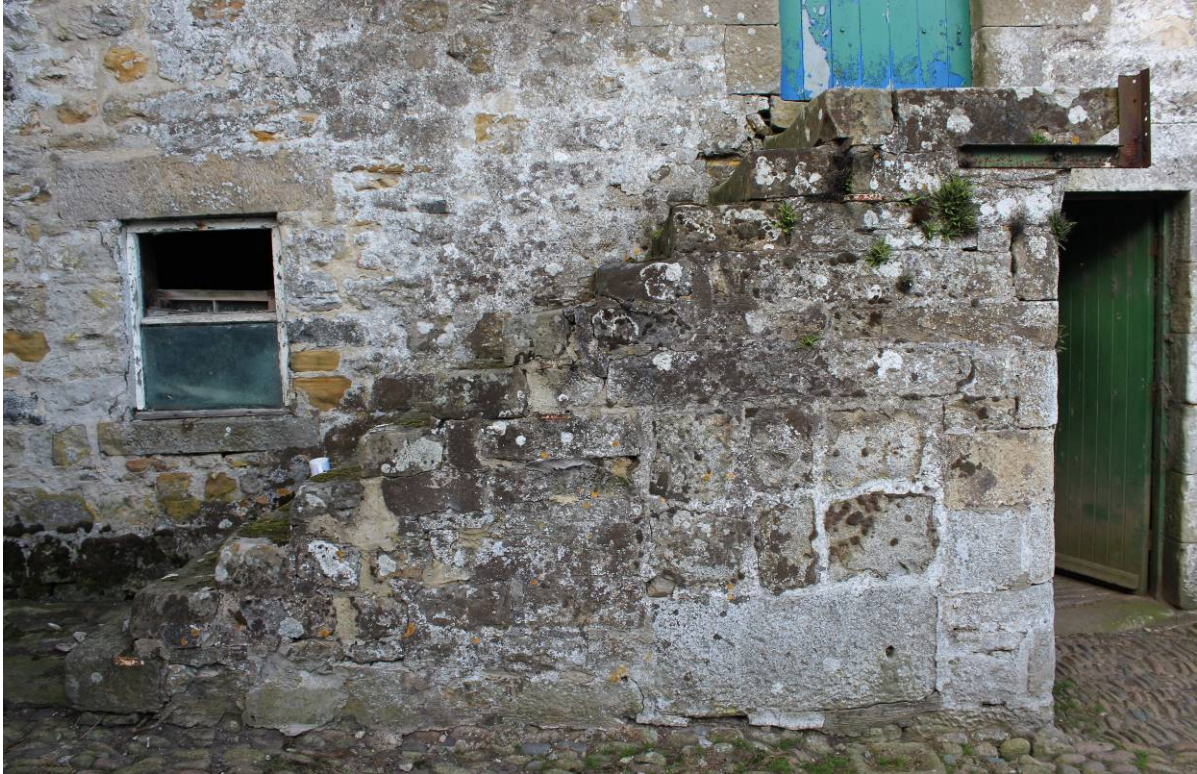
Western Elevation: Note the window with missing vertical glazing bars in a poor condition. Note the external stair is unprotected and is hazardous to use.
