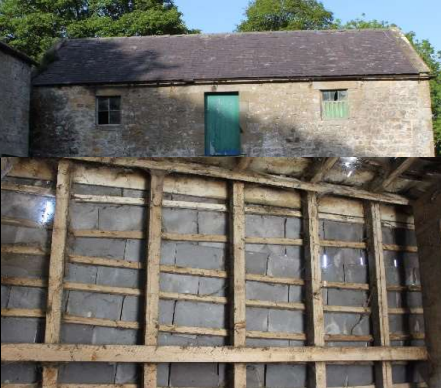
Item no.	Location	Defect description	Photograph	Recommended Repair & Quantity	Repair Category & Spec ref	Tender Price
<b>1.0. ROOFS</b>						
1.1	West Face	The roof is in poor condition with holes and water penetration . There are a number of slipped, displaced and missing slates. There are cracks along the mortar fillet to the water tabling with vegetation growth. The slating latts are cracked and displaced.

Strip the slates and reslate the roof, with lead soakers at the water tabling with a mortar fillet finish. Rebed the ridge tiles.  (38.5m sq.)	1  Spec 1

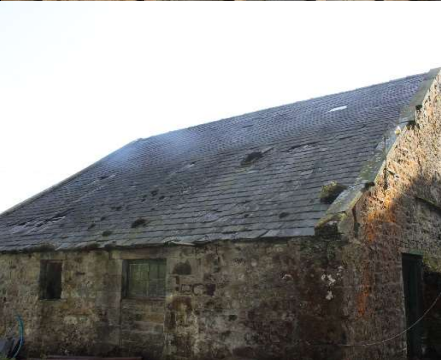
1.2	East Face	The roof is in poor condition with holes and water penetration. There are a number of slipped, displaced and missing slates. There are cracks along the mortar fillet to the water tabling with vegetation growth. The slating latts are cracked and displaced. One of the glass slates is missing.

Strip the slates and reslate the roof, with lead soakers at the water tabling with a mortar fillet finish. Rebed the ridge tiles. Include for refitting the glass slate.  (91m sq.)	1  Spec 1

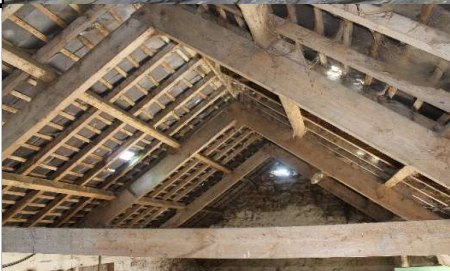
1.5	Granary - Roof structure.	The roof structure is generally sound. The trusses, purlins, ridge and most of the rafters appear serviceable. There are a few split rafters and one rotten rafter on the eastern face.

Include for the removal of the split and rotten rafters and renewal with new timbers.  (Allow for 6no. 80x60mm treated rafters approx. 3.7m long.)	1  Spec 2

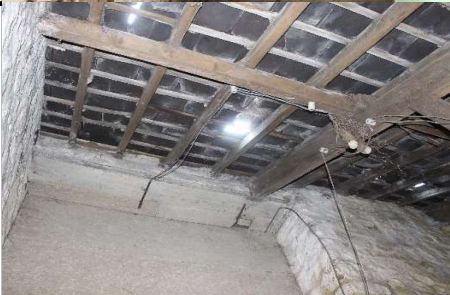
1.6	Store - Roof structure.	The principal rafters and purlins appear reasonable. There are a number of rotten rafters at the bases and tops, and there is rot in the wall plate at the eaves.

Include for the removal of the rotten rafters and renewal with new timbers and a new wall plate.  (Allow for 14no. 80x55mm treated rafters approx. 4.5m long, and a new wall plate 150x38mm 6m long.)	1  Spec 2

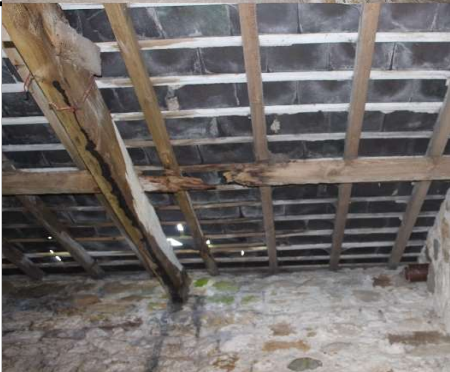
1.7	Kennel - Roof structure.	The roof structure is in poor condition with rot in most of the components, i.e. principal rafter, purlins, rafters and wall plates.

Include for the removal of the complete roof structure and renewal to match the existing.  (Allow 2no. C24 75x225 purlins spanning the entire width, with 8no. C24 50x100mm rafters approx. 4.5m long, with 150x38mm wallplate approx. 3.3m long.)	1  Spec 2

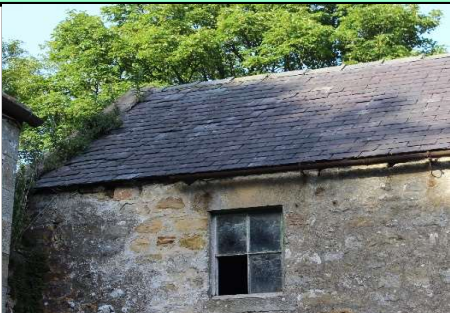
2.0. Rainwater Goods					
2.1	West roof	The gutter is corroded and there is a section missing at the northern end.

Install new cast guttering on rafter brackets.  (1no. length of 11m of deep flow guttering with 1no. stop ends and rafter brackets.)	1  Spec 4

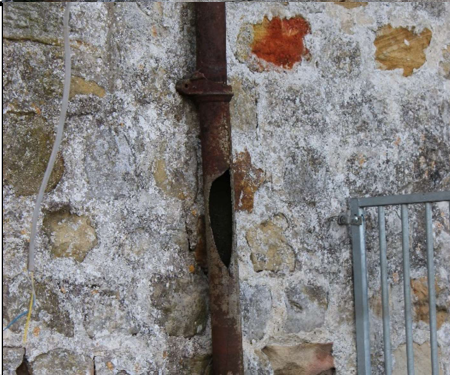
2.2		The guttering runs along the southern elevation with a downcomer to a gulley. The downcomer does not discharge directly to the gulley and the pipework is corroded and split.

Install new guttering and downpipe with angled section to direct the downpipe to the gulley.  (1no. length of 3.0m of deep flow guttering with 1no. corner, 1no. stop end, 1 no. outlet, spiked brackets, 1no. 5.5m downpipe with 2no. 45 degree angles, with eared brackets and outlet shoe.)	1  Spec 4

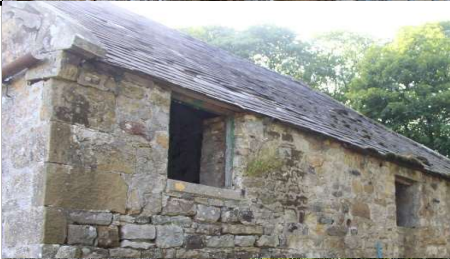
2.3	East roof	The existing guttering is largely missing with only a small remnant remaining.

Install new cast guttering on rafter brackets.  (1no. length of 11m of deep flow guttering with 1no. stop ends and rafter brackets.)	1  Spec 4

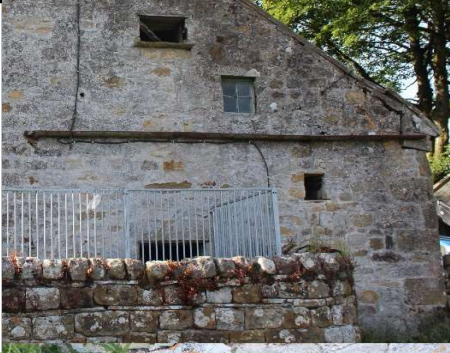
2.4		The guttering runs along the southern elevation, only the gutter remains and the downcomer is missing.

Install new guttering and downpipe with angled section to direct the downpipe to the gulley.  (1no. length of 3.0m of deep flow guttering with 1no. corner, 1no. stop end, 1 no. outlet, spiked brackets, 1no. 3.0m downpipe with eared brackets and outlet shoe.)	1  Spec 4	
2.5		The outlet at the southern end of the range is centrally located. There is no grid and the stone surround is cracked.

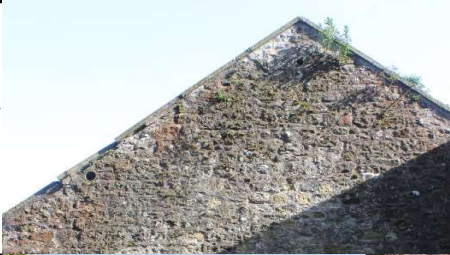
<b>3.0</b>		<b>WALLS</b>			
<b>3.1.0</b>		<b>External Walls</b>			
3.1.1	North Wall	There are open joints to the watertables, which have displaced and there is loose stonework below. There is a build up of vegetation.

Remove the vegetation and watertables, rebuild the top of the wall and rebed the water tables.  (Assume the top 500mm of wall is to be rebuilt and 12.1m of watertable rebedded.)	1  Spec 5

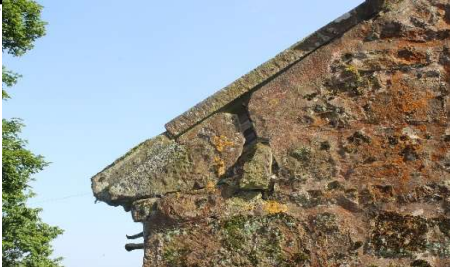
3.1.2		The eastern kneeler at the base of the watertable is displaced.

Remove and rebed including resin pins to secure the kneeler to the stonework below.  (Assume inserting 3no. 10mm stainless steel pins in resin approx. 500mm long.)	1  Spec 9

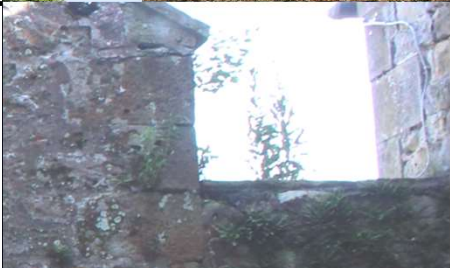
3.1.3		There is vegetation growth and open joints to the watertable above the northern gateway.

Remove vegetation and the watertables, rebuild the top of the wall and rebed the water tables.  (Assume the top 200mm of wall is to be rebuilt and 1m of watertable.)	1  Spec 5

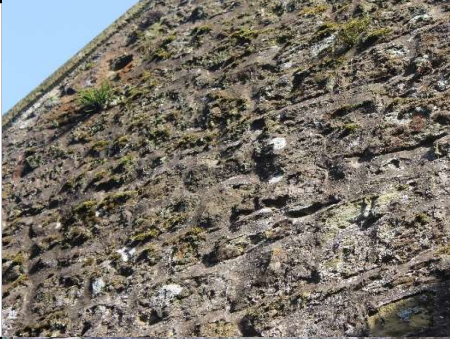
3.1.5		The wall appears to have been repointed in the past with a cement based mortar, which is having a detrimental impact on the stone, which is eroding more quickly than the stone leaving water traps on the wall. There are areas of loose and cracked mortar and vegetation growth at high level.

Rake out and repoint the wall  (36m sq.)	2  Spec 6	
3.1.6		There is an area of washed out and friable joints to the west of the Granary door.

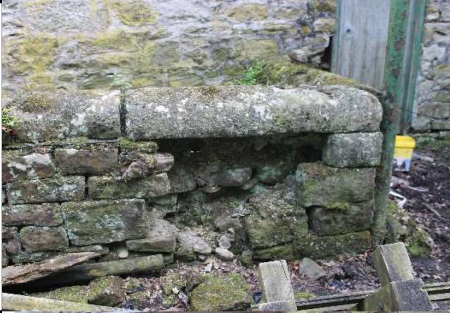
3.1.13		There is a small walled enclosure, which is full of debris and the walls are in poor condition with open joints and a hole in the northern wall.

Clear out the debris repoint and fill in the collapsed hole.  (Rebuild and piece in at the collapsed section 1m sq. Repoint 18m sq.)	3  Spec 10 & 6	
3.1.14	East Wall	The is an area of washed out and missing mortar joints at the southern end of the wall.

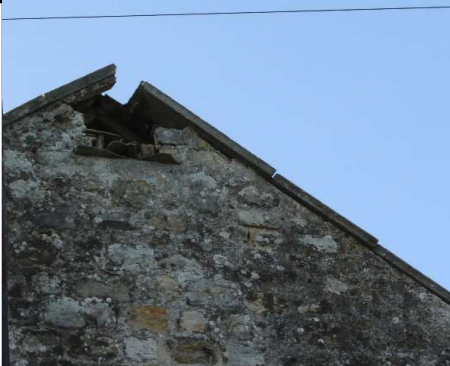
3.1.17	South Wall	There are open joints to the watertables, which have displaced and there is loose stone below, and there is a section of missing masonry at the apex.

<p>Remove the vegetation and watertables, rebuild the top of the wall and rebed the water tables.</p> <p>(Assume the top 500mm of wall is to be rebuilt, 12.1m of watertable and piece in missing area of stone apex approx. 1m sq. but maintain the dovecote opening.)</p>	1	Spec 5 & 10

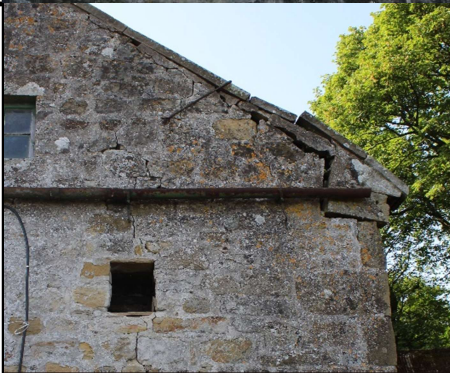
3.1.18		The eastern kneeler at the base of the watertable is displaced together with the surrounding stonework, which has cracked.

<p>Remove and rebed the kneeler and surround stonework include for resin pins to secure the kneeler to the stonework below.</p> <p>(Assume inserting 3no. 10mm stainless steel pins in resin approx. 500mm long. And rebuilding 2.5m sq. of wall with integral stainless steel bed reinforcement)</p>	1	Spec 5 & 9

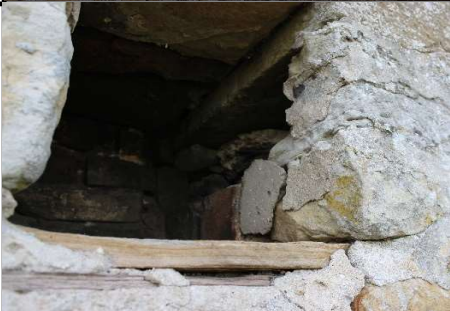
3.1.19		There is an open gap and missing stone to the jamb of the eastern small opening, which is blocked up internally.

<p>Piece in stone and repoint the jamb, and piece in stone to secure the opening</p> <p>(200x300mm hole in jamb, piece in stone to consolidate the existing internal blocked up opening.)</p>	2	Spec 10

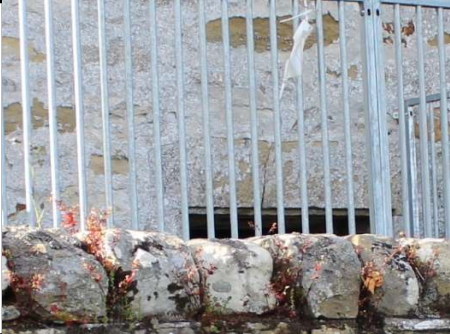
3.1.20		There is a crack to the stone lintel over the door to the kennel.

Undertake pinning and repoint the crack. (Skew drill the head and insert 2no 10mm stainless steel rods bedded in resin.)	1 Spec 9	
3.1.21		There are washed out joints to the wall above the gulley

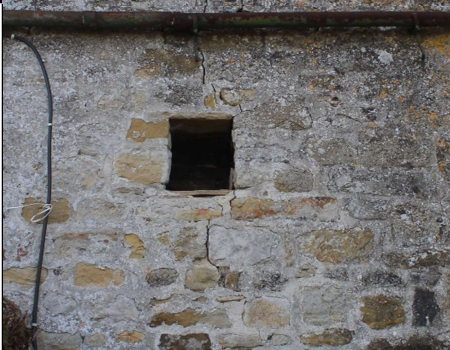
3.1.23		The wall appears to have been repointed in the past with a cement based mortar, which is having a detrimental impact on the stone which is eroding more quickly than the stone leaving water traps on the wall. There are areas of loose and cracked mortar.

Rake out and repoint the wall  (51m sq.)	2  Spec 6

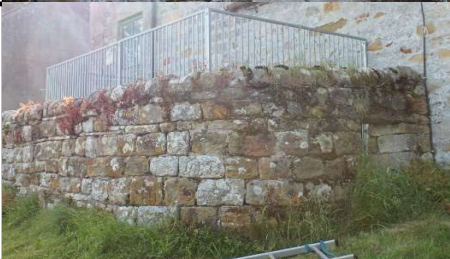
3.1.24		There is a small yard with walls which have loose tops, as well as open joints..

Rebed the coping stones and repoint the upper face of the wall.  (Allow 8m of coping and 8m sq. of repointing)	3  Spec 5 & 6

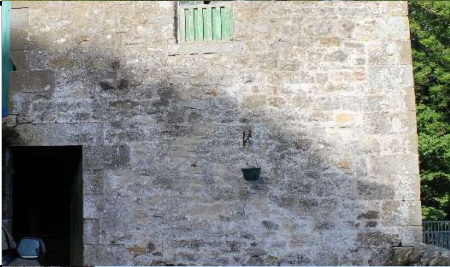
3.1.25	West	There are a number of cracks to the southern end of the wall.

Install reinforcement across the crack, and repoint the crack.  (Allow for 5no. 2400mm stainless steel helibars horizontally across the crack at approx. 450mm vertical centres within the stone joints.)	1  Spec 8

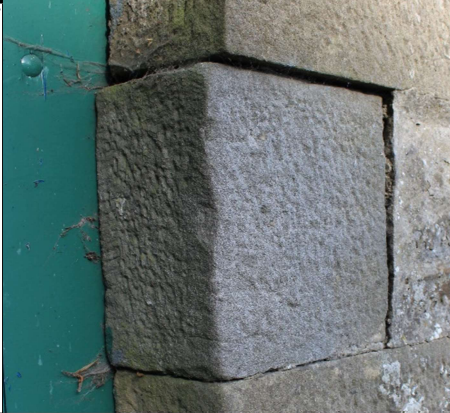
3.1.27		A quoin at the southern jamb of the first floor doorway has displaced.

Rebed the stone.  (1.5msq.)	2  Spec 5	
3.1.28		A section of one of the quoins to the first floor door at the southern jamb has broken away, the cracked piece is on site.

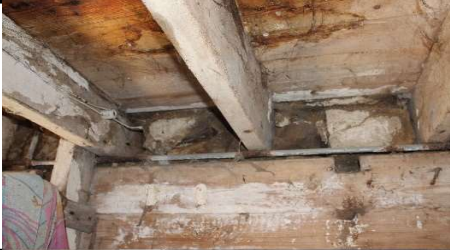
3.2.5		To the north of the door there is loose stonework and open joints around the floor joists.

Piece in stone and repoint.  (Assume piecing and repointing around the northern most 10 joist ends.)	2  Spec 10	
3.2.6		There is evidence of rot to the window lintel.

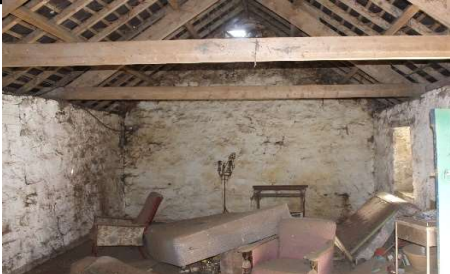
Repoint  (1m sq. )	3  Spec 6	
3.2.40	Internal walls generally	The walls have been whitewashed in the past.

Consider whitewashing the walls to all the internal walls once the various repairs have been undertaken.  (Allow for 250m sq. )	3  Spec 17	
					sub total

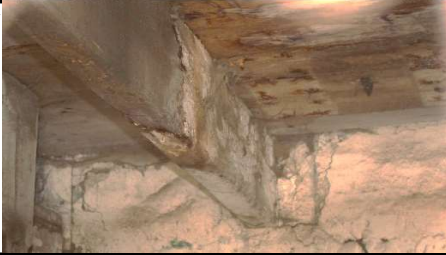
No works required.	—	—
4.2	Granary Ground Floor	There is rot in one of the floor joists due to the leak from the roof.

Cut out the beam and renew with a new treated timber beam and make good the walls around the new joist. (1no. 225x75mm C24 joist.)	1  Spec 12

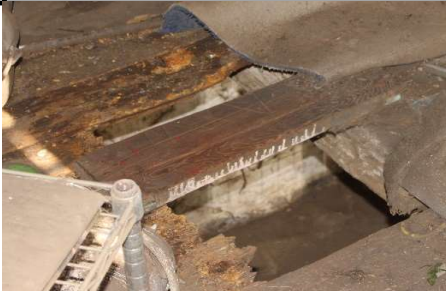
4.5		The floor is in a poor condition with a number of holes. There are rotten sections of timber floor boarding due to the water penetration and areas with wood worm holes.

Take up the areas of rotten boards and renew.  (Allow for 45m sq of 150x25mm T & G boards)	1  Spec 12

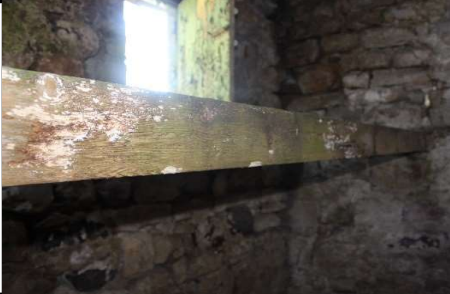
4.11		There is rot to the existing first floor joists and these appear undersized and there is no flooring remaining.

Remove the existing joists and renew.  (Assume 8no. 75x175mm C24 treated floor joists. Include area of 11.5m sq and finish with 150x25mm T & G boards)	3  Spec 12

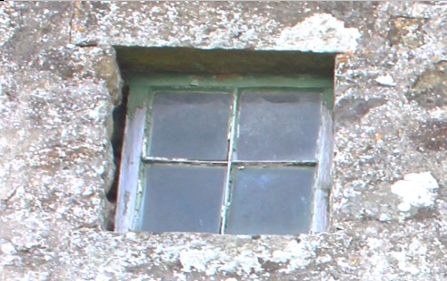
5.12	Kennel Central Window.	The putty is missing and the window has little paint and the whole window is loose.

Secure the window, renew the putty and decorate.	3  Spec 14 & 17

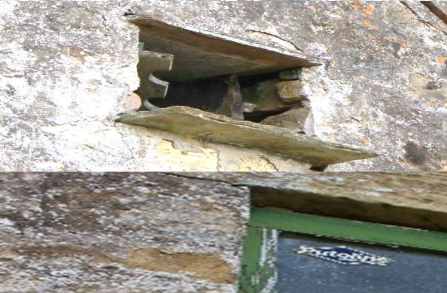
5.13	Kennel Upper Opening	It appears this opening formed a dovecote, most of which is missing.

<p>Include for forming a timber boxed dovecote.</p> <p>(Approx. size 780mmx 480mm and 400mm deep. Allow a provisional sum)</p>	2  Spec 15

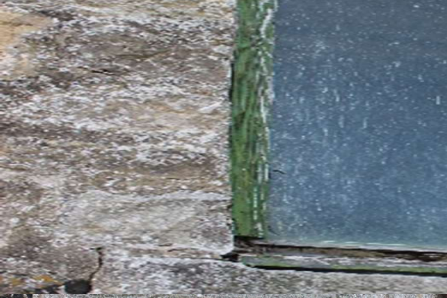
5.14	Granary Ground Floor south window	The window is in poor condition with missing putty, rotten timbers and flaking paintwork.

<p>Renew with a simple opening casement window with 4 panes.</p> <p>(Approx. size 900mmx 1100mm)</p>	2  Spec 15
