Our Ref: 19152 BTB SMW

Date: 30th September 2019

SEWINGSIELDS FARM

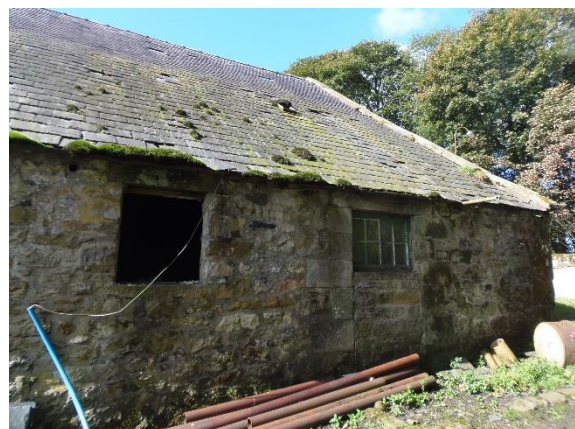
It was apparent that the roof requires re-covering throughout, and the head of the gable walls requires re-building, along with re-setting the stone tabling and providing additional restraint straps or dowels to

the tabling, in order to prevent the kneeler/ skew stone from rotating. There some cracks to the walls, on all elevations across which you have suggested some helibar ties. Other than to the heads of the walls, there is no major rebuilding required. There are however extensive areas of cement-based smear pointing that will require attention. The floorboards to the first floor are rotten to most areas and require replacement, but the floor joists appear to in reasonable condition. Additional joists are required to bring the floor in the southern end of the offshoot over the gable kennel area back into use.
