**HIGHGREEN MANOR
DANISH BARN**

STRUCTURAL INSPECTION REPORT

Project No: 341/DS

Issue No:	1					
Date:	02-03-20					
Prepared by:	D M Ramsay					
Approved by:

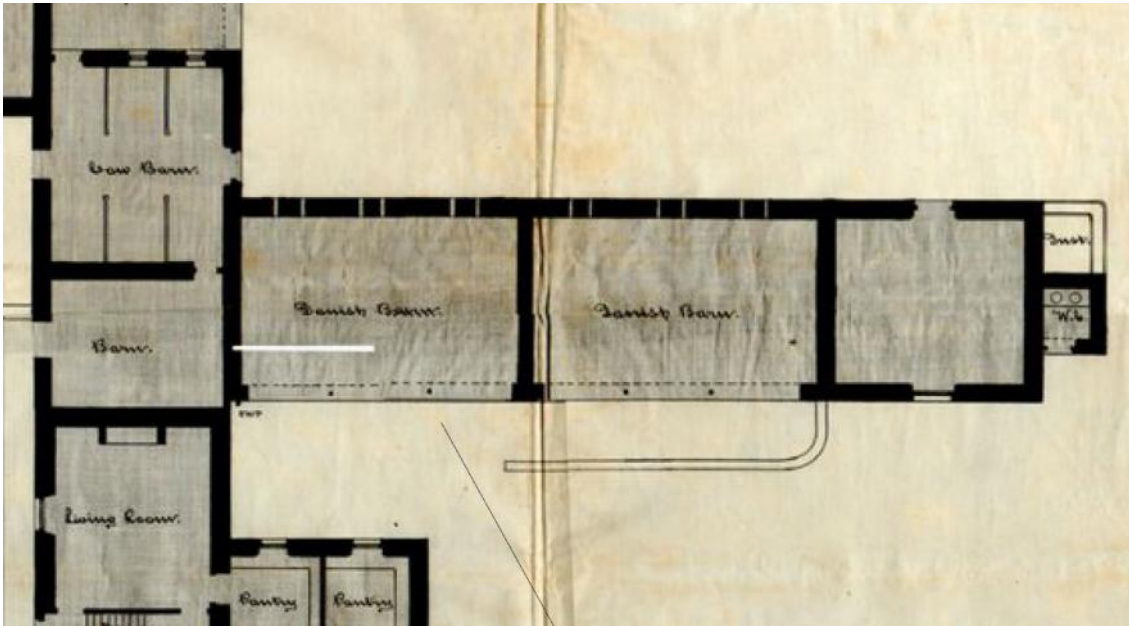
- 1.2 At Highgreen the client has been considering the removal of a wall to the Danish Barn in order to improve drainage between the barn and part of the building to the south. Original plans indicate that the barn, as built, was open on the southeast elevation and there are indications that the eaves were supported by four posts, ref Appendix A.

5.1.3 Where the former internal dividing wall would have been the south end of this remains as a pier 1000mm wide integrated into the rebuilt wall. This corresponds well with the detail indicated in the original plan (Appendix A).

Original Plan (showing posts on south elevation and dividing wall)

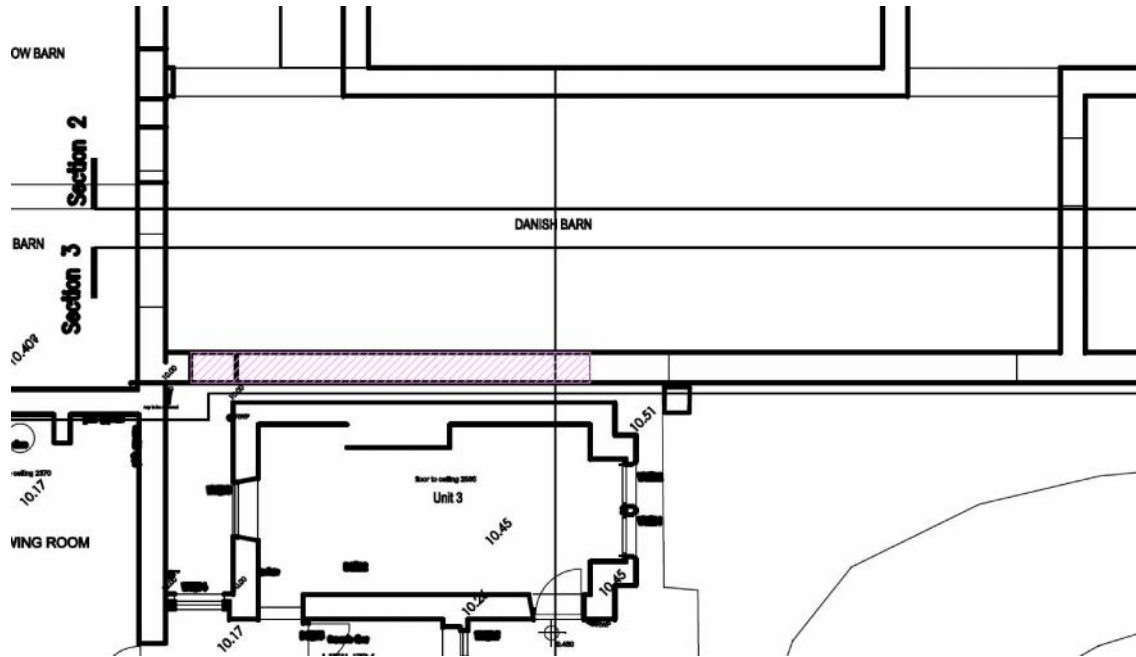
Existing Plan (showing wall proposed to be removed)

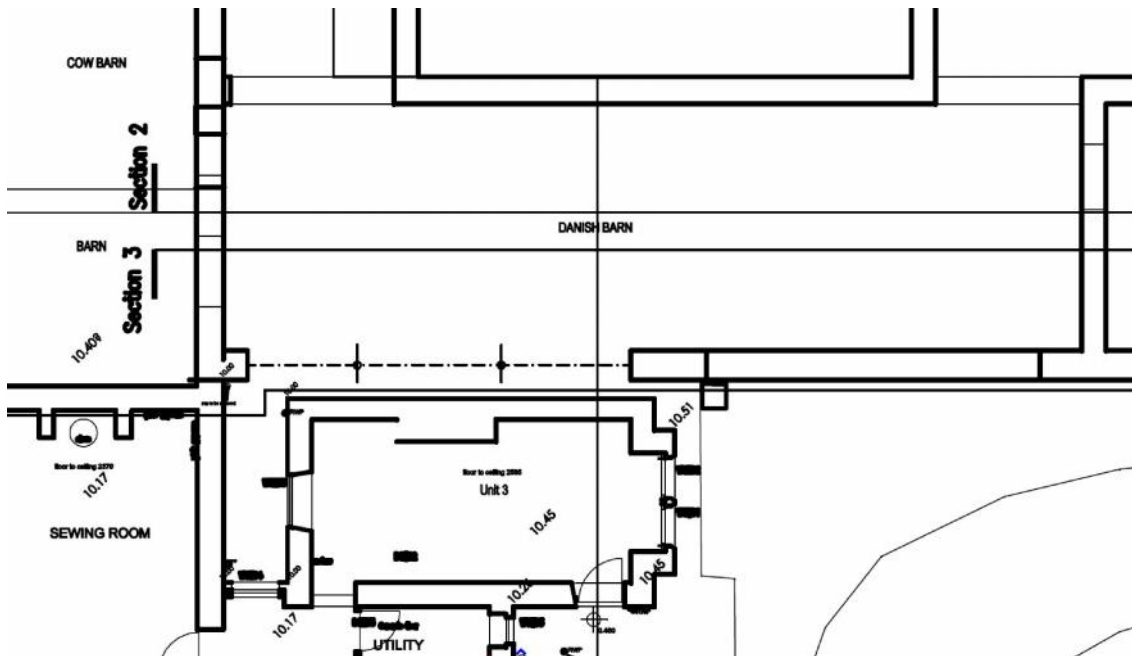
Proposed Plan (showing proposed new posts)

- 7.1 In order to enable the removal of approximately 7.85m of the existing south wall it is proposed to reinstate the two posts which are indicated on the original plans.

- 7.2 It may be possible to find the new posts on pre-existing stone plinths, if they exist, in which case the location of these will determine the post locations. If existing stone plinths are not discovered under the existing wall then new concrete pad foundations will be required. The size and formation level of new pads will be determined following further excavation.

- 7.3 The new posts maybe steel or possibly oak timbers. Provisional sizes of the steels are circular 180 diameter. Final diameter and thickness will be determined by detailed calculations after the overall arrangement has been confirmed by the architect.

- 7.4 Due to the absence of the original internal cross wall in the Danish Barn it is considered prudent to provide short props between the head of the posts and the adjacent building to restrict any lateral movement. The short prop may be bolted to a channel fixed to the face of the adjacent building, running under the line of the new valley gutter, or alternative detail as proposed by the architect.

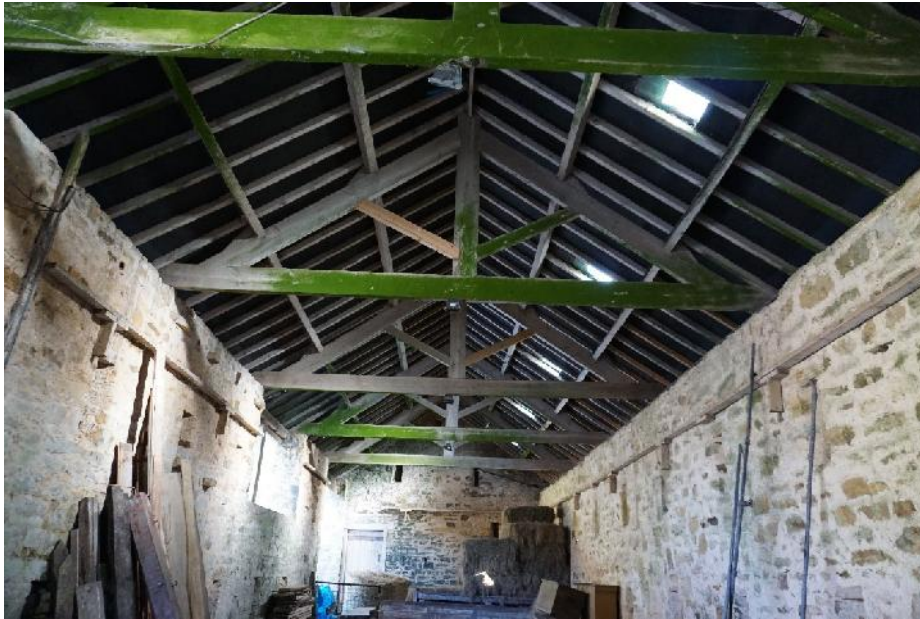
PHOTO 3 – Roof Structure

- 4.3 Internal dimensions are approximately 17760 x 5070mm. The south wall has a height of 4030mm topped with a substantial timber wallplate 300 x 150 on which are seated 5 no king post timber roof trusses, photo 3 and 4. The roof covering is of Welsh Slates at approx. 35 deg pitch.

5.2.1 It is understood that repairs to the roof were carried out ten years ago. All small number of new timbers are evident however most of the timber structure appears to be original.

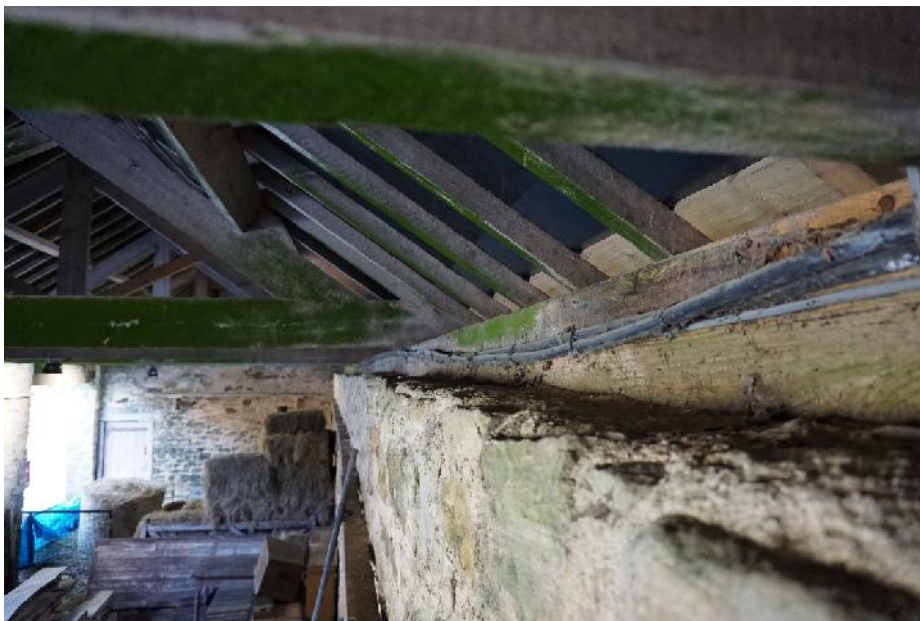
5.2.2 The condition of the 300 x 150 wall plate was examined as far as was practical with the access available. In general it appeared to be in fair condition though some localised decay was noted, coincident with locations where rafter repairs had been carried out.

5.2.3 Over the area where it is proposed to remove the south wall, a length of approximately 7850mm, the wall plate appears to be a single timber with no joints evident, photo 4.

PHOTO 4 – Eaves Detail (300x150 timber wallplate)

- 7.5 The depth to bedrock or suitable formation level is not yet known and must be determined by excavation.
- 7.6 When full access is available the condition of the existing wall plate must be confirmed. This appears to be in fair condition and it is thought likely that no repairs will be required, however this is based on limited access from the north side only. Some minor areas of decay were noted. Renewed timber preservative treatment should be applied when access is available.

- 7.7 Temporary propping of the existing wall plate will be required in order to remove the wall. Details of any temporary works must be determined by the builder.
