**The Old Hen House / Kennels**

**Harbottle**

**Red Fox Consulting Engineers**

**Project No: 20031R**

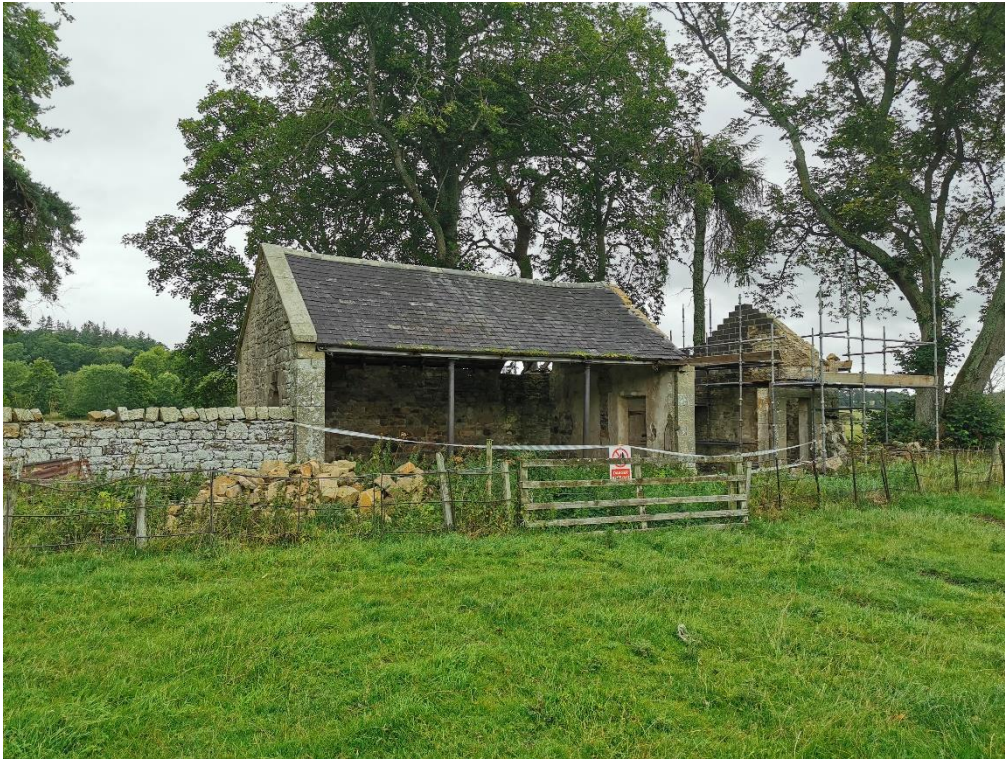
The structure is a traditional, small agricultural building, rectangular on plan with a duo pitch roof. The building runs northwest to southeast and measure approximately 13m by 5m overall. The height to ridge and eaves is approximately 5.0m and 3.8m respectively. See Photograph No. 1.

Photograph No. 1 – General view of structure

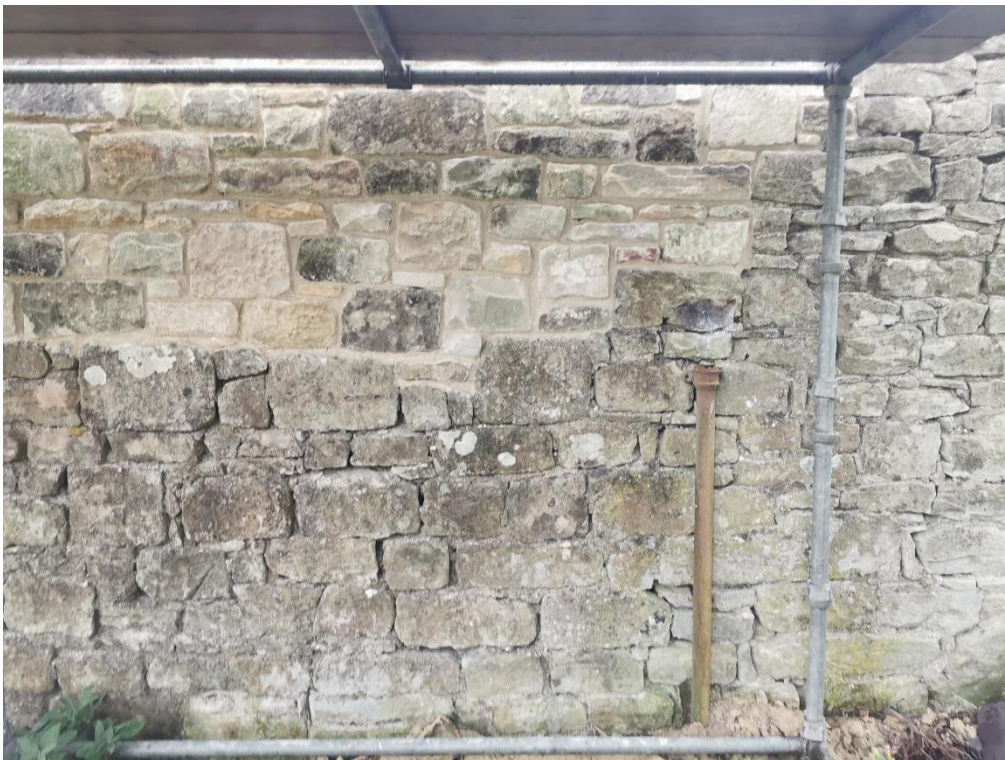
Generally, the stonework of the building is in good condition with only minor issues apparent. There are patches of mortar loss and loose and friable mortar. Some localised areas have been repaired with cementitious mortar. See Photograph No. 2.

The stonework is generally in a good condition with only minor defects apparent. There is ongoing work to the masonry, and it is likely that this will remedy the defects. However, the use of cementitious mortar could lead to degradation of the stonework and so this should be substituted with a suitable lime mortar where applicable.

Photograph No. 2 – typical condition of masonry

Cementitious and loose mortar should be raked out and the wall repointed with a suitable lime mortar to all elevations.

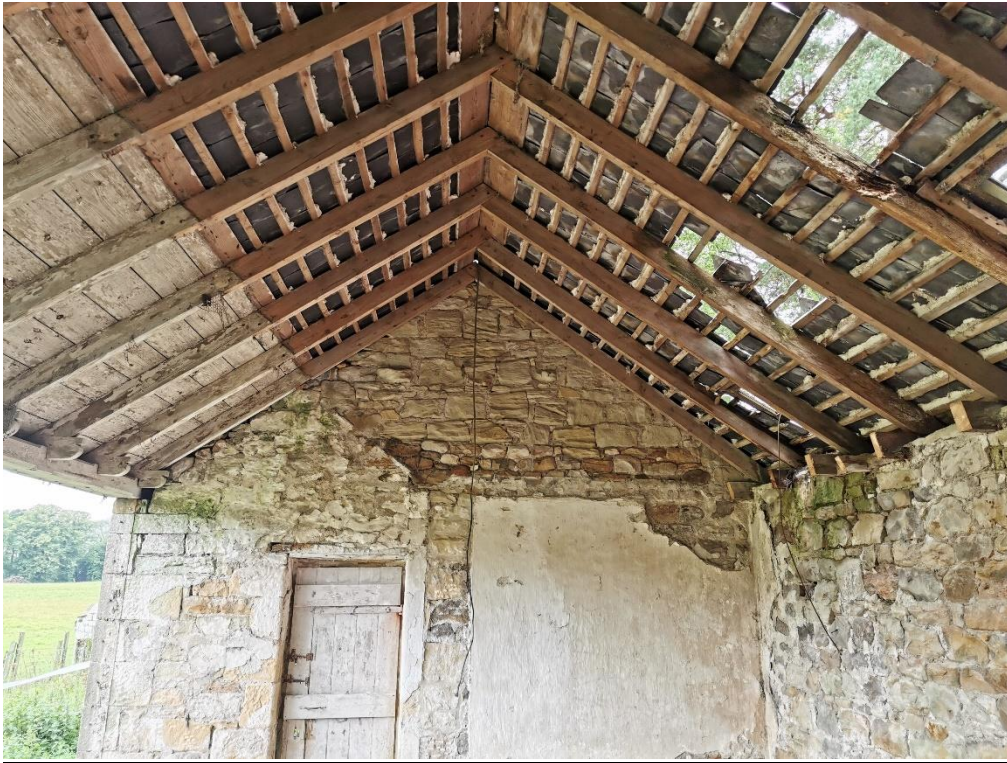
The bottom chords of the roof trusses have been removed which has resulting in spreading of the roof. This has pushed the front, large section timber out, leading to displacement of the stonework at either end. The front columns have been pushed out of plumb. See Photograph No's 3 & 4.

The roof is completely compromised and has led to displacement of the stonework and front cast columns. It is not possible to retain the current roof structure.

Photograph No. 3 – internal view of roof structure

The roof and supporting structure to the southwest should be taken down and replaced with a new roof structure. New foundations will be required for the cast iron columns and front wall construction. A new roof structure should be installed above the small, southeast section.

The displaced stonework adjacent to the main front beam should be taken down and rebuilt. The water table should be reset to the northwest and reintroduced to the central gable.

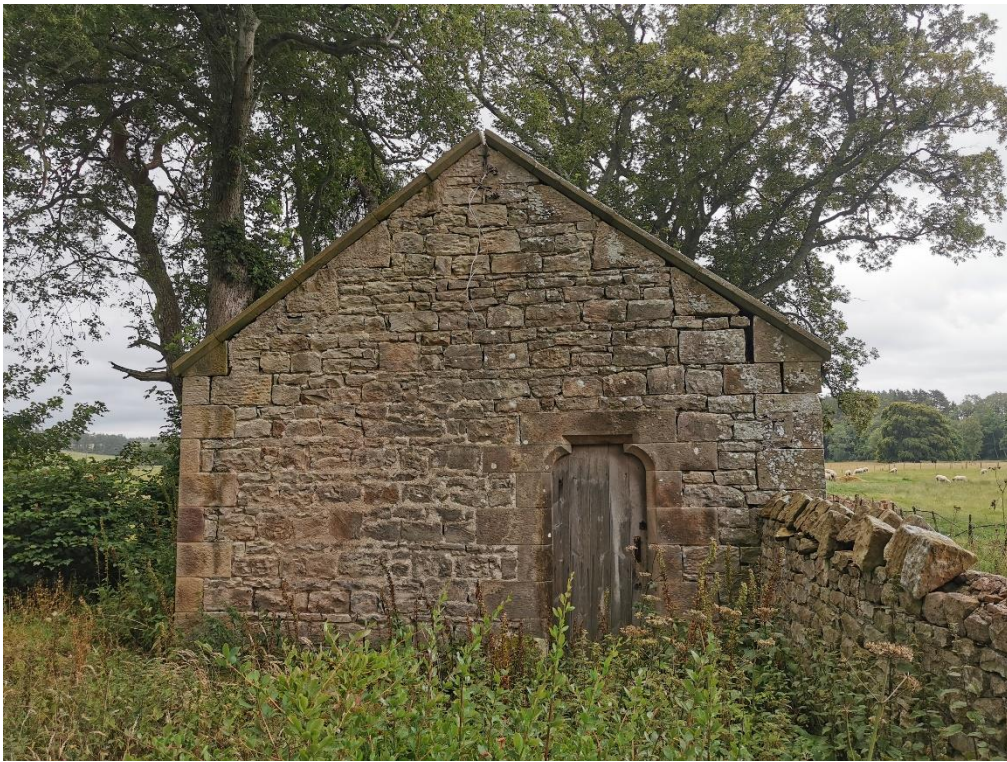
The water tables to the northwest gables have slipped, resulting in gaps between the stones. There is no water table present to the central gable. See Photograph No's 4 & 6.

Photograph No. 4 – northwest gable

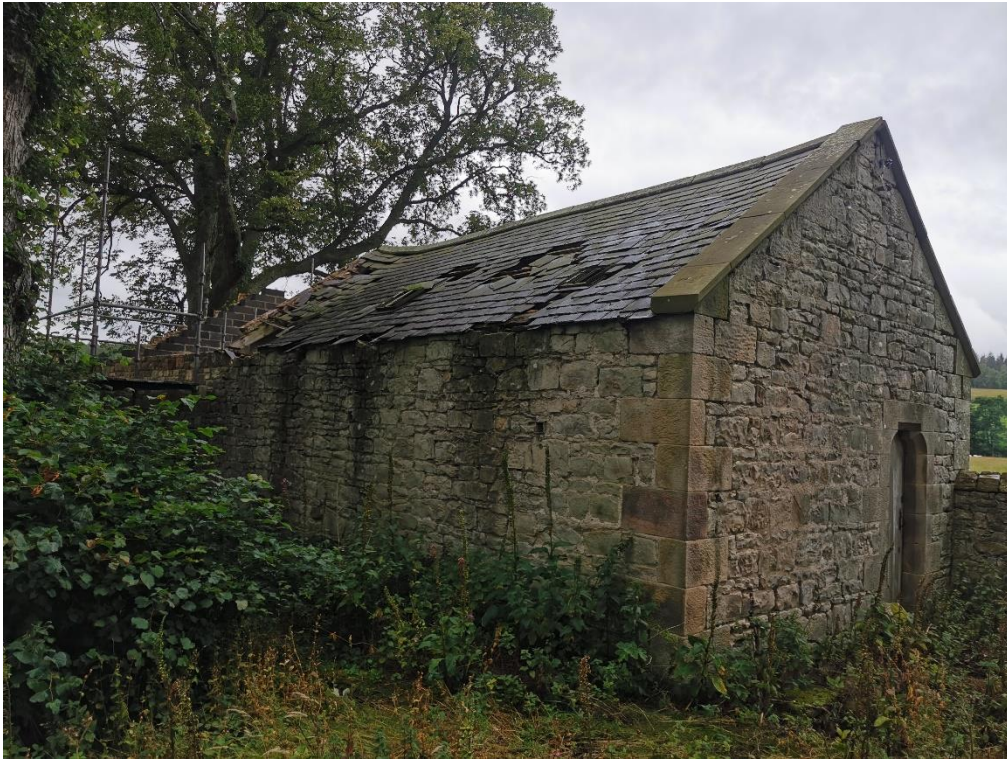
The roof covering is compromised in a number of areas which has resulted in water ingress into the building and wall head. See Photograph No. 5.

Water ingress to the wall head at both the rear wall and gables, due to missing or displaced water table and/or degraded roof covering will lead to degradation of the stone wall below.

Photograph No. 5 – view from rear of building

Reinstatement of roof coverings and rainwater goods to stop all water ingress. It is likely that a suitable drainage system will be required to divert the surface water away from the building satisfactorily.

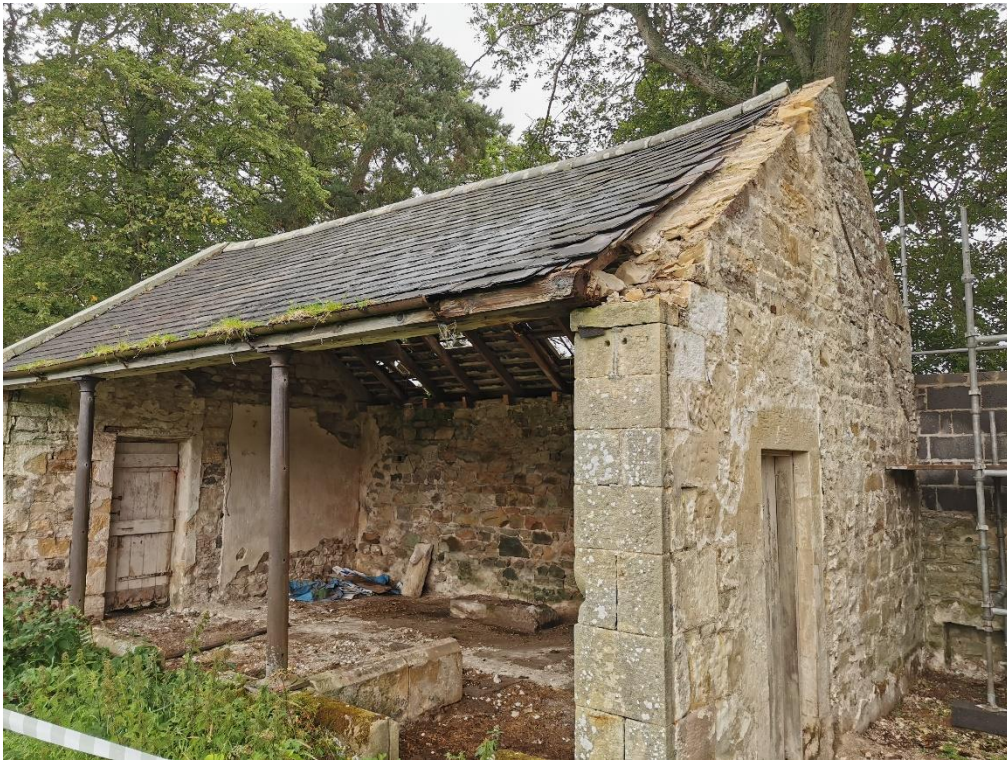
Photograph No. 6 – missing water table to central gable

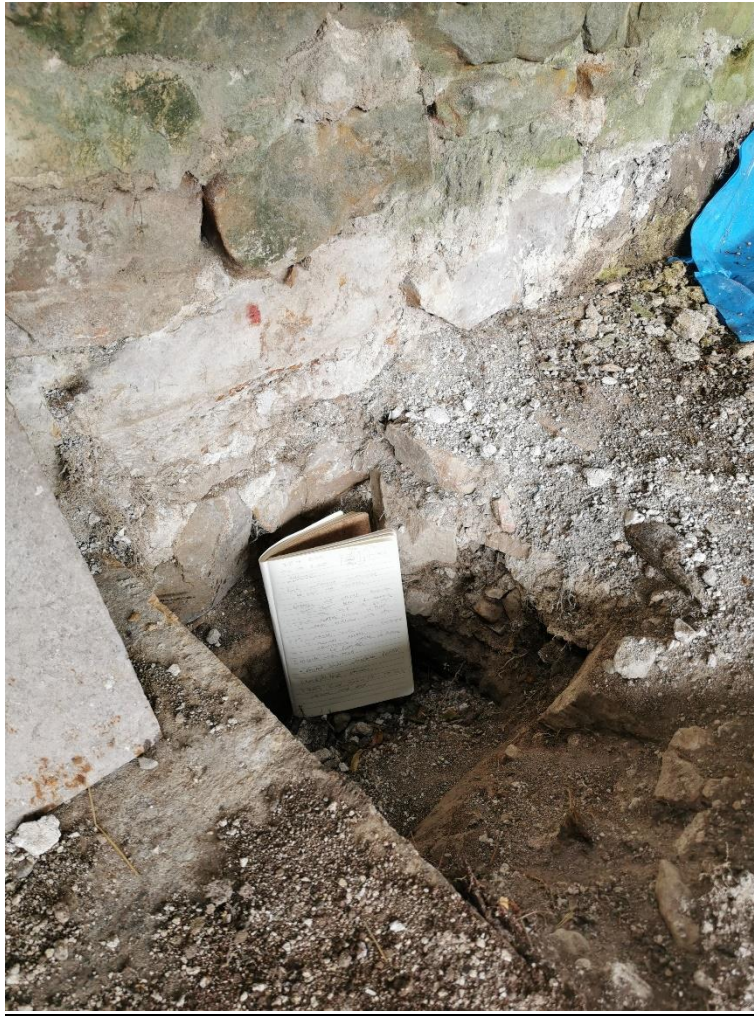
Trial pitting was undertaken internally, adjacent to the rear, northeast wall. The walls are built directly off the ground and extend down by approximately 300mm into it. See Photograph No. 7.

The depth of the base of the walls means that there will be no issue with introducing a new slab to all areas of the building. It is likely that the front cast columns will require a new foundation but there is no issue in installing these at that location.

Photograph No.7 – trial pit indicating base of wall

Replace all slabs/bare earth with a suitable reinforced concrete slab, with suitable insulation subject to building control requirements.

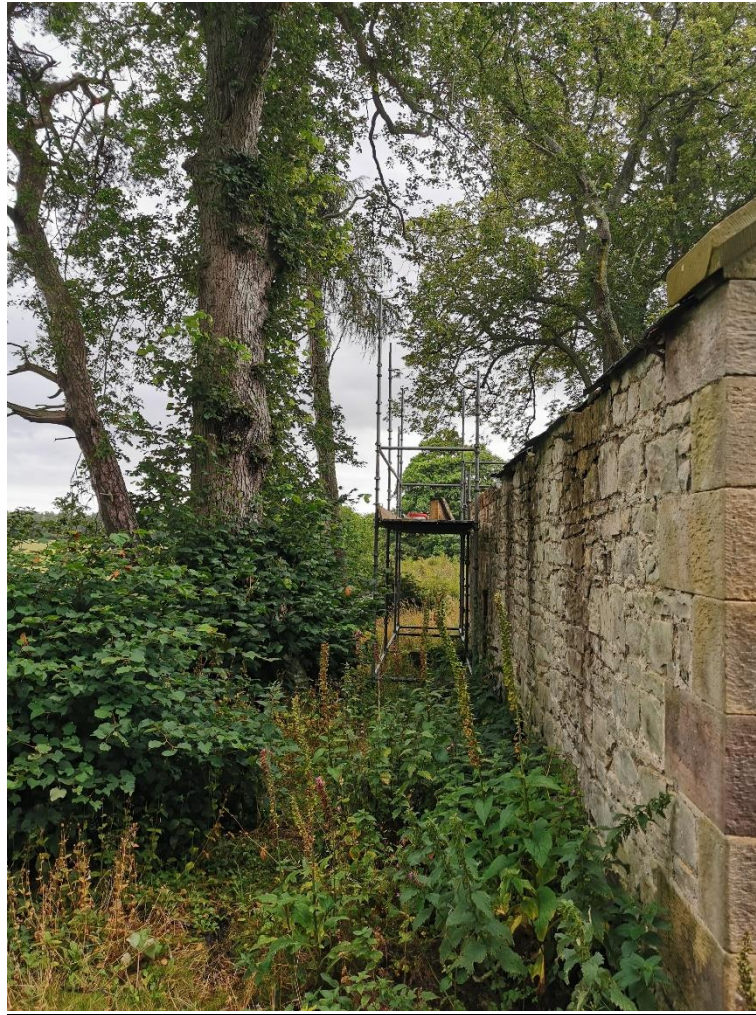
There are a number of mature trees adjacent to the rear, northeast elevation. However, there is no evidence that these have had an effect on the main structure. See Photograph No. 8.

The trees do not appear to be having a detrimental effect upon the main building but have caused displacement/collapse within the low level, northwest wall.

Photograph No. 8 – mature trees adjacent to rear of wall

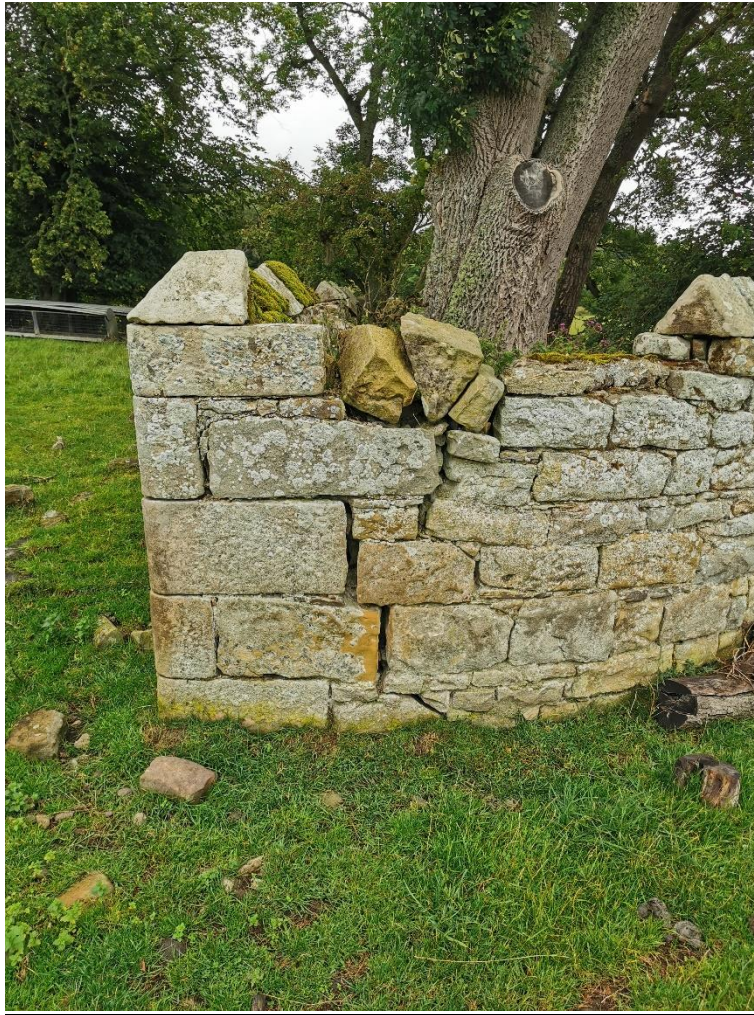
The lower wall extending to the northwest exhibits displacement and loss of stonework due to the tree growing within close proximity. The wall has also lost a number of coping stones and exhibits collapse of the northwest return. See Photograph No's 9 & 10.

Photograph No. 9 – displacement of northwest, low wall

The coping stones to the northwest, low level wall should be reinstated. The wall should be taken down in areas of collapse and rebuilt. It may be necessary to reroute the wall run to avoid the mature trees and ongoing issues.

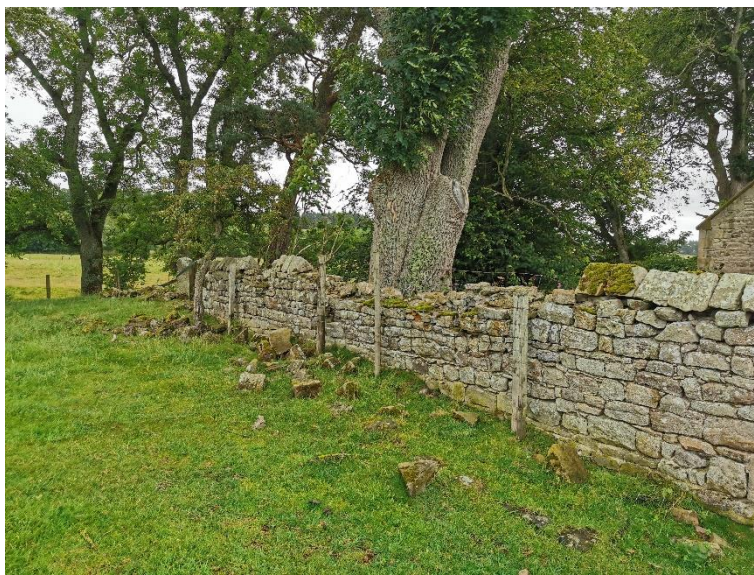
Photograph No. 10 - deterioration to northwest, low wall
