Design & Access Statement and Heritage Statement for Grade II Listed Redmire Bridge

Executive Summary.

Redmire Bridge is a Grade II listed masonry arch structure comprising three equal 8.5 m spans which carry the single track C199 minor road over the Tarset Burn. The C199 road is signed as "Unsuitable for HGV's". The bridge is located at Ordnance Survey Grid Reference 378789E, 585874N (see figure 1) within the boundaries of Northumberland National Park.

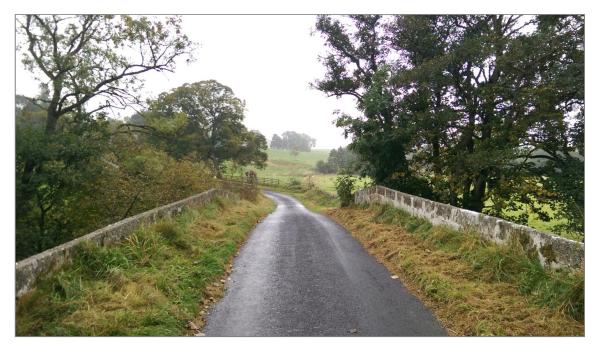
The carriageway over the bridge appeared to be in fair to poor condition. Verges to both sides of the road were overgrown with vegetation.

Photograph 1 – Poor surfacing and vegetation growth in verges looking southeast over bridge (16.10.2016)

Carriageway reconstruction will include kerbs and hardened verges to prevent water ingress and to mitigate the risk of falling with the low parapet present.

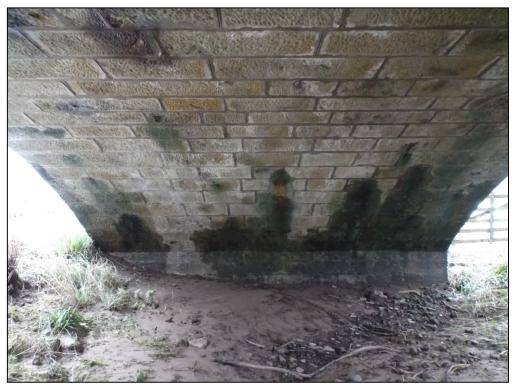
Photograph 2 – Dampness and staining to arch barrel masonry of north abutment

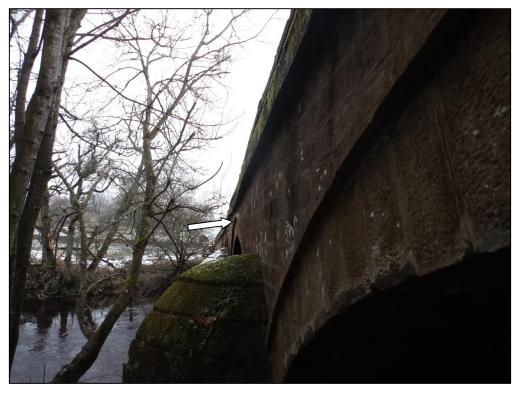
Photograph 3 – Bulging spandrel wall above west pier upstream elevation

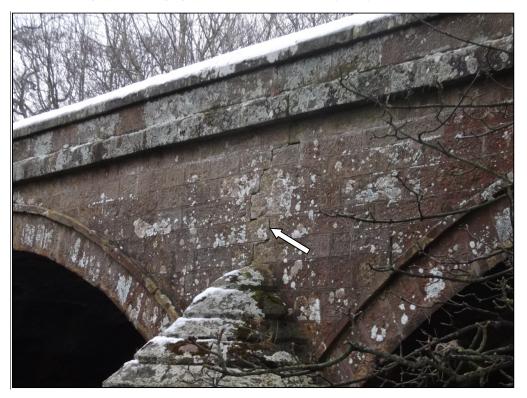
Photograph 4 – Crack above east pier to downstream elevation

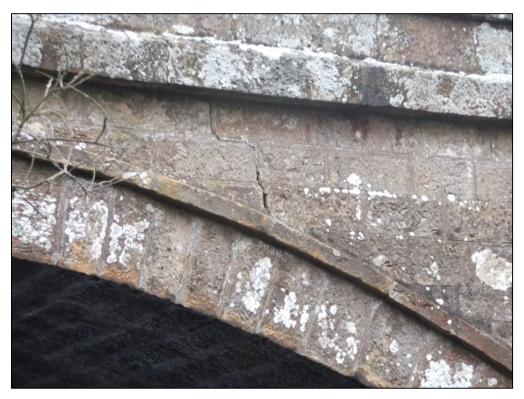
Photograph 5 – Crack in centre span spandrel to downstream elevation

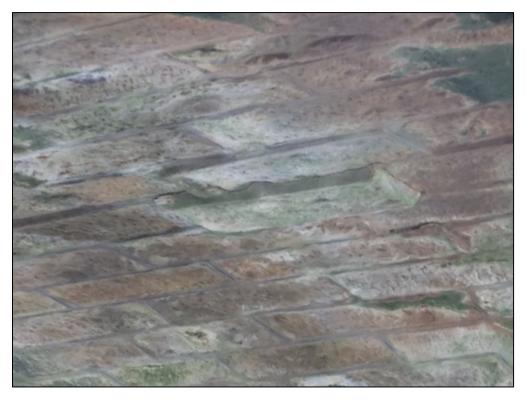
Photograph 6 – Displaced masonry block to south span arch crown

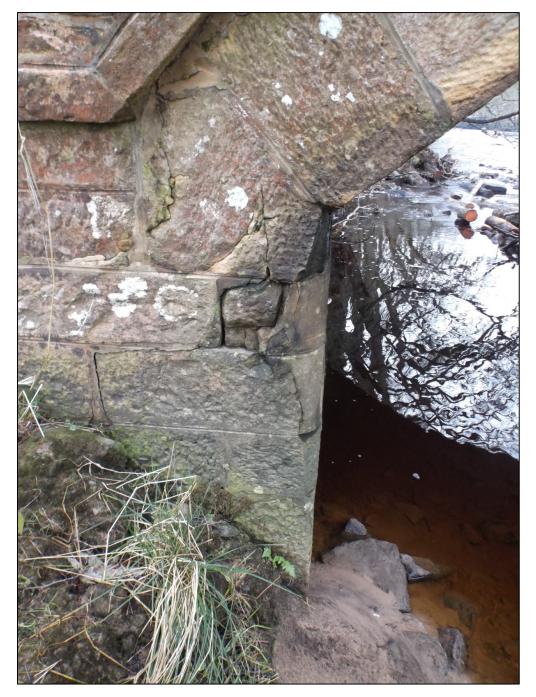
Photograph 7 – Masonry crushing at south abutment springing

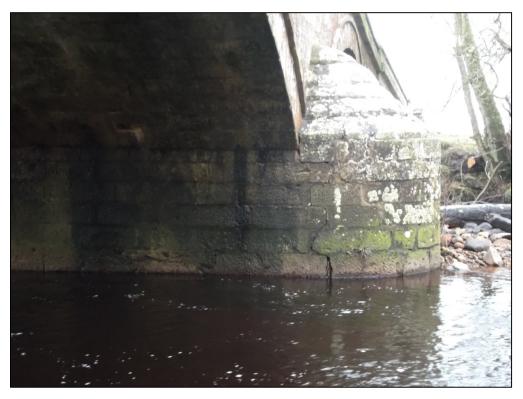
Photograph 8 – Crack and open joints to east pier downstream cutwater

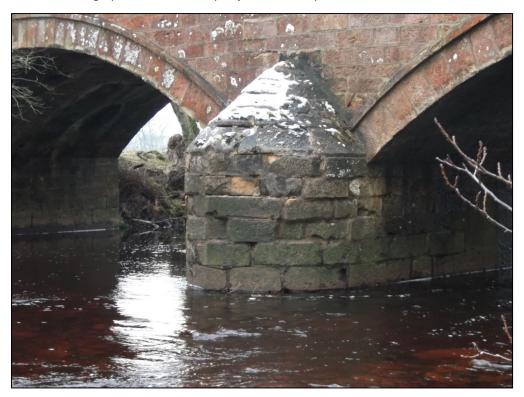
Photograph 9 – Open joints in east pier upstream cutwater, note evidence of recent spalling

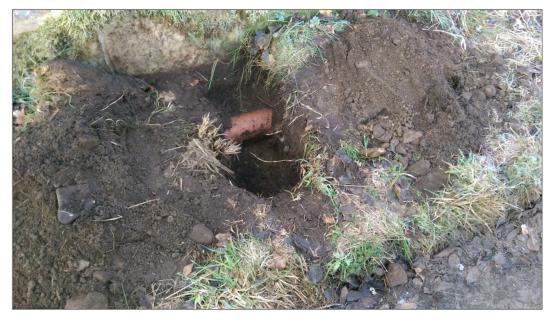
Photograph 10 – Downstream verge BT duct (05/12/2016).

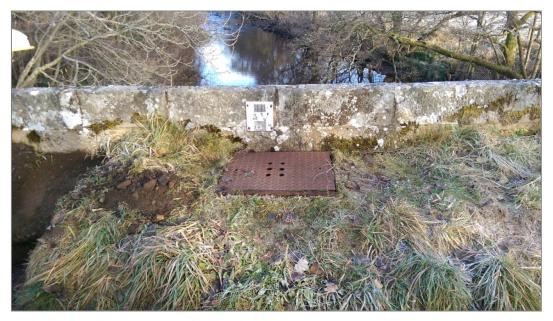
Photograph 11 – Abandoned water main cover to the Upstream verge (05/12/2016).
