THE STAR INN, HARBOTTLE

CONTAMINATION ASSESSMENT

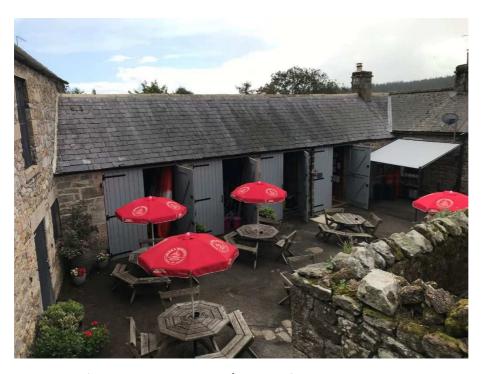
P1 – View of hard paved courtyard / garages from upper rear garden

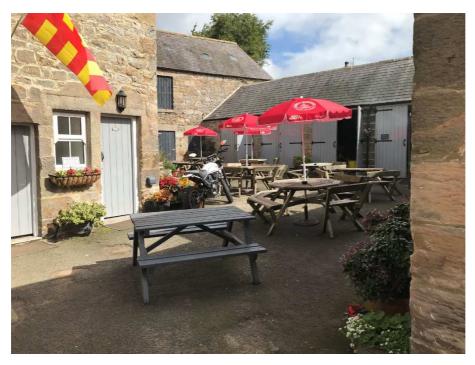
P2 – View of hard paved courtyard from road entrance

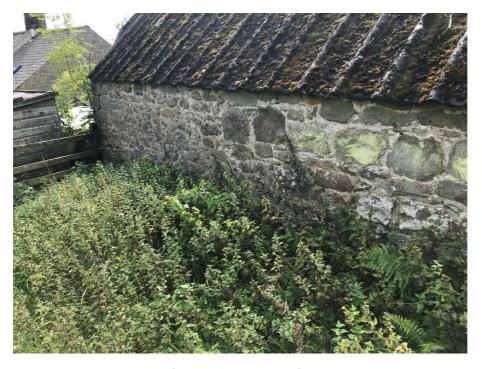
P3 – Asbestos cement roof sheets to north roof slope

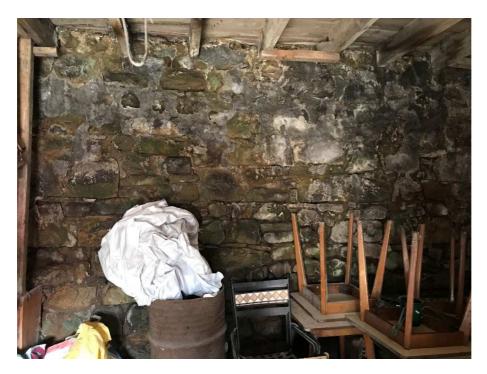
P4 – View of interior of former stables

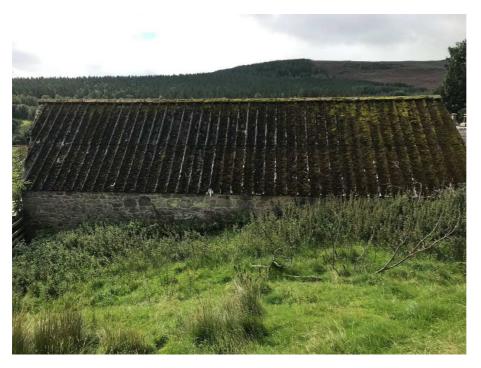
P5 – Rear agricultural field to north of site

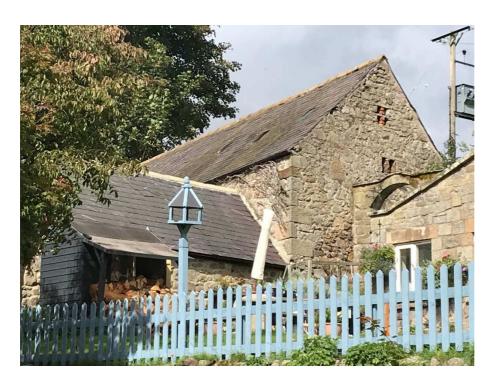
P6 – Residential use to east of site
