01 October 2020

REPORT ON STRUCTURAL INSPECTION OF STORES & GARAGES AT THE STAR INN

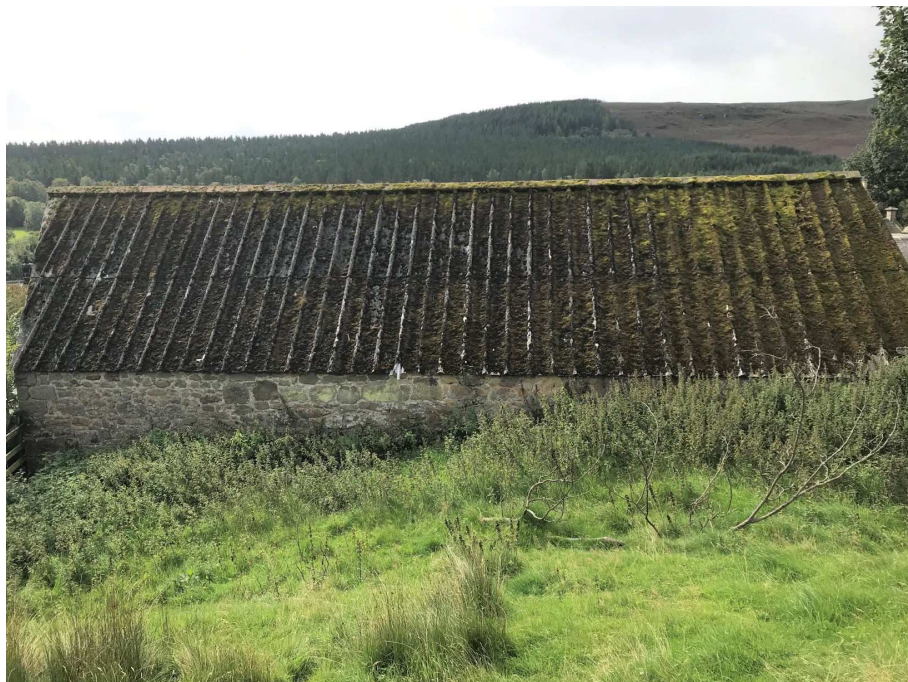
3.2.4 The north roof slope of the two-storey building is covered with asbestos roof sheeting. This material should be removed under controlled conditions in accordance with HSE guidance documents and disposed of to a licensed waste facility.

P2 – Rear of two-storey building / asbestos roof sheets

5.11 The asbestos roof sheet material should be removed under controlled conditions in accordance with HSE guidance documents and disposed of to a licensed waste facility.

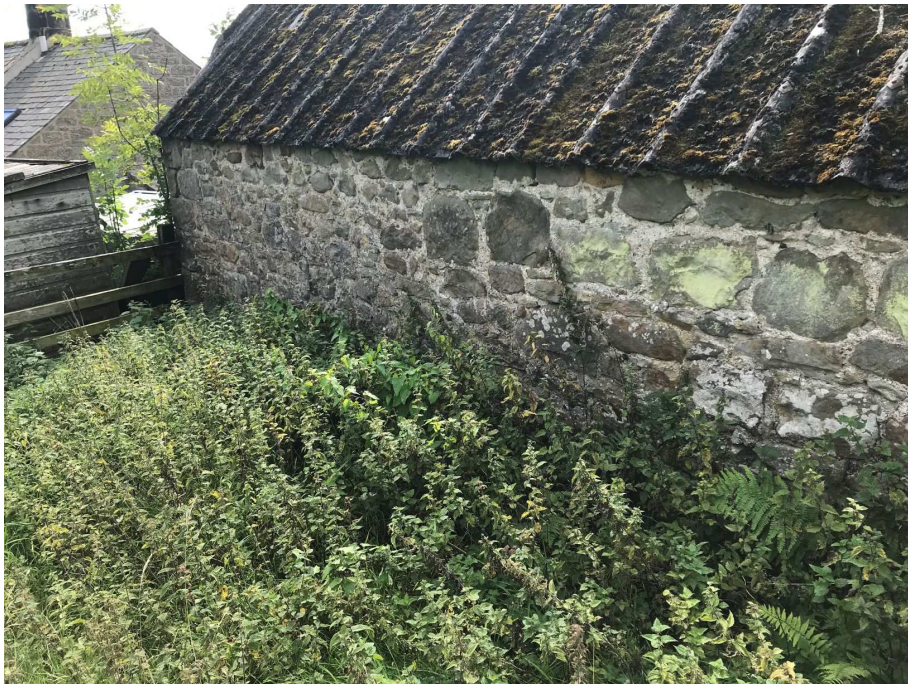
3.1.9 The north wall of the two-storey store building retains the ground behind to an approximate height of 4.00m above courtyard level. The wall appears structurally sound and in fair / good condition for its age, element of support and exposure to ground water. The internal face of the wall appears damp and is sporadically covered with algae however no running water was identified. The wall will require the application of an internally applied cavity drainage membrane linked to the waterproof membrane in the new ground floor slabs.

P3 – High ground level at rear of two-storey building

5.8 The north (retaining) wall will require the application of an internally applied cavity drainage membrane linked to the waterproof membrane in the new ground floor slabs.

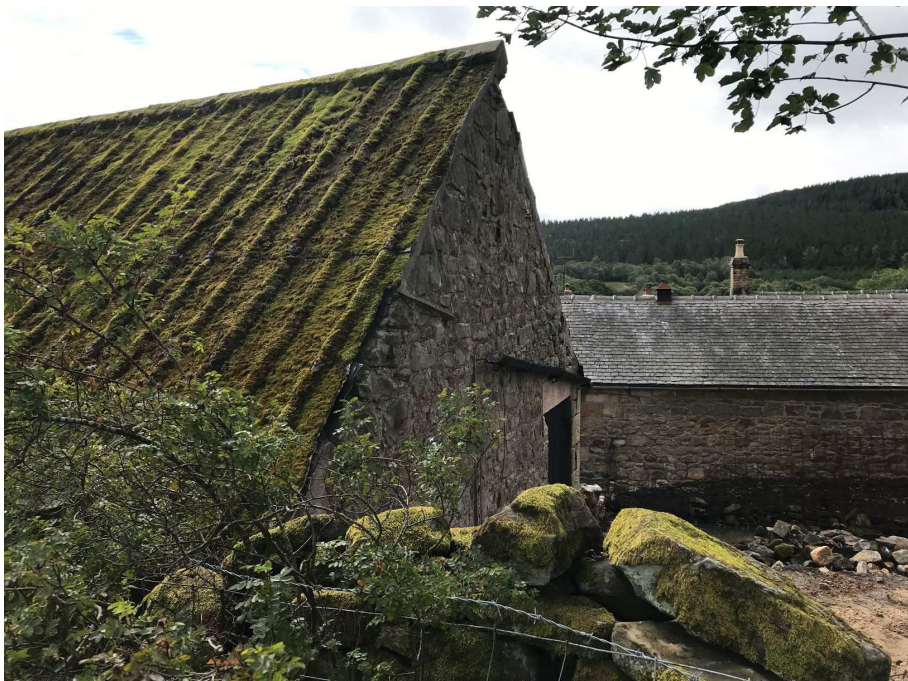
3.1.5 Some small areas of stonework to the external leafs are loose, particularly at gable peaks / verges and the mortar joints are open. Loose sections of stonework can be rebuilt and verges stabilised / pointed during the proposed conversion works.

P4 – West gable wall / loose verge stones

5.4 Small areas of loose stonework particularly at gable peaks / verges can be rebuilt and verges stabilised / pointed during the proposed conversion works.

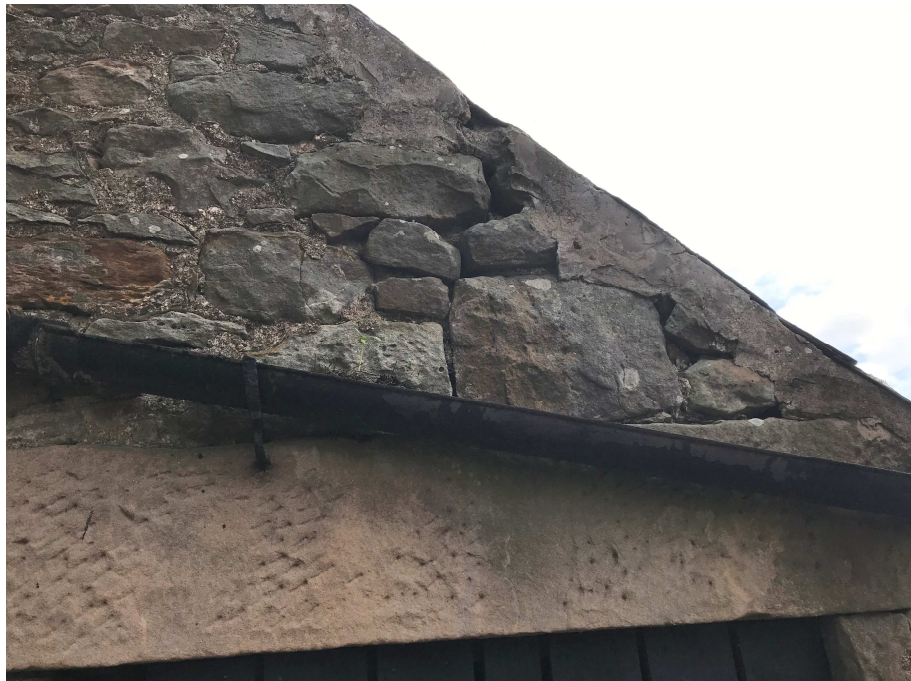
P6 – Loose stonework over west gable door opening

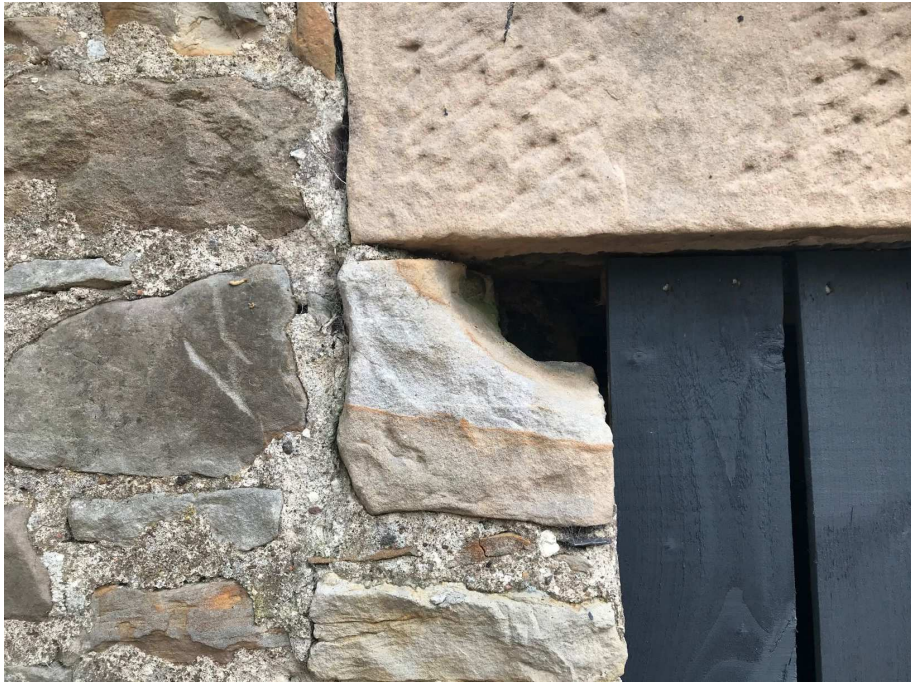
3.1.6 Generally, the external sandstone is in good condition. It is greyish in colour in places which is an indication that it is more hard-wearing than lighter coloured sandstones. A few isolated stones have eroded due to weathering over the years which can be carefully cut out and replaced or indented during the conversion works.

P7 – Eroded stone to west gable door jamb

5.5 Isolated eroded stones can be carefully cut out and replaced or indented during the conversion works.

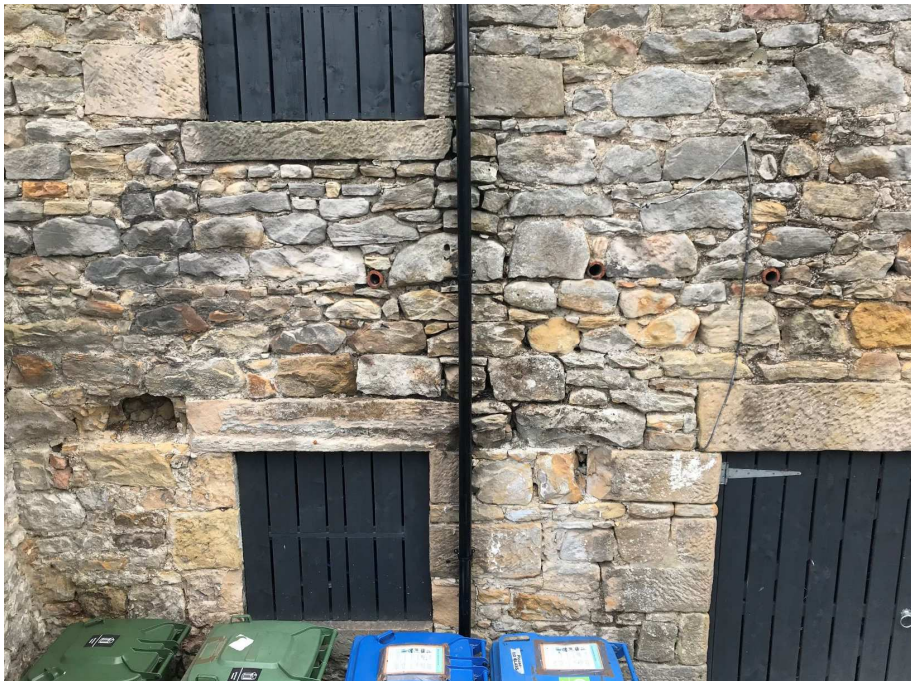
3.1.7 Externally the lime mortar pointing is generally in fair condition but has weathered back in places behind the faces of the stones. Re-pointing in natural hydraulic lime is advised which will provide protection to penetrating water and allow the fabric of the building to 'breathe' as originally intended.

P8 – Open mortar joints to external walls

5.6 Re-pointing of external walls in natural hydraulic lime is advised which will provide protection to penetrating water and allow the fabric of the building to 'breathe' as originally intended.

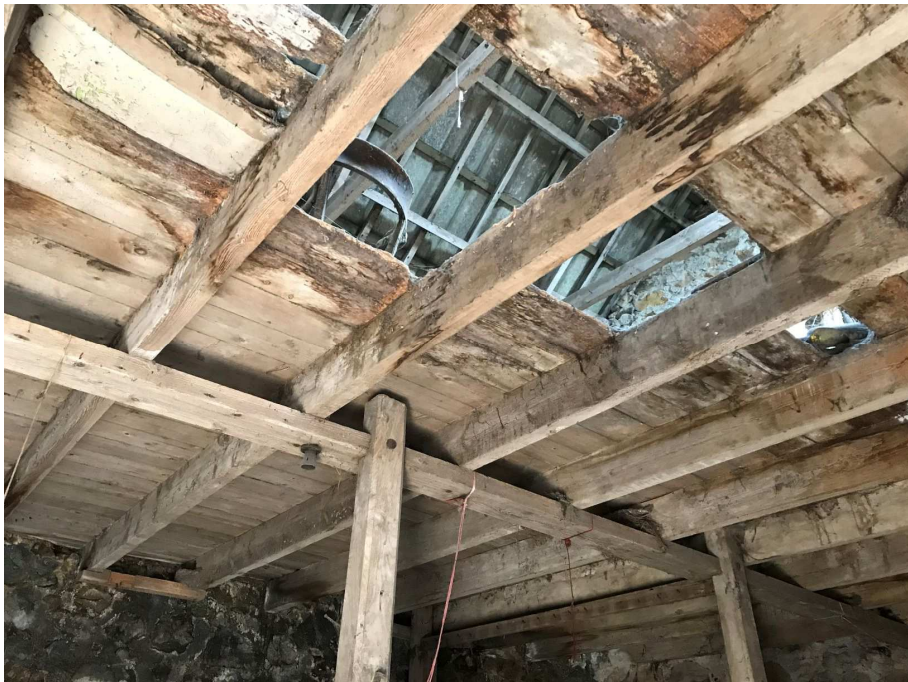
3.3.2 The first-floor structure in the two-storey building consists of timber T&G boarding on timber joists. Further support is afforded by a central timber beam and posts. The joists span front to back and are built in to external walls. The floor boards are severely decayed in places where exposed to water ingress from previous roof leaks and complete renewal of the floor-boards is advised. The joist ends are damp (and probably decayed) where built in to the rear (north) wall and exposed to ground water. It is advised that the joist ends are cut off from the rear wall and the joists fixed to a new timber bearer or fixed to the wall with galvanised steel joist hangers. Some repairs and renewals of joists can be anticipated.

P10 – Section of decayed floor-boards to two-storey building

5.14 Complete renewal of the first floor-boards is advised. It is advised that the joist ends are cut off from the rear (north) wall and the joists fixed to a new timber bearer or fixed to the wall with galvanised steel joist hangers. Some repairs and renewals of joists can be anticipated.

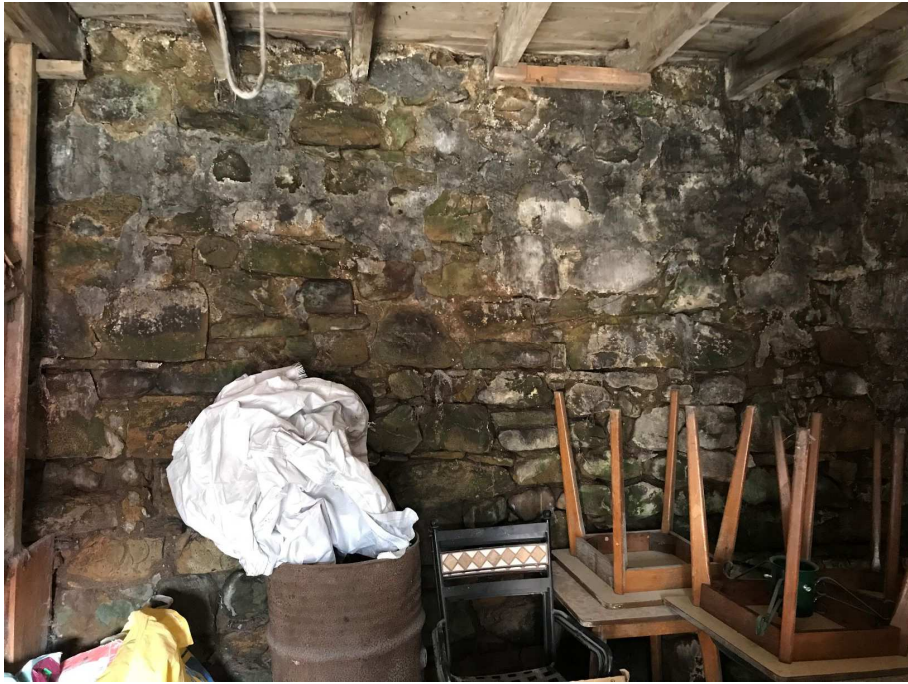
P11 – Algae growth / dampness to rear (north) retaining wall

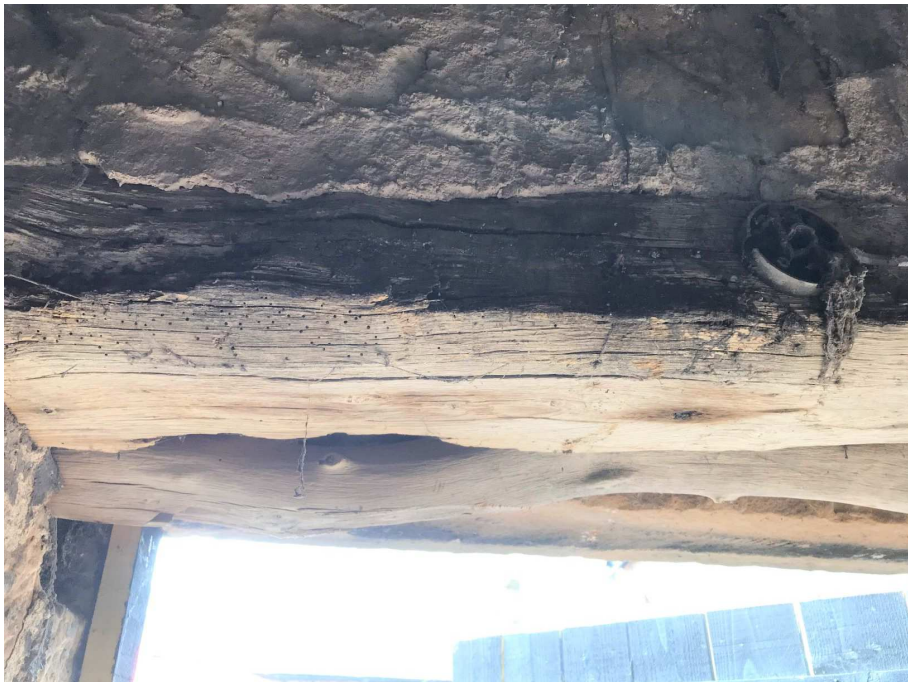
3.1.8 Support over window and personnel door openings consists of natural sandstone lintels to the outer leaf and timber lintels behind supporting the inner stone leaf and rubble fill. The sandstone lintels are generally in good condition and no cracks or similar defects were noted. Minor woodworm was noted in some timber lintels, which may be historic however precautionary treatment with pesticide is advised.

P12 – Minor woodworm flight holes to timber door lintels

5.7 Precautionary treatment of timber lintels with pesticide is advised.
