Bat Risk Assessment Report

Vindolanda Museum, Northumberland

Vindolanda Charitable Trust

BAT RISK ASSESSMENT SURVEY

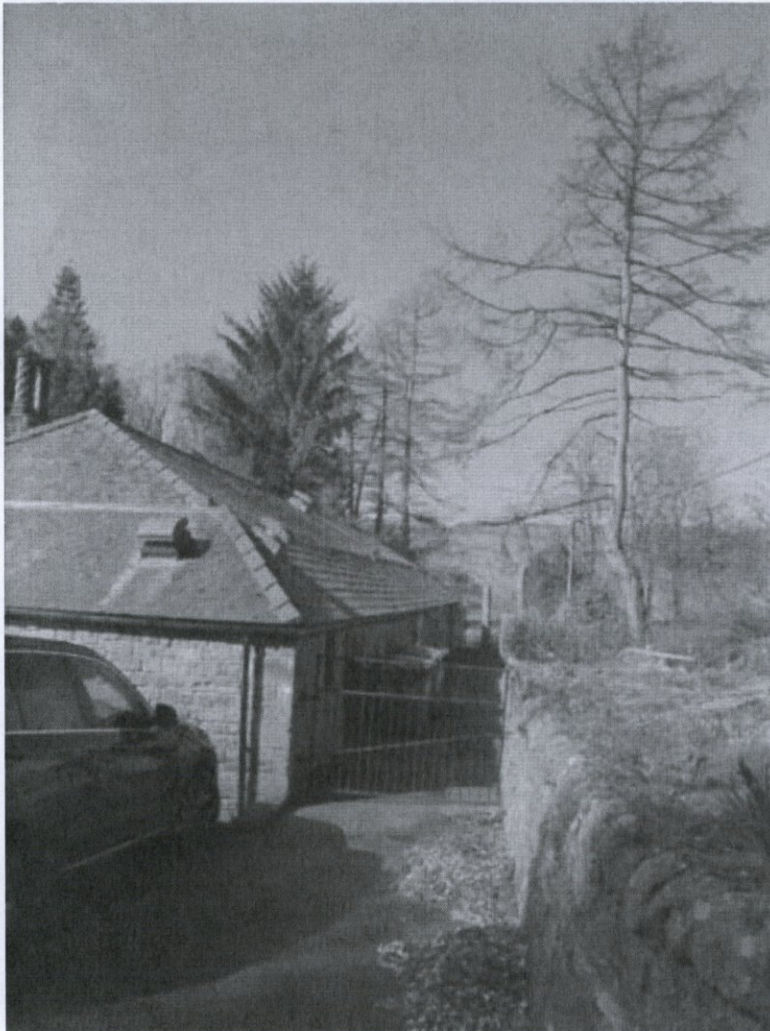
4.3.1 Full details of the findings of the building assessment can be found in Table 2 overleaf with photographs in Appendix B and building plan shown in Figure 3, Appendix A. In summary, evidence of bats were found in building A1 where bat droppings were recorded on the northern elevation and bat species found on the wall top. The bat was located where the proposed extension will be carried out between the two windows (Photograph 4, Appendix B). Several access points

were noted during the survey, large gaps under the fascia boards, gaps in the mortar and under the ridge tiles and flashing on the northern elevation where the proposed extension will take place. Building reference A2 was noted to have large gaps in the mortar on the northern elevation where buildings A1 and A2 adjoin (Photograph 7, Appendix B). Further gaps were noted on the eastern elevation of building reference A3; gaps were present in the mortar and under tiles on the roof edge. Two species of bird's nests are present to the entrance of the museum, several house martins *Delichon urbicum* and a blackbird *Turdus merula* nest were noted during the risk assessment survey.

Photograph 3 Northern elevation of Building A1, where proposed extension will be carried out.

- 6.1.4 Any works to the Vindolanda Museum (Building reference A1) should not be undertaken without nocturnal surveys being carried out.

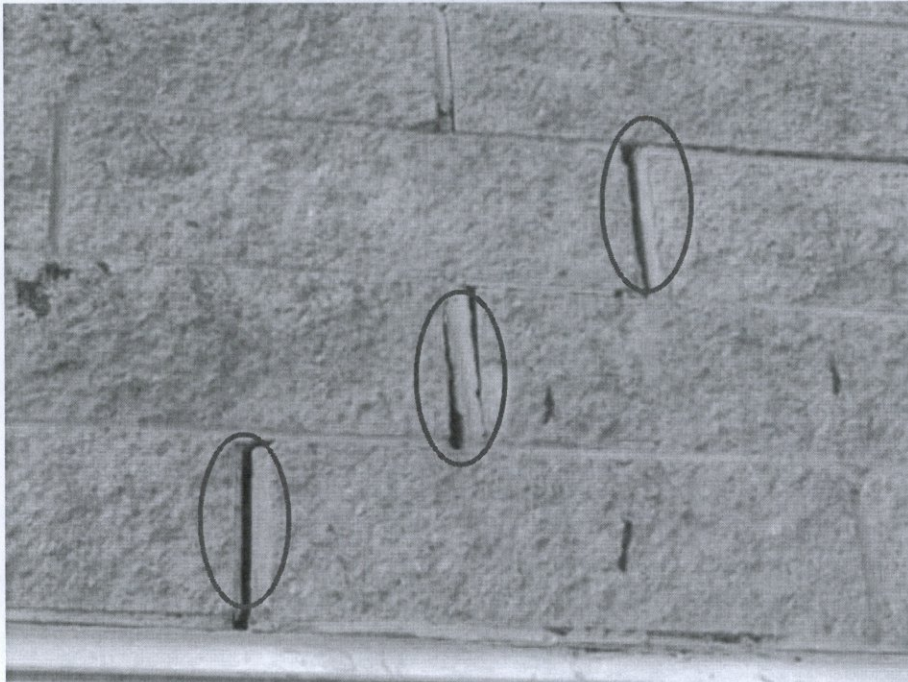
- 6.1.3 There are several access points in all buildings surveyed. Particularly in building reference A1, where there were bat droppings recorded under the ridge tiles on the northern elevation (Photograph 5, Appendix B). Potential access points are gaps in the mortar on the western elevation of building reference A2 (Photograph 6, Appendix B). Gaps were noted on the northern elevation where buildings A1 and A2 adjoin (Photograph 7, Appendix B). Further potential access points were noted on the roof edge under the eastern elevation of building reference A3. The surrounding habitat offers good forging potential in close proximity, consisting of several water bodies including a lake and the River South Tyne, nature reserve and woodland located within a 2km radius of the site.

Photograph 6 Example of potential bat roosting opportunities, located on the western elevation of building reference A2.

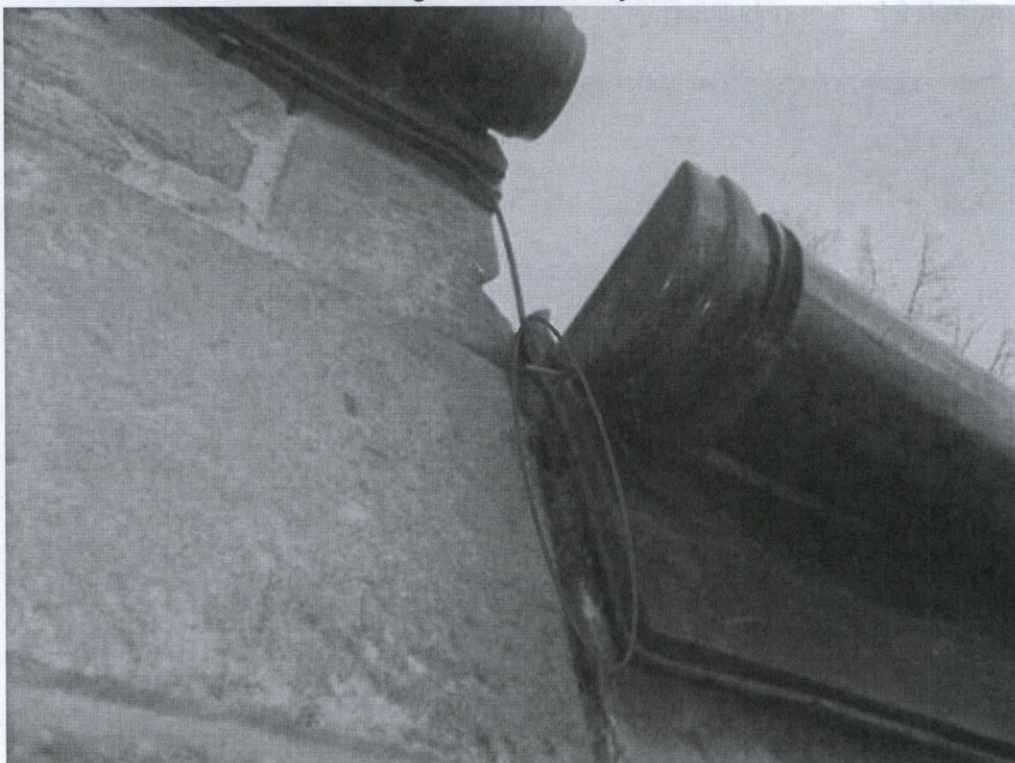
Photograph 7 Further potential bat roosting opportunities, gaps located on the northern elevation where buildings A1 and A2 adjoin.
