DESIGN, ACCESS & HERITAGE STATEMENT

The repair of the existing farm buildings at Langleeford Farm.

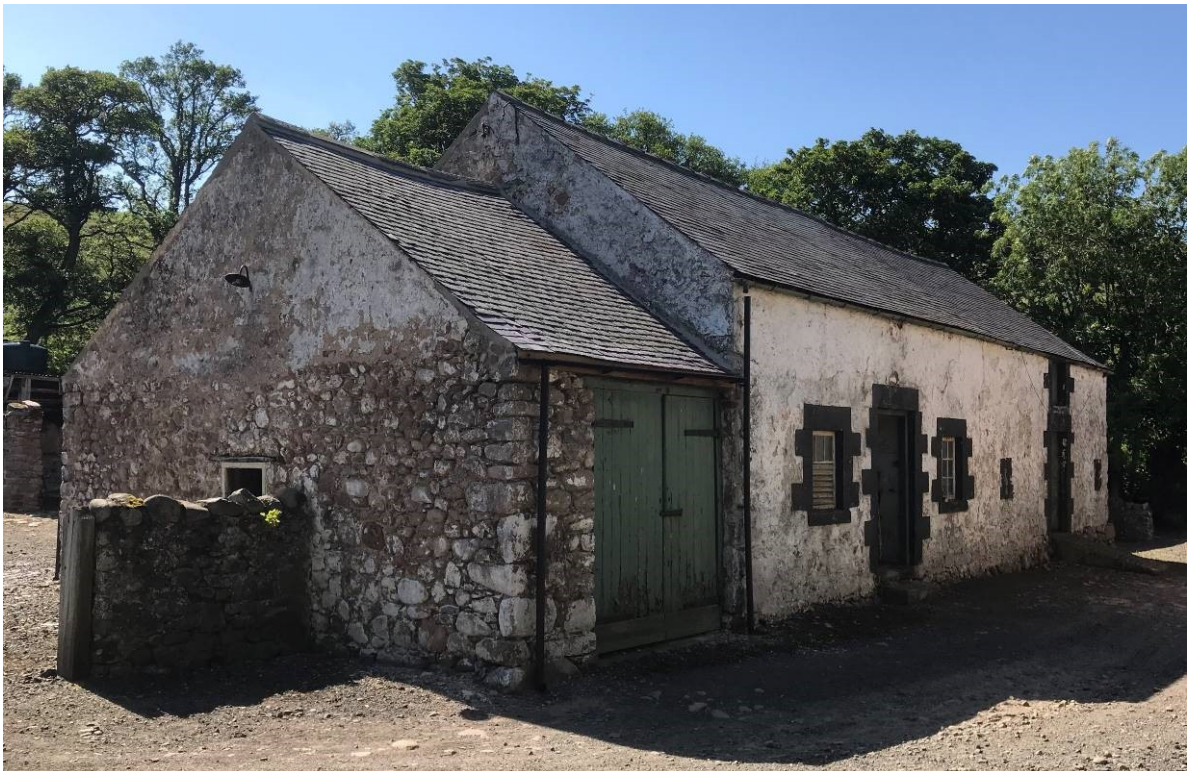
Overleaf Plate 01 Top - view of the main range looking north along the eastern elevation. Bottom left View of the western elevation of the main range and the southern elevation of the rear range. Bottom right - A view of the Pigsty

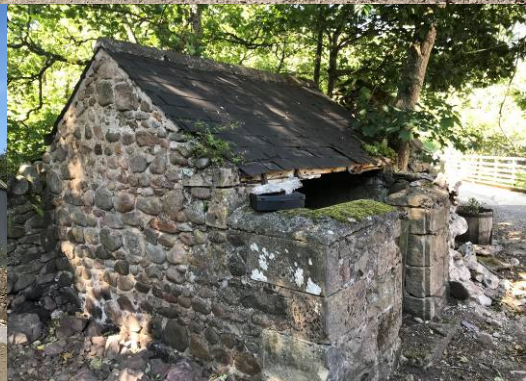
The pigsty roof is suffering from a rotten lintel over the opening at the south. This timber is beyond repairs so it will be replaced in its entirety. This will require the reslating of the roof to undertake these repairs, however a number of the slates have slipped and require re-fixing. The existing slates can be reused.
