Flood Risk Report

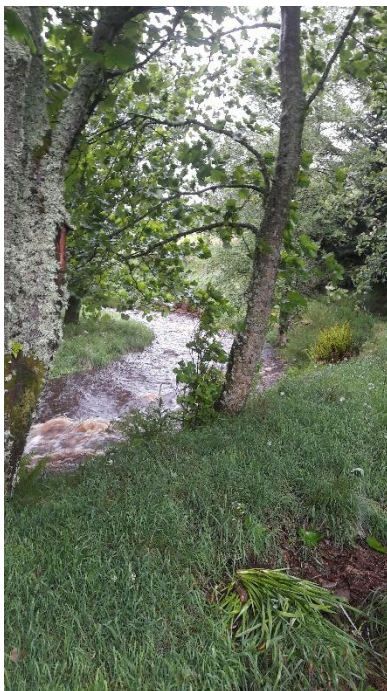
The bank and bend that is up stream running behind the barn, where there was apparently water ingress in 80's, has now been built up several feet where the water barrels round. The increased height bank has been secured with tree growth and established vegetation and has been constructed from large rocks place there by heavy machinery

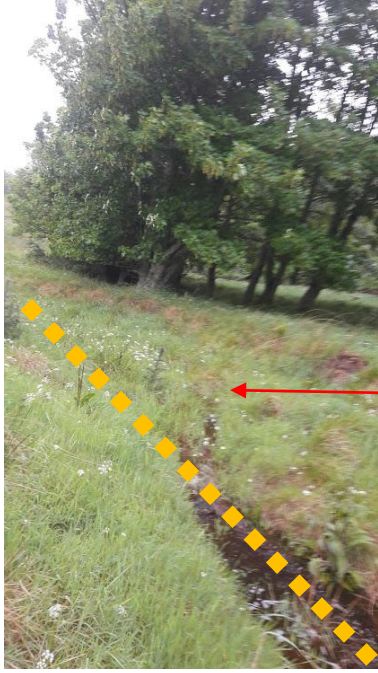
As well as the raising of the bank. We have also constructed a relief ditch that ensures flood water has a straight path through the property when it is in flood. This picture shows these ditches diverting the flow

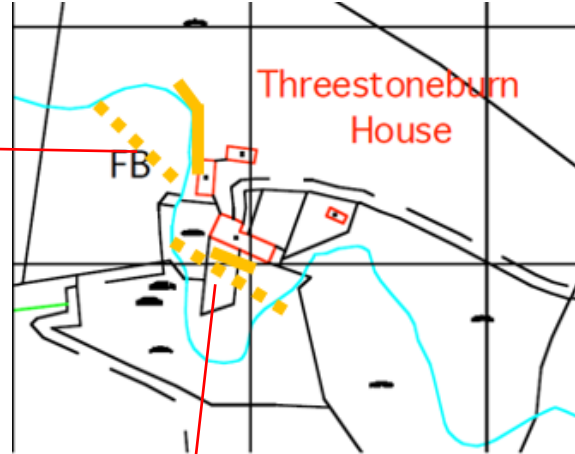
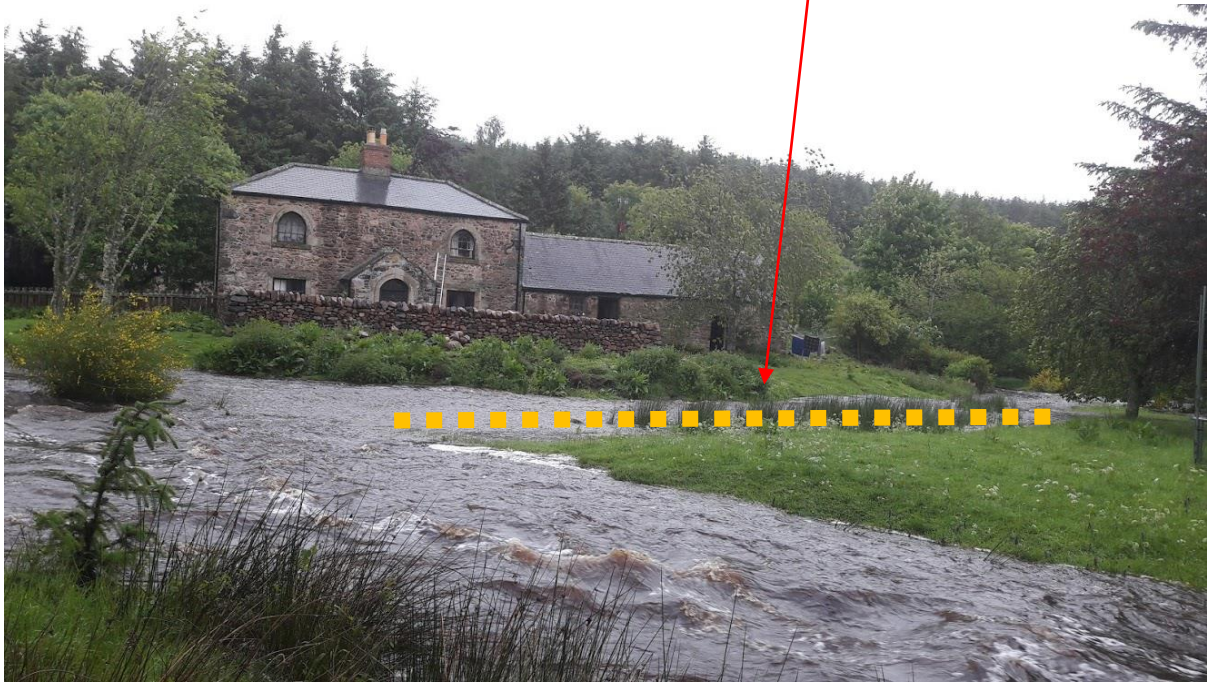
New ditches represented by dotted line act as overflow to “straighten out” the path of the flood water so it avoids the S-bends

Even in the above extreme conditions there is still no less than 3ft of additional height “capacity” before it reaches the house, including the remaining height on the ditch and the fall off from the house.
