Ecological Impact Assessment and Bat Risk Assessment

WEST HIGH RIDGE, BELLINGHAM, NORTHUMBERLAND

January 2023

Ruth Hadden, BSc. MCIEEM
Ryal Soil and Ecology
Ryal
Northumberland

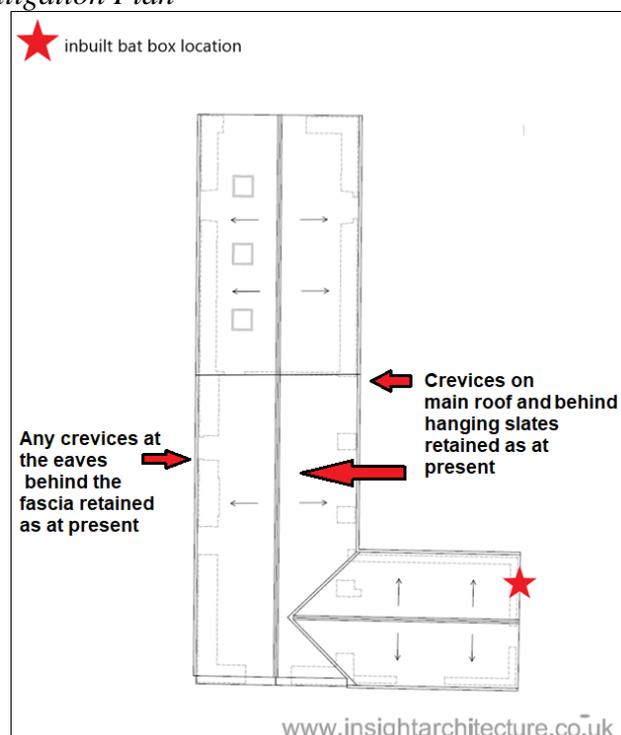
Figure 1. Ecological Mitigation Plan

- No bat roosts will be affected by the planned works. Mitigation will be put in place, to provide an additional bat crevice and the retention of the existing crevices in the main section of the studio not affected by the proposals.

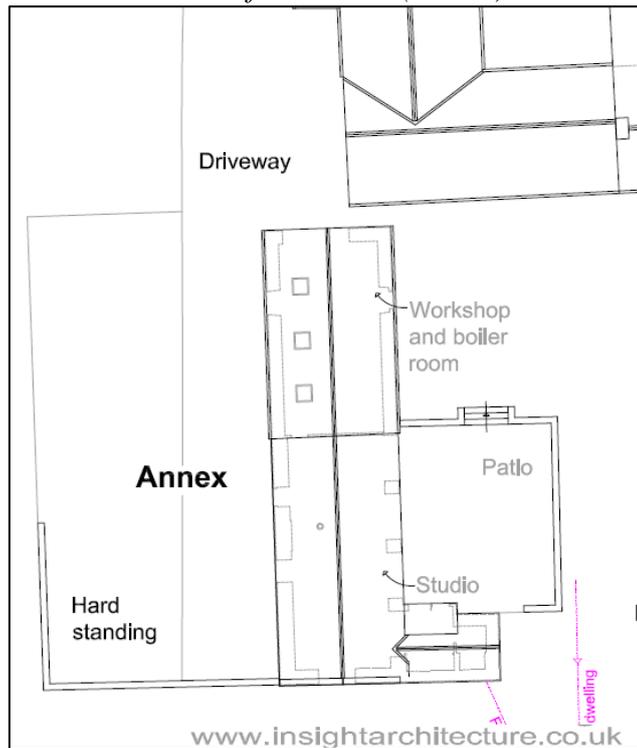
Figure 2. Survey area -Southern section of the Annex (Studio)

The survey area covered the house only within the red line boundary as shown within Figure 2 and included searching for signs of any wildlife using the site with the key aspects listed below.

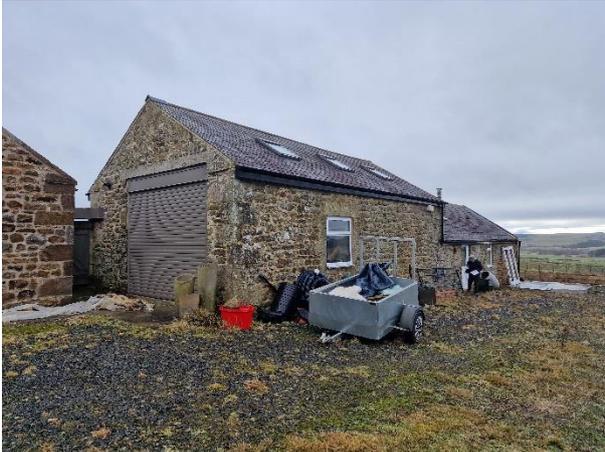
The building is a stone-built annex studio with a pitched slate roof with a higher roofed garage on the north aspect and a single storey extension on the east side at the southern end. Externally the walls are well pointed with only the occasional unsuitable crevice. The fascia's are a black pvc with crevices behind leading to the wall top. The main section of the annex had a few slipped and raised slates however the slates have been spray foamed

Annex viewed from the southwest, note roof vents.

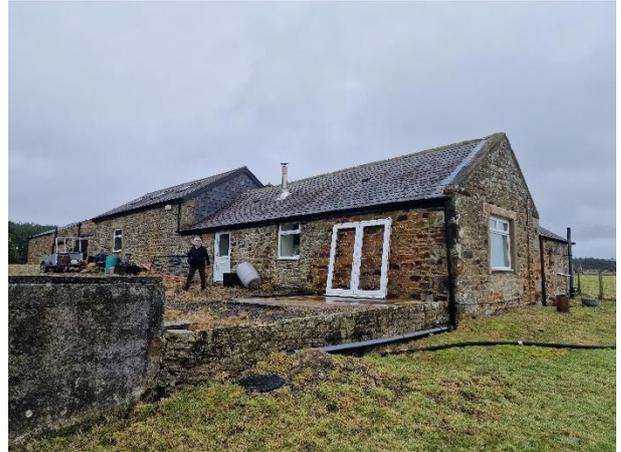
Annex garage viewed from the northwest.
(Ecologist for scale).

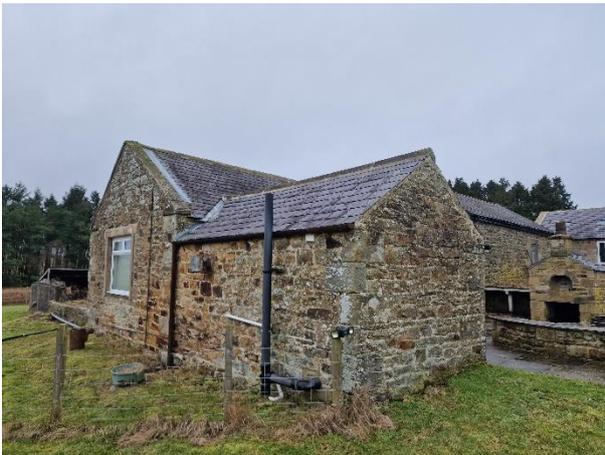
Annex extension viewed from the northeast.

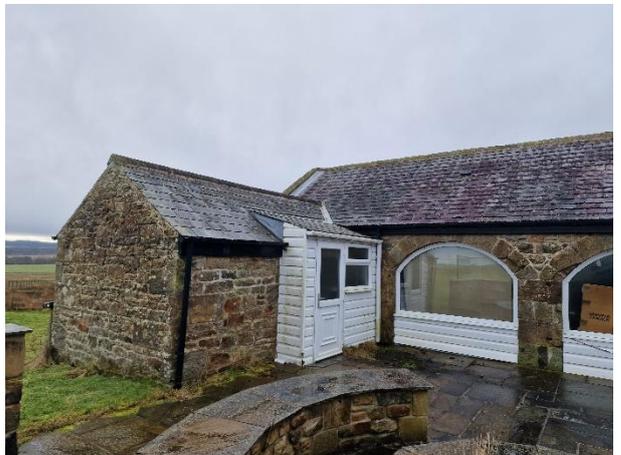
The small extension had a sound ridge, no suitable crevices were noted in this affected section (shallow crevices present below the wall plate) and on the north aspect a small shallower pitched slate roof was present. A bitumen felt sarking was present in the southern extension, the loft space was less than 60cm high and no traces of bats were identified. Due to the negligible roost potential in the area of works, no further surveys were recommended.

Annex gable and small extension viewed from the southeast.

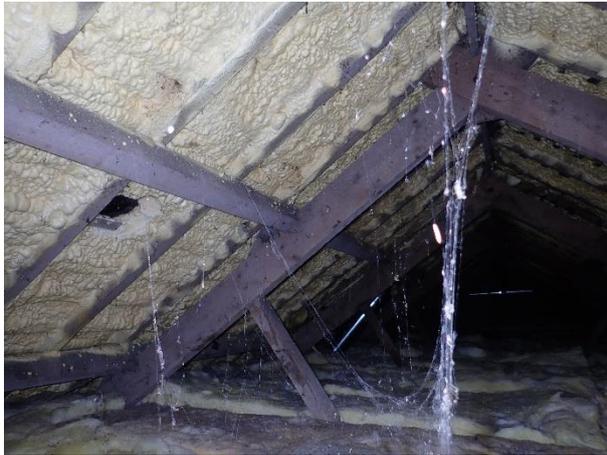
Closeup of roof section affected

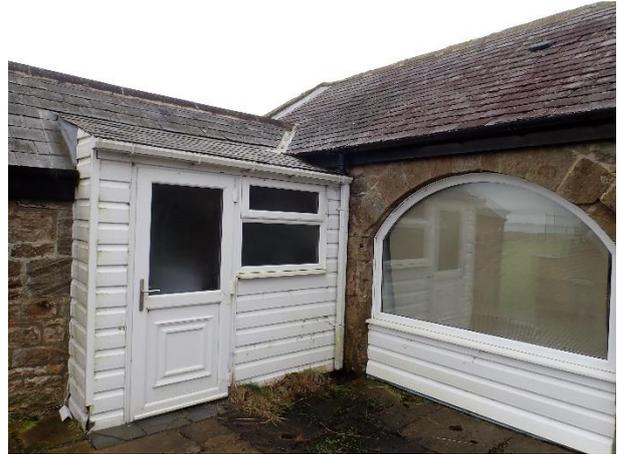
beneath the slates. The loft was insulated with fiberglass and the void was very cobwebbed. No traces of bats were located in the loft space. Mice droppings were present.

Loft of main Annex

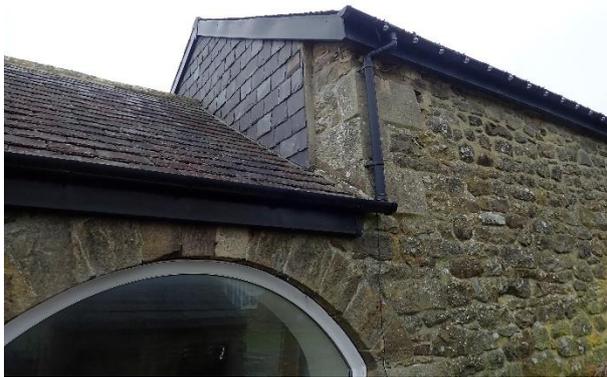
South gable of Annex, door will be created in location of the window

The proposals are to convert the annex studio and demolish the existing extension and replace it with a larger extension. A door will be created in the southern gable wall.

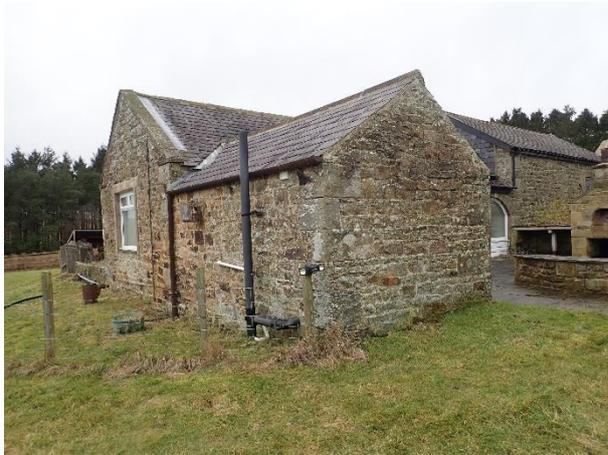
East gable of small extension, well sealed with a sound mortar fillet.

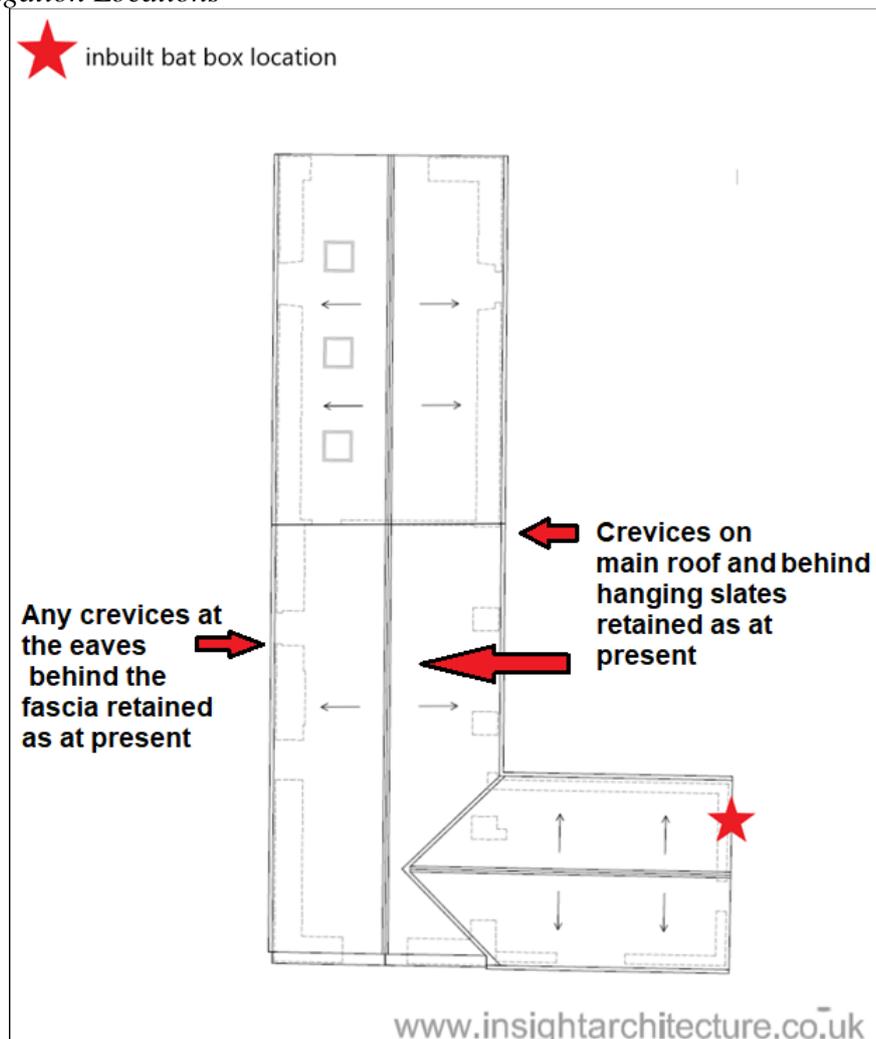
Figure 7. Mitigation Locations

One integrated Build-in WoodStone Bat Box, to be located on the east aspect of the new extension, 500mm below the apex. The access hole through the timber to be sanded and smooth. Please see plan below for locations.

Location	Mitigation Type
north side of east facing extension gable.	Inbuilt bat box at eaves height.
Roof of annex studio and hanging slates	Any existing crevices to be retained as at present.

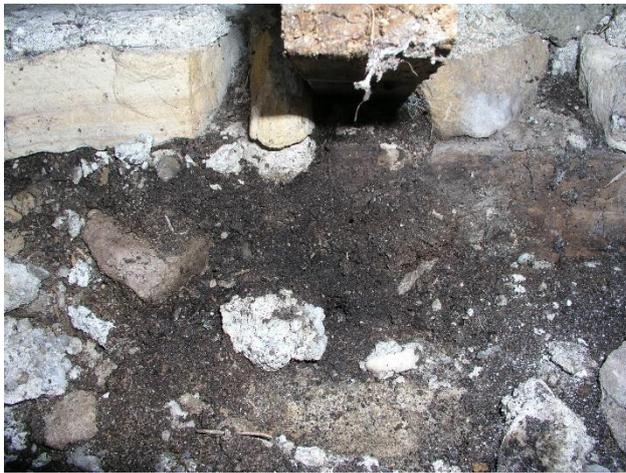
Other traces that can indicate a past presence of bats are their droppings. These resemble mouse droppings but unlike mouse droppings can be crumbled to dust between finger and thumb. Droppings may be found on wall tops and beneath slates and tiles on top of any sarking.

Photo showing disintegrated bat droppings beneath coping stones. If examined carefully, in the black dust exoskeletons of insects can be seen shining.
