BAT RISK ASSESSMENT

Old Shepherd's Cottage, Ingram
Extension

July 2014

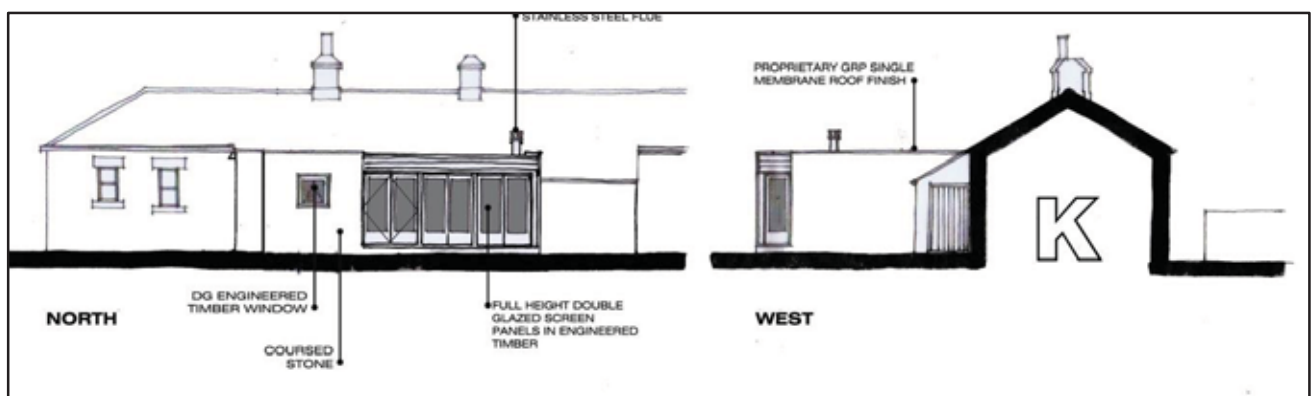
Figure 2. Proposed Elevation (not to scale, from Architect's Plans)

A small wooden extension (currently housing the kitchen) will be demolished and replaced by a larger stone, glazed and timber extension.

Approximately 6 rows of slates from the bottom of the existing roof will be removed to allow room for the extension.

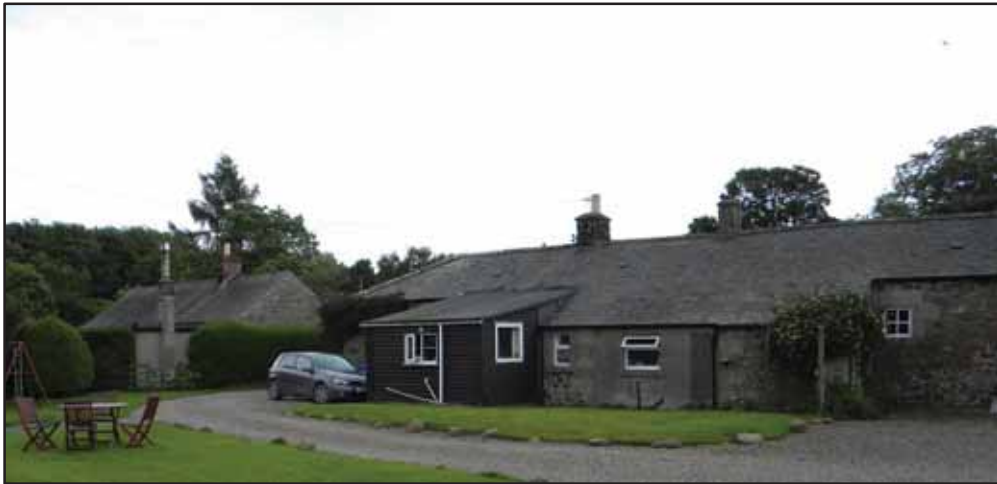
Figure 4. View from rear showing existing extension.

The extension is a wooden cladded structure with a sloping bitumen roof. The cladding is tightly sealed as is the bitumen sheeting. Slates from the house roof are generally well sealed at the join to the bitumen roof with few gaps, all of which are very shallow. The access for bats to this area is limited due to the drop height required to exit/enter a roost in flight. No signs of bats were found.

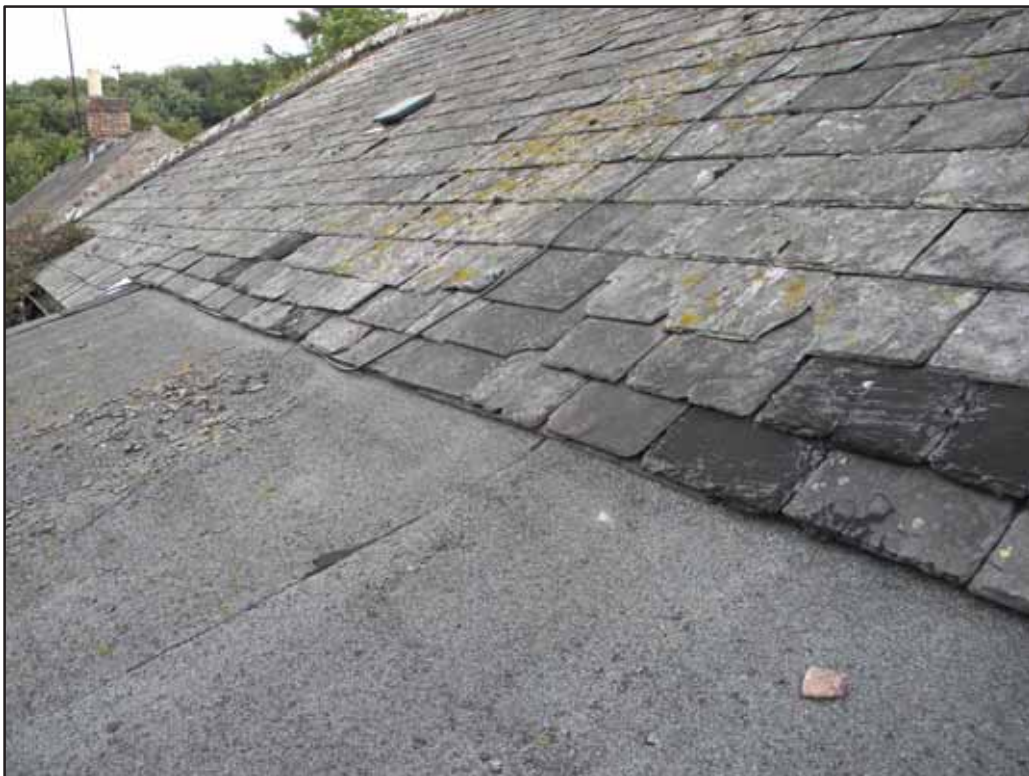
Figure 5. Detail of the join to the main house.

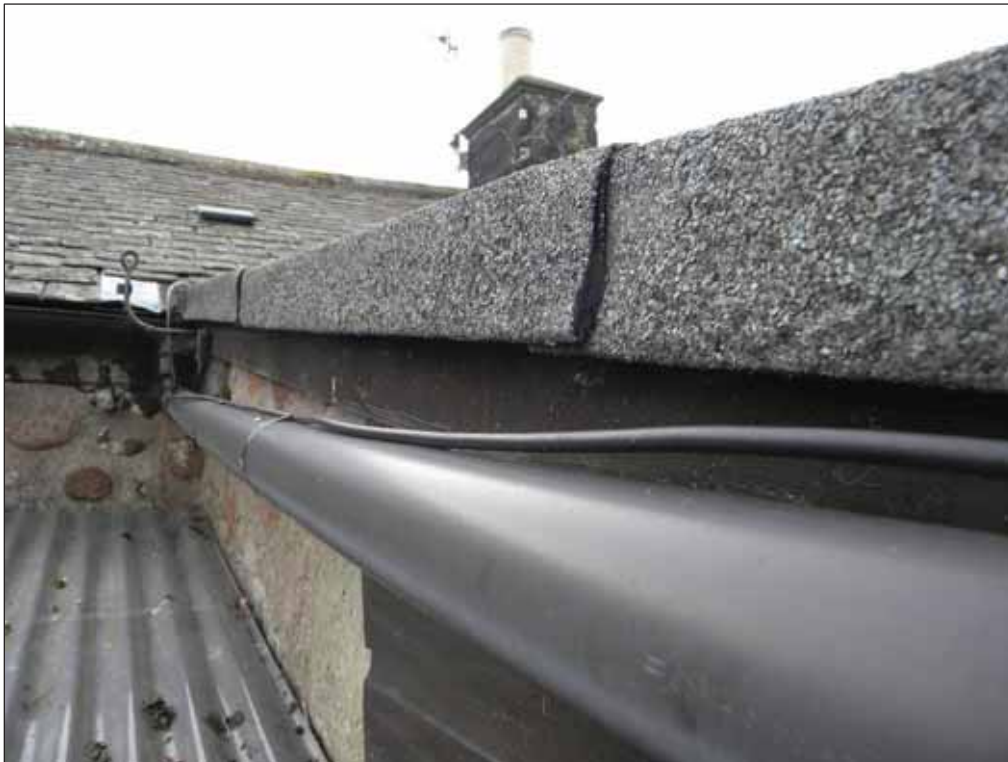
Figure 6. Detail of join to the main house, above door.

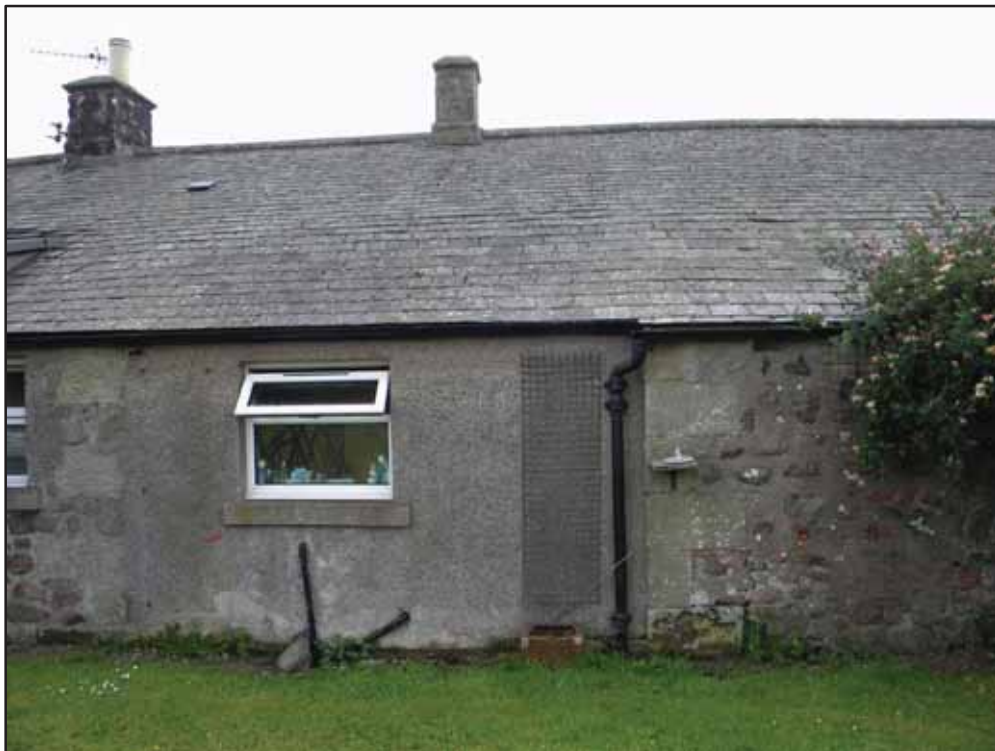
The wall tops to the rear are >2m high and shallow. No signs of bats were found and this is an unlikely bat roost due to the height required for easy access/entry to roosts in flight.

Figure 7. Rear wall (to be extended)

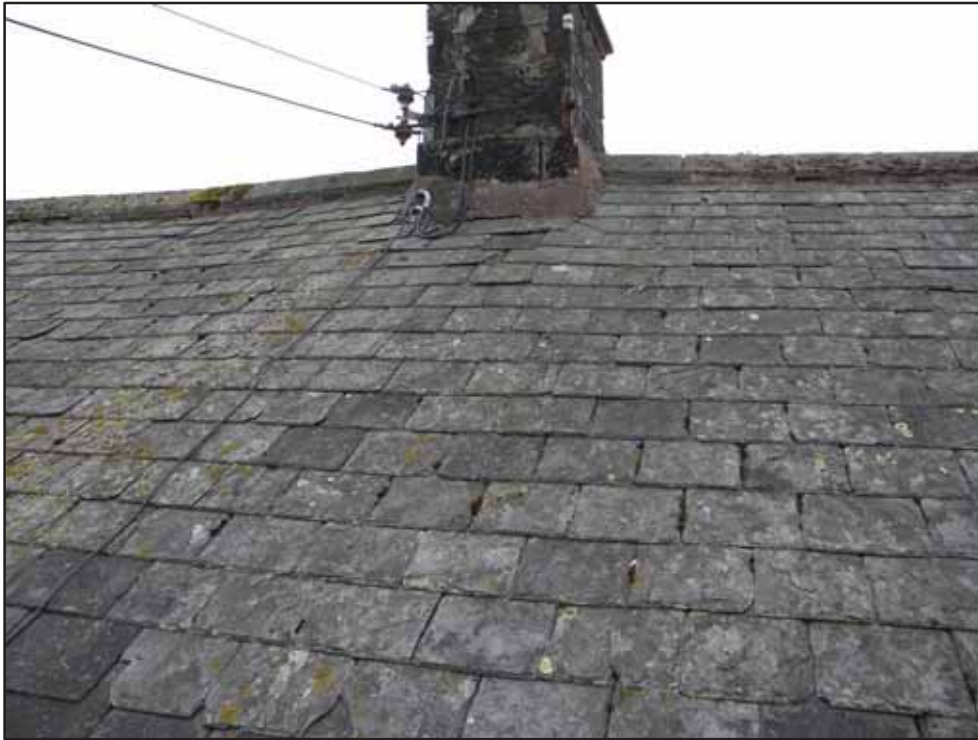
Figure 8. Roof to the rear.

At the rear roof above the site of the extension gaps in the ridge tiles are present, although no signs of bats were seen. Providing that certain precautionary working methods are followed should a roost be present here it will not be impacted by any of the proposed works. The front of the house has solar panels which limits roosting opportunities. This area will not be impacted by the works.

5. Any timber treatments will be approved for use where bats may be present.
6. Roofs and high risk structures (doorframes, window frames, beneath roof panels, in mortise joints, cavity walls, areas of loose stones, between lintels) should be carefully dismantled by hand with checks for bats as the work proceeds.

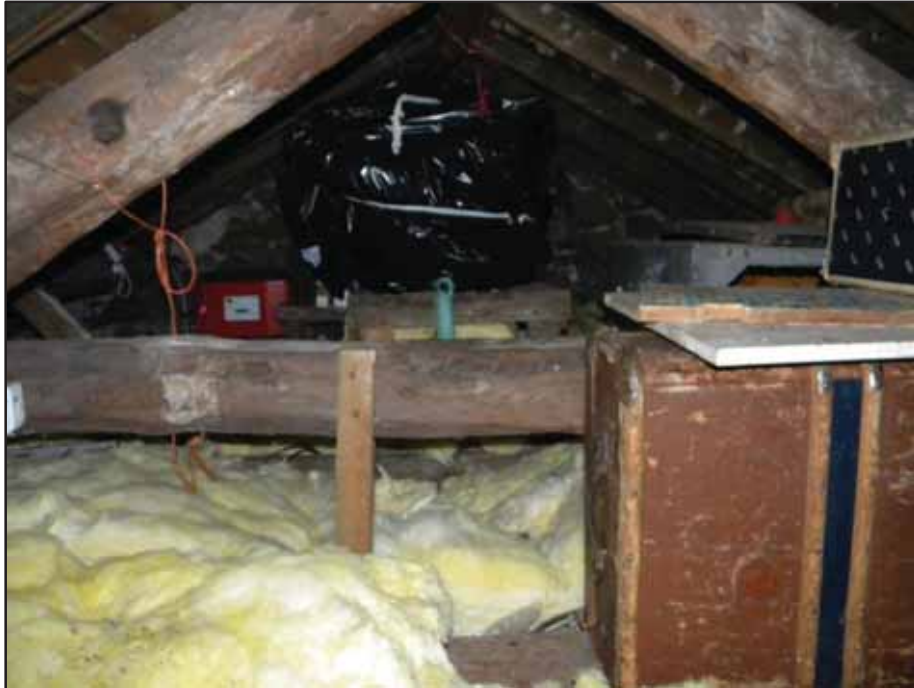
The loft space was fully accessible. No signs of bats were found. The loft was wooden cladded under the tiles and well insulated.

Figure 10. Interior of loft, main house.
