# BAT RISK ASSESMENT

## LOW LEAM FARM, WEST WOODBURN

**Report No 1  
Draft  
October 2014**

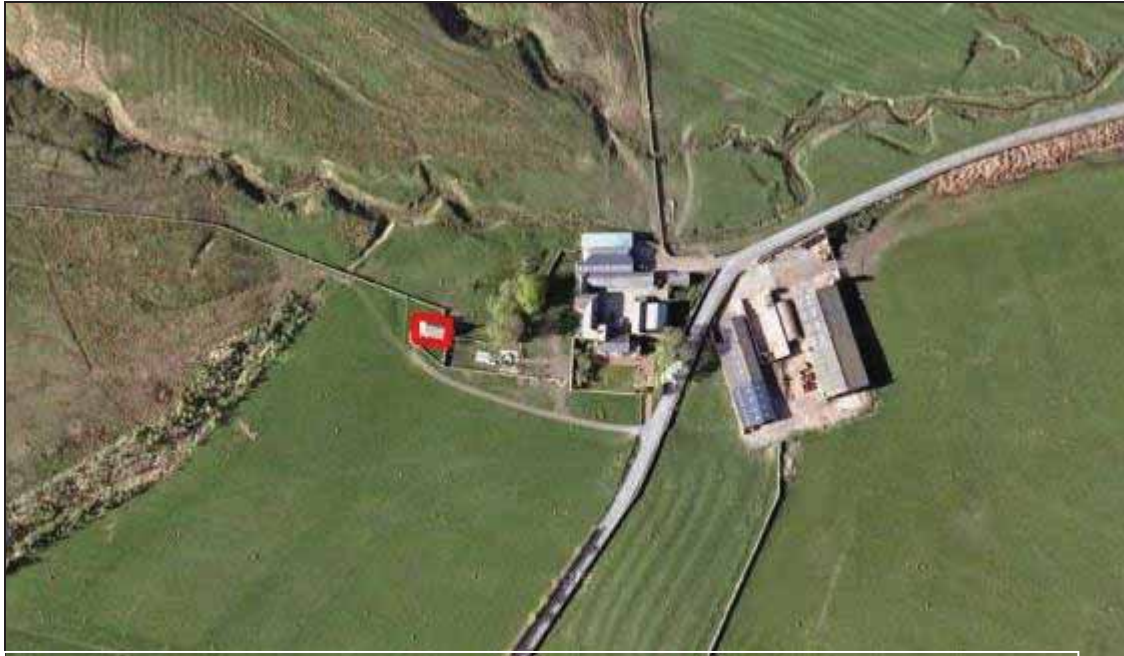
Figure 2 – Aerial photograph illustrating the extent of the site with a redline boundary (Reproduced under licence from Google Earth Pro.)

Figure 2 illustrates (in red) the site boundary whilst Figure 3 illustrates the broad habitats present on site and within an approximate 500m buffer zone.

The most recent aerial photograph of the site (Figure 2, C1, December 2009) indicates that habitats on site are dominated by grazed grassland.

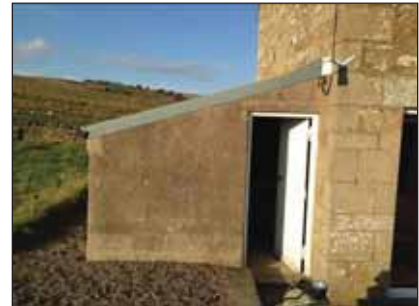
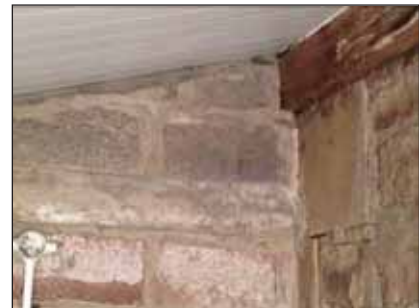
The structure comprises a small single storey extension, measuring approximately 5m x 2.5m, on the western elevation of a two-storey stone cottage. The structure supports a single pitch corrugated metal roof. The walls of the extension support plastic bargeboards and are concrete rendered offering no opportunities for roosting bats. The internal space is well sealed with no opportunities present for roosting bats. **No evidence of bats was recorded** from the structure.

The structure to be demolished is disused and well sealed and provides few opportunities for roosting bats.

Based on the findings of the survey, the structure to be demolished is considered to have a negligible potential for supporting roosting bats and the area of the cottage to be affected is considered to have a very low potential.

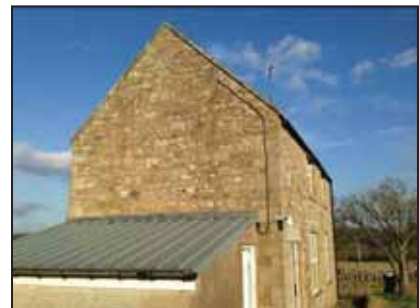
The extension is connected to a two storey stone building associated with the farm. The building supports a pitched slate roof and a chimney on the eastern elevation. The rendering of the building is in very good condition offering very few opportunities for roosting bats. The windows and doors are well sealed and appear recently fitted. A section of lead flashing is present where the extension meets the main building, though this is also in good condition. The structure supports stones associates with the water table. These are the only section of the main building to be affected by the development. Small gaps are present on the ridge line and in the south western corner of the structure.

The small numbers of cavities that are present on the main building will be unaffected by the proposals though provide opportunities for roosting bats. A small gap is present within the stones associated with the water table to be affected by the proposals. Though it is west facing and likely to be exposed to the elements. No evidence of bats was recorded within either structure.

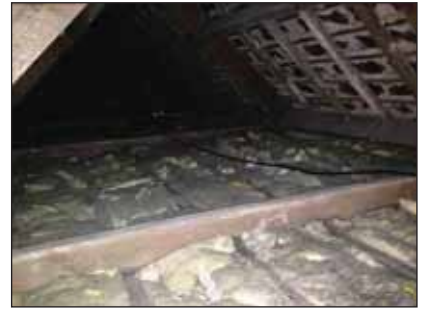
The cottage supports a traditional timber roof structure. The roof slates are unlined and the void is open and uncluttered. The space is dry, free from perceptible draughts and warm leading to good conditions for the persistence of droppings, though none were recorded. The central ridge beam was heavily cobwebbed. The stone gables provide only a few opportunities for roosting bats, though all crevices were heavily cobwebbed.

**No evidence of bats was recorded** from the structure.

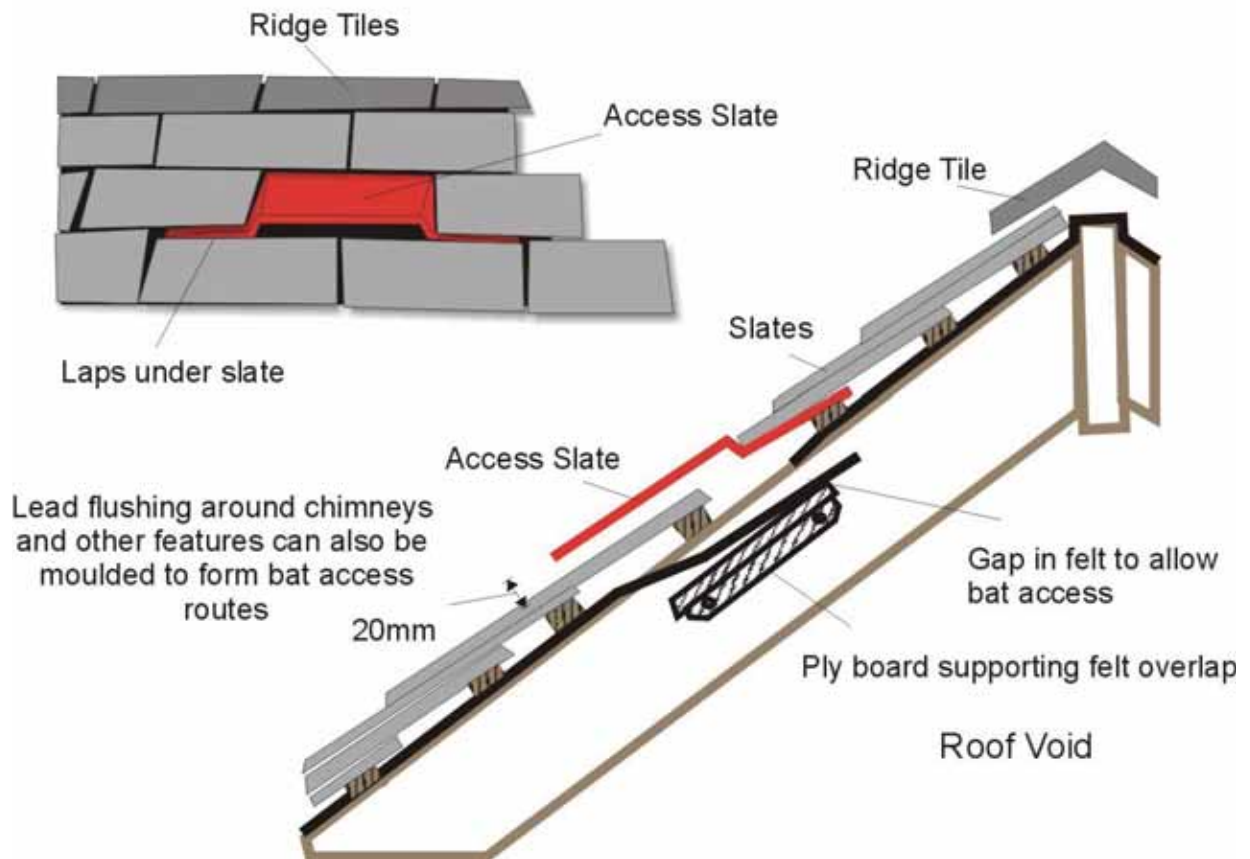
### 'Bat Slate'

## G.2 Appendix 2: BAT ACCESS SLATE

- Initial works to the water table will not be undertaken between mid November and mid March, should works start prior to this, the section will be made unsuitable for hibernation use.
- Works associated with the western water table will be undertaken to the attached method statement (Appendix G.2).
- If bats are found during works, works will stop in that area and the ecological consultant will be contacted immediately. If it is necessary to move the bats for their safety, this will be undertaken by a licensed bat handler.
- Three bat slates installed within the new extension.
- Three bat boxes to be sited on trees within the farmstead.
