PRE-DEVELOPMENT TREE CONSTRAINTS ASSESSMENT

WALLTOWN CRAGGS VISITORS CENTRE.

September 2014

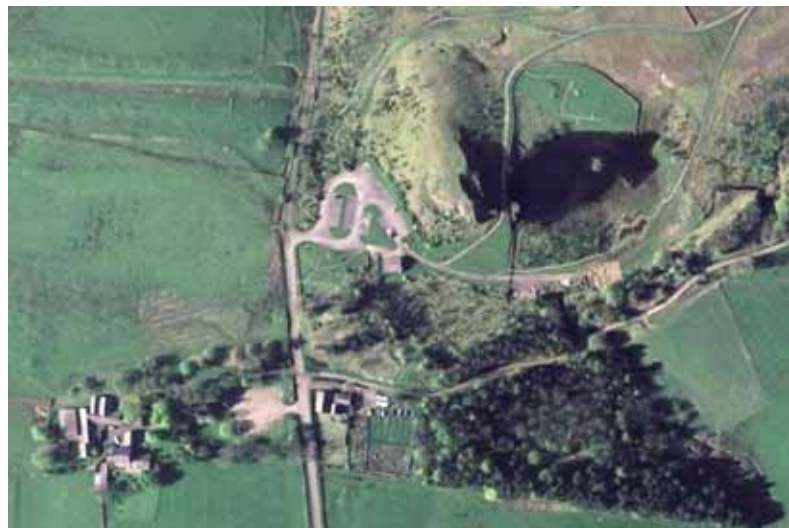
Figure 2 – Aerial photograph of the site location showing individual trees within the context of the land surrounding the site. Reproduced under licence from Google Earth Pro. (2014)

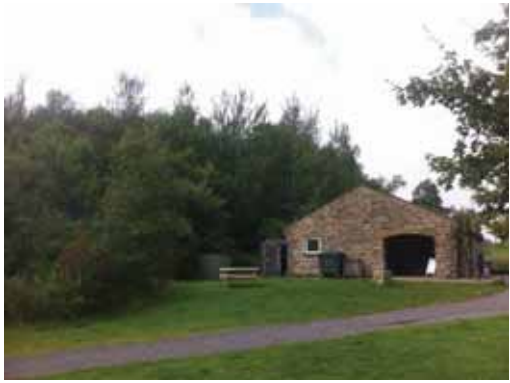
<p>Image illustrating the proximity of the planted trees to the rear of the existing building (east face).</p>

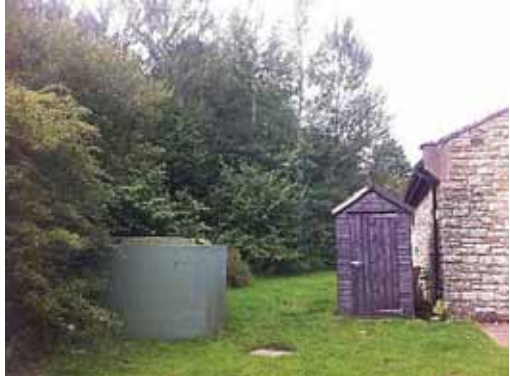
<p>The rear of the building will be extended and a two storey eco-cabin located to the left of the image to be used as office space.</p>

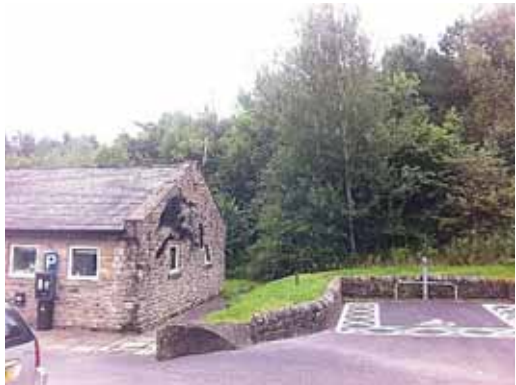
<p>West face of the building with the disabled parking area. The semi-mature grey poplars can be seen to the right of the image.</p>

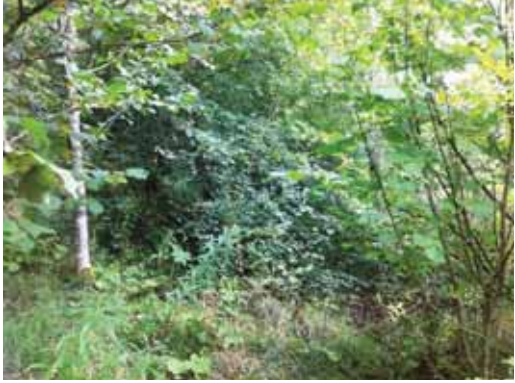
<p>Trees within group A are generally low growing scrubby species which have not been allowed to reach their full potential, due to the enclosed canopy and the planting spacings.</p>

- Spacings between the planted trees within the copse of woodland to the rear of the building are already tight. This area would benefit from a systematic thinning and coppicing regime to encourage natural regeneration and the development of the ground flora.

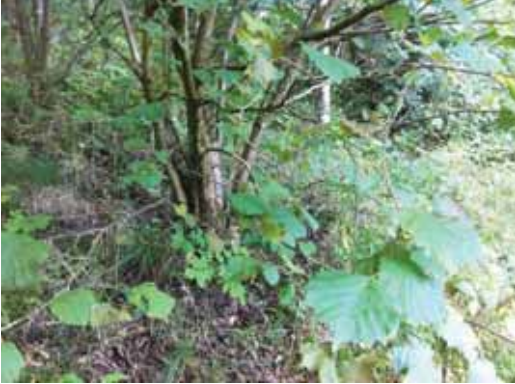
<p>A number of the trees, such as the hazel, have been coppiced in the past, but are beginning to outgrow their coppice stands.</p>

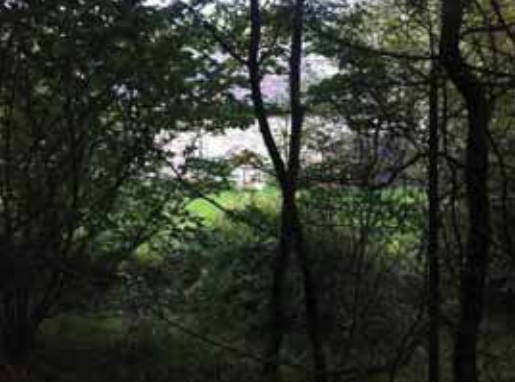
<p>Image looking down the slope from the south of the building, illustrating the scrubby growth of the low value young trees forming the copse.</p>

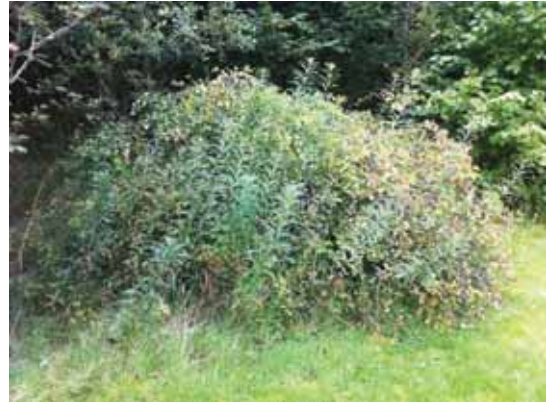
A weeping Midland Hawthorn; an unusual ornamental species to be found within this group.
