**WALLTOWN CRAG CENTRE, NEAR GREENHEAD,
PROPOSED DEVELOPMENT
BAT AND BARN OWL REPORT – SUMMER 2014**

SECTION 1 BACKGROUND AND SUPPORTING INFORMATION

- Walltown Crag Centre is situated close to Hadrian's Wall near Greenhead in Northumberland. The Centre is stone built with a slate roof. The proposals are to create two extensions/lean-to's to the Centre and to enclose the present seating area as a visitor centre.

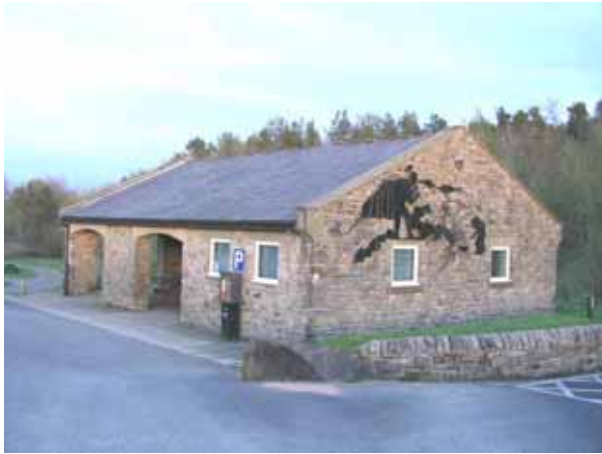
The building from the southeast.

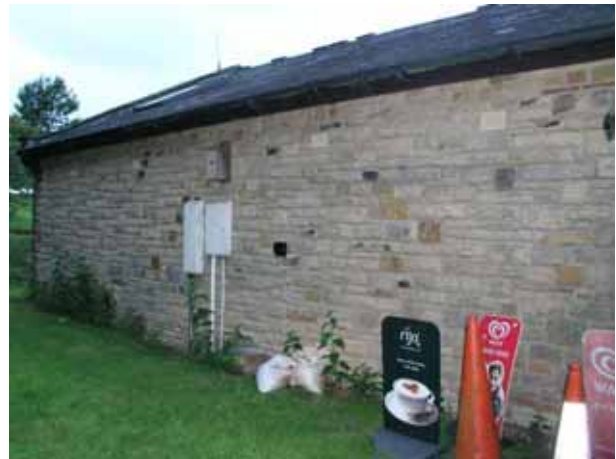
The Centre from the northwest.

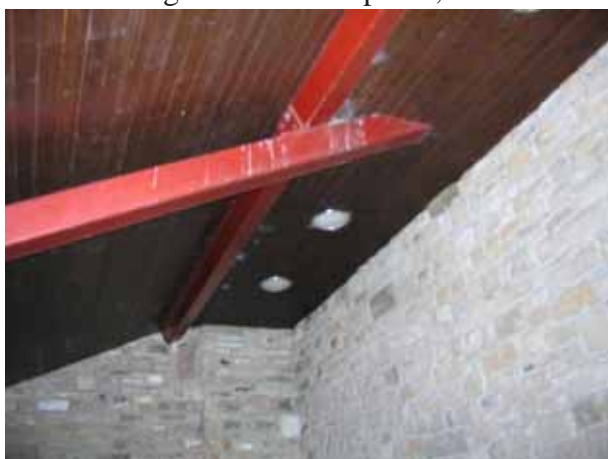
The centre is stone built with a slate roof with a felt sarking and the occasional missing slate. The building has two loft spaces, one over the toilets and one over the kitchen/ shop area. An

open covered area is lined with wood with crevices present where it abuts the stonework. A bat box is in place. The bat box was checked in June 2010 and though bat droppings were seen no bats were present or emerged during the May survey. No bat droppings were present in 2014 with only Woodlice droppings present.

The bat box is presently located on the far wall.

The bat box will be checked and moved to the new location by a licensed bat handler.

The bat box will be relocated on the west wall, please see plan below at C1.4 for location

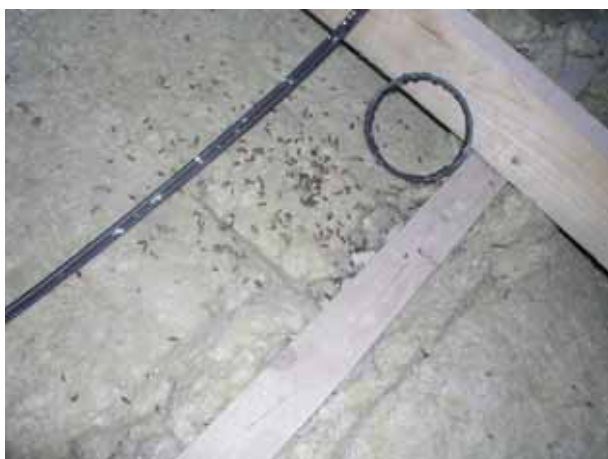
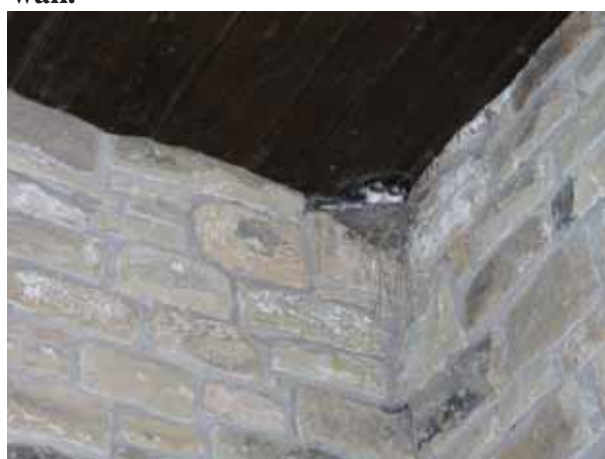
Active swallow nests

Small patch of large Brown Long-eared bat droppings, 2014.

No bat droppings were present on the walls and windowsill on the north wall, where a crevice is present around the insect mesh at the eaves and from where a Whiskered/Brandt's bat emerged in 2010. The building is well pointed with only one crevice seen on the west gable wall close to the apex, it was from this that 2 Pipistrelle 45kHz bats emerged confirming that the roost is still in use this year. Internally in the kitchen loft small clusters of large bat droppings were located internally on the west wall and on top of the water tank (the lid and insulation had slid off, needs to be resealed) and floor of the loft (2010). Fresh bat droppings consistent with Brown Long-eared were also found in 2014.

There was no evidence of barn owl activity on site. Several active swallow nests were present in the covered area and on the south eaves.

Not applicable as roosts are being retained. Provision for swallows will be provided below the sheltered walkway and covered area as at present, access to active nests will be provided at all times.

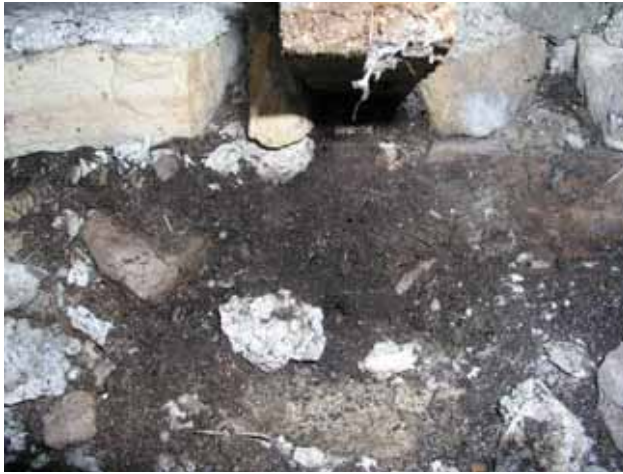
Photo showing disintegrated bat droppings beneath coping stones. If examined carefully, in the black dust exoskeletons of insects can be seen shining.

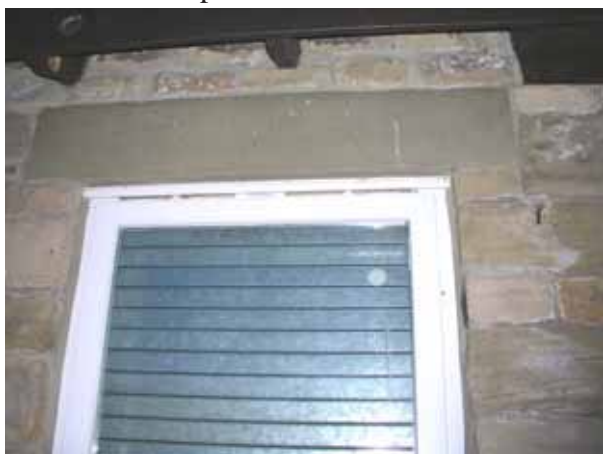
Crevice used by bats on the west gable wall

The crevices in the west gable wall and above the window on the north wall will be retained as at present. Similarly the loft space will be retained together with bat access beneath a ridge tile. Please see plan below at C1.4 for locations.

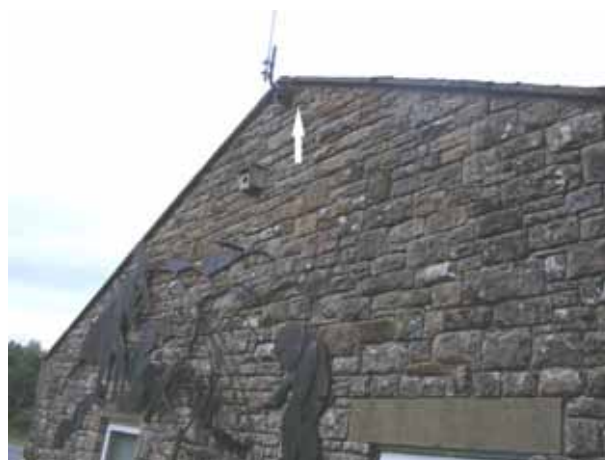
A crevice used by a bat is above this window on the north side (2010).

No crevices on the south aspect of the roof will be blocked, if repairs are necessary to the slates or ridge tiles, a crevice measuring 15 x 20+mm will be retained allowing bat access to beneath the slate or tile.
