Bat Survey Report

Wilderness, Harbottle Village, Morpeth, Northumberland, NE65 7DQ

Survey undertaken May 2015

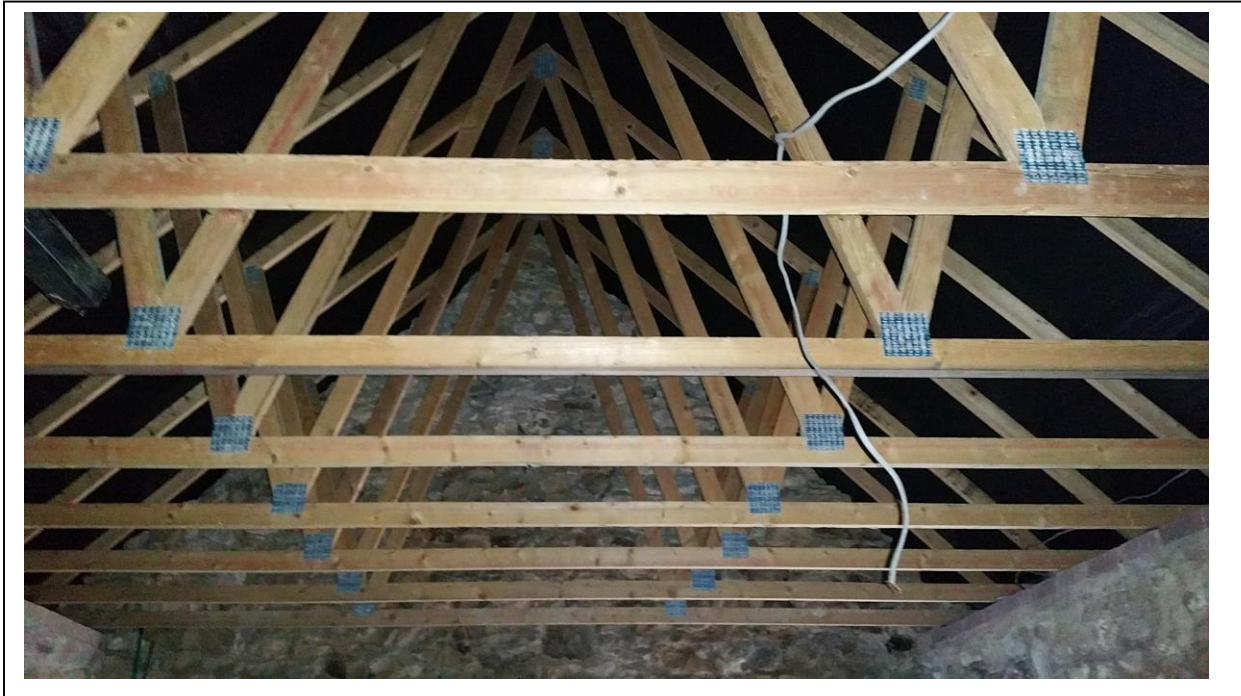
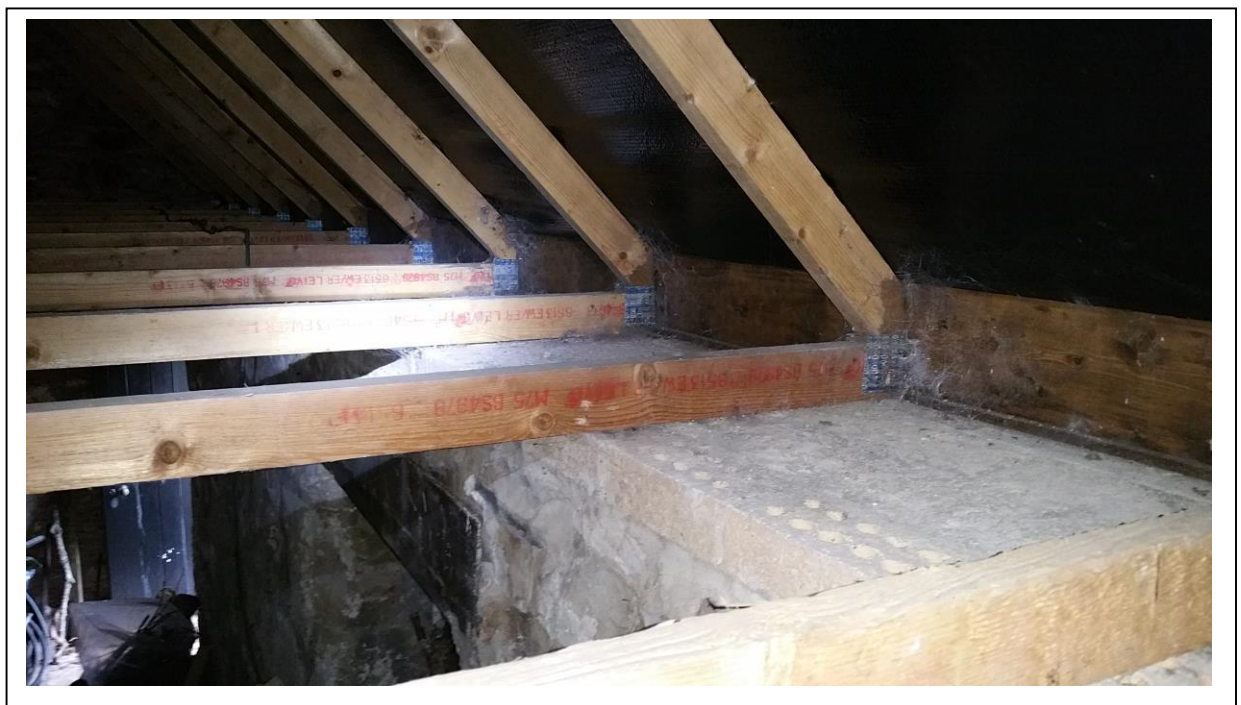
The building is single storey, with pitched tiled roof and of sandstone construction, potentially double skin with rubble interior and dressed stone to the exterior. Internally the walls have been capped off with brick and concrete in order to provide a ledge for which the open rafters of the building is sitting upon. The brickwork does have cracks mainly identified to the southern gable end of the building with missing mortar. The north, west and east elevations have been previously re-pointed. Upon closer inspection of the crevices it was noted that the gaps did not have the field signs to suggest bat was present at the building. The majority of holes were dismissed due to the amount of spiders webs identified within the gaps suggesting no recent entry or exit to these crevices. Gaps were also checked with an endoscope for further clarification. Closer inspection was also given to the small gap to the lintel above the doorway and door frame to the building – which did not show any field signs for bats.

The building has a pitched roof and internally includes open rafters. The roof section is fairly recent and possibly the building was re-roofed within the last 10 years (as this work was undertaken by the previous owner).The roof section is a tile construction secured to batons and with felt underneath. There are a number of tiles which have slipped; mainly to the north west which was the result of vehicle damage. These slipped tiles have created small gaps providing some bat roosting potential. The gable end have cracks within the mortar where the roof tiles

Internal – demonstrating the open rafters and roof of recent construction and capping to the walls of the building

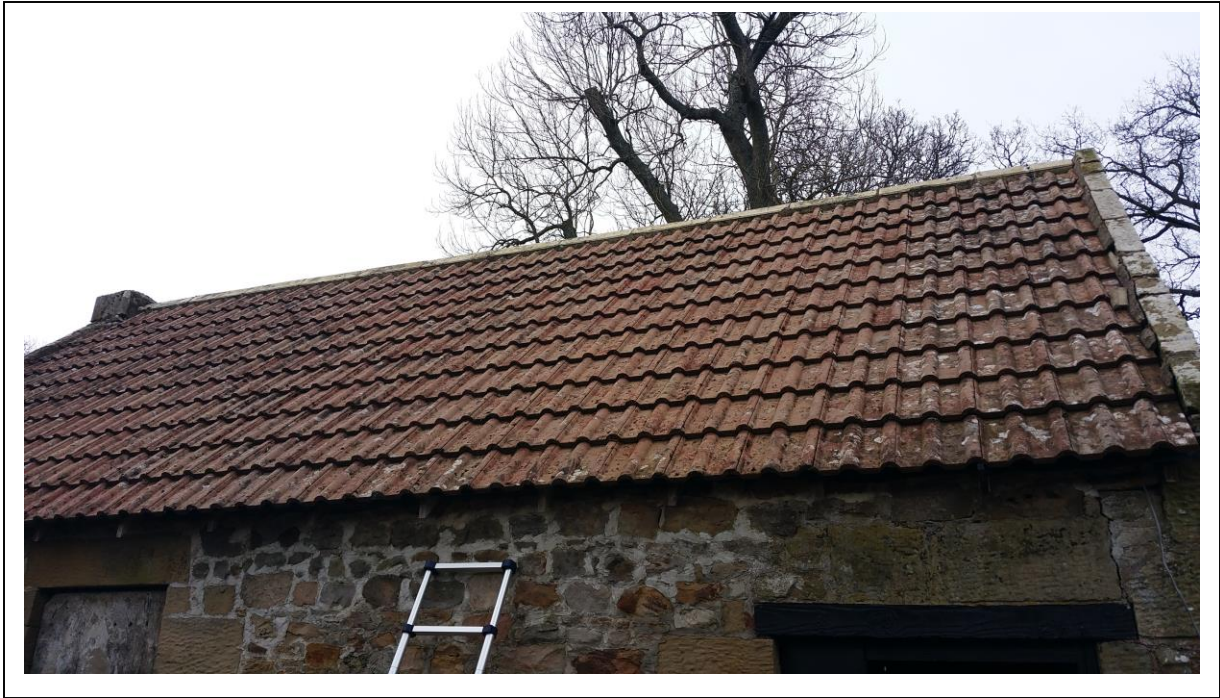
meet the sandstone gable. There has previously been a chimney which is now blocked with no field signs evident. Between the top of the wall and the eaves creates a small ledge – evidence of four remnant bird's nests are identified externally to the west and east elevations. A bird checking survey should be carried out by a competent ecologist if works are to take place during the bird nesting season (March – August).

Roof Section – with gaps to the mortar to the southern gable end

The building as it currently stands was considered to be low risk irrespective of the gaps which have been identified within the building survey (including – slipped tiles, cracks within the stonework, gap above the doorframe and the windows being boarded). The property was identified within close proximity to existing maternity roost at Holly's Cottage to the immediate north of the site and also from ERIC records to the east of the site (approximately 200m away) and the site does have good connectivity to the woodlands, open water and watercourse to the south of the site and to the River Coquet to the north. However overall there was a lack of field signs identified during the bat risk assessment and from the emergence survey undertaken to support the building as having low potential for bats.

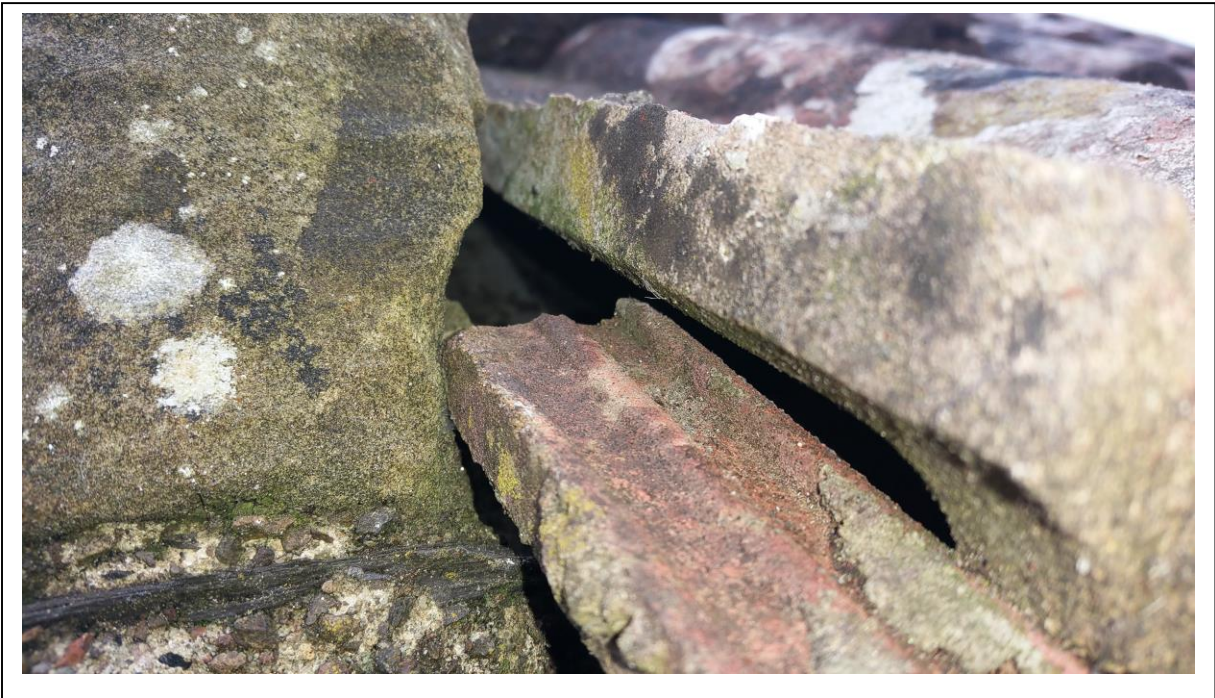
South west corner roof section with slipped tiles

- Roof tiles, window frames and door frames are to be removed with checks for bats as work proceeds
- If bats are identified, all works must stop immediately and licensed Ecologist called (in the first instance - DHB). Bats should be left in-situ and gently covered over to allow the bat to freely emerge during dusk. If safety is compromised then bat(s) should be removed to a safe place (small ventilated box); wearing gloves at all times until advice is obtained.

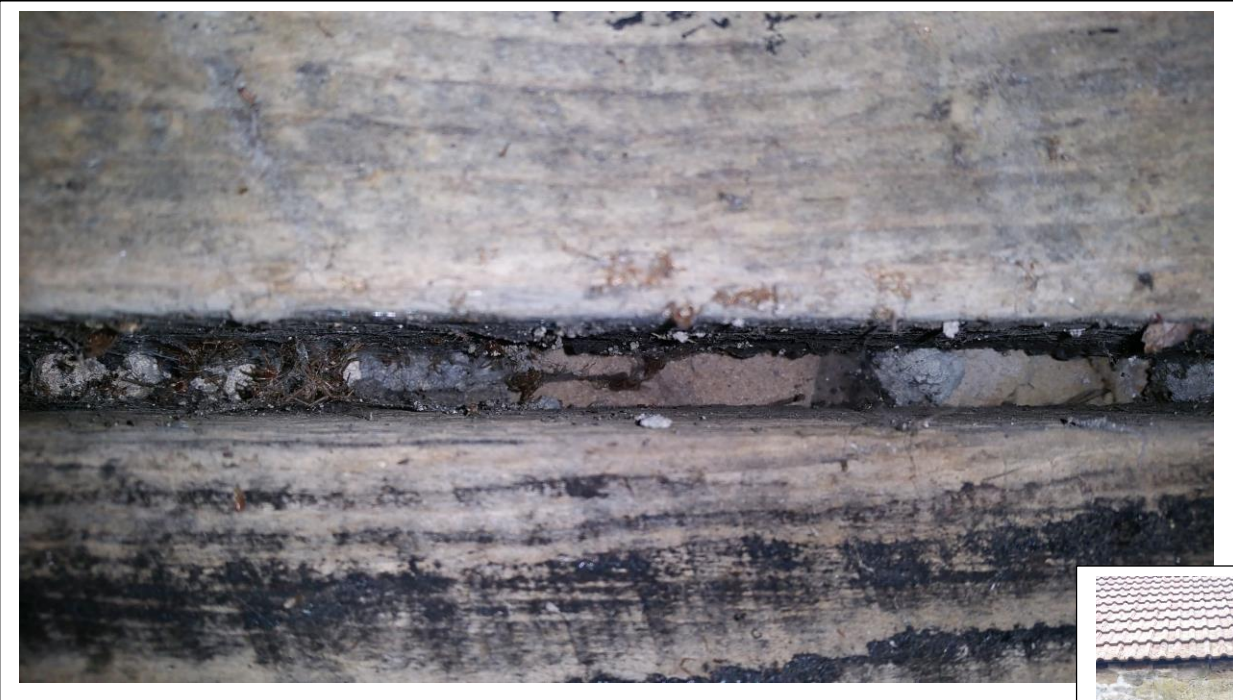
Gap above the doorframe

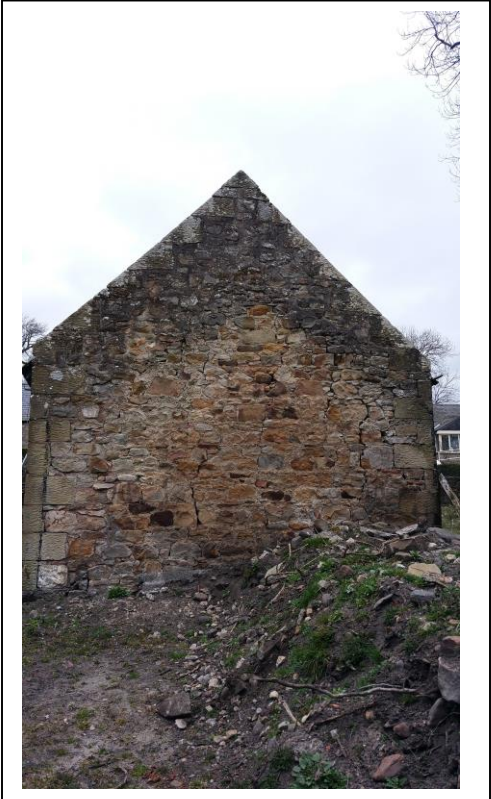
Southern elevation

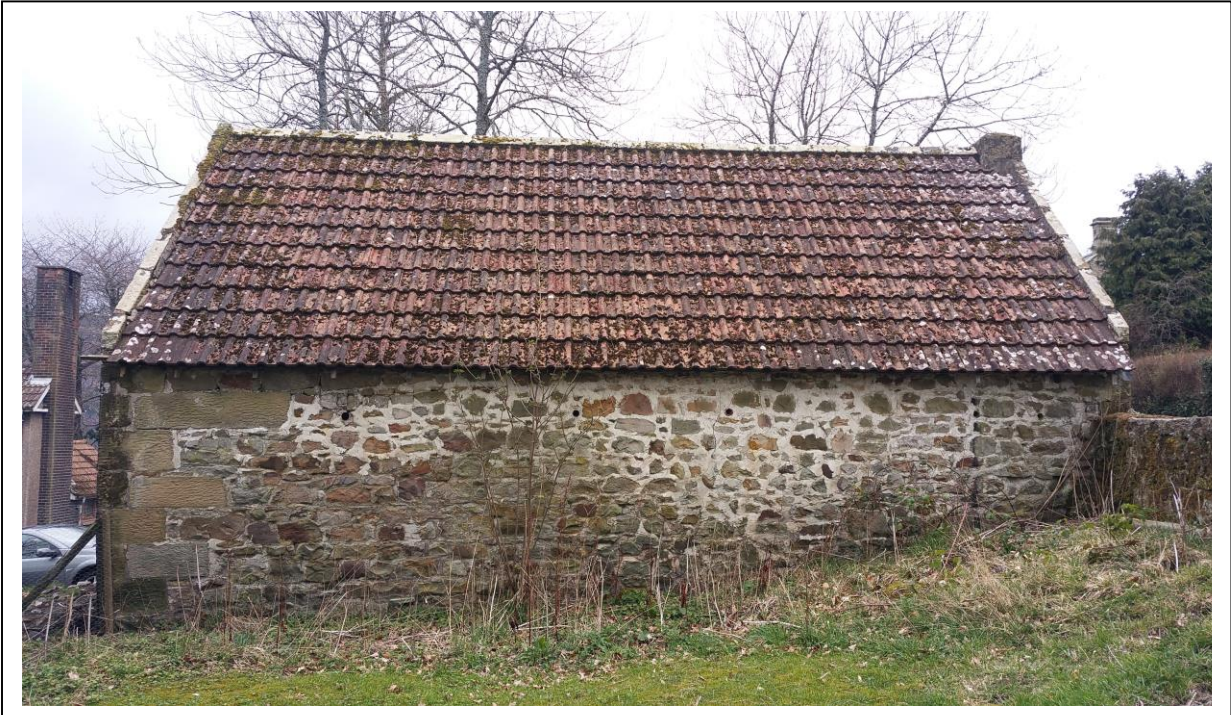
Eastern elevation showing repointing

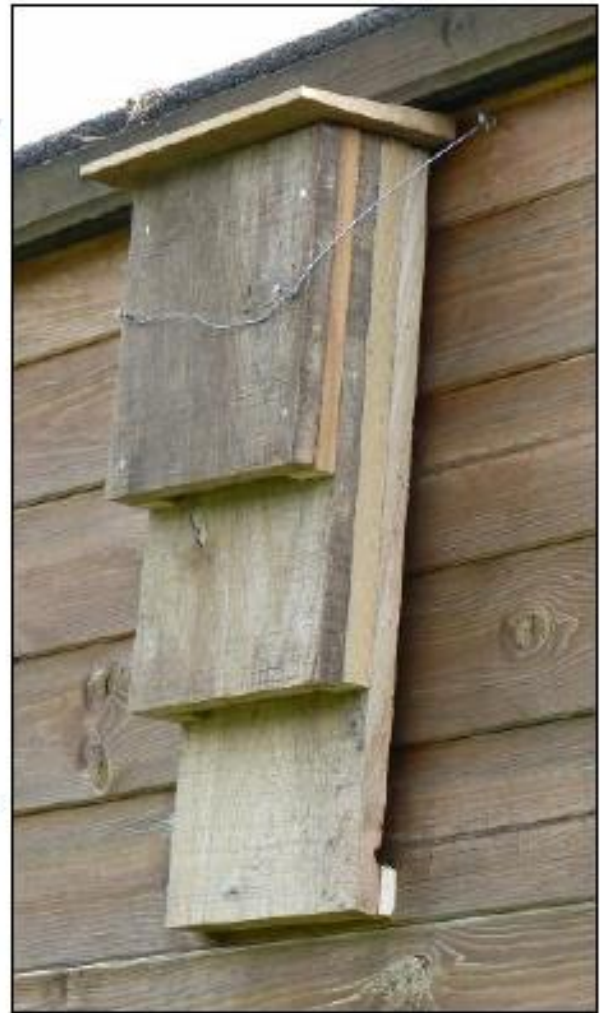
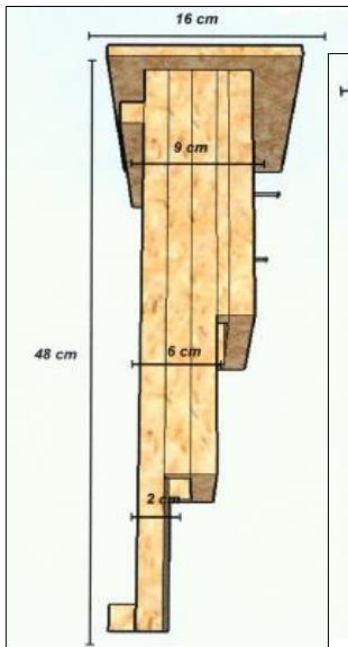
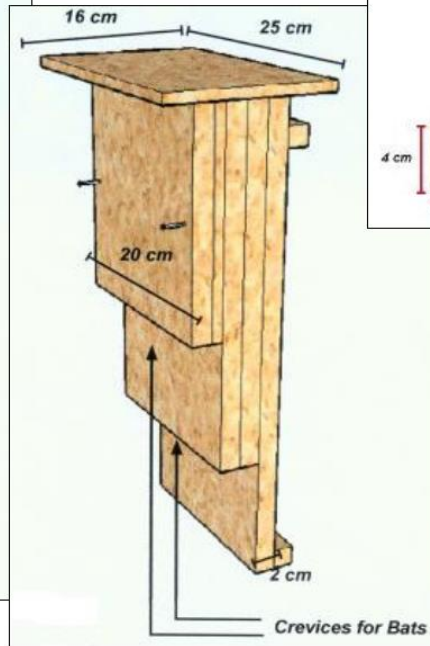
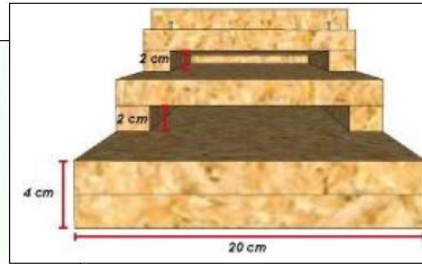
Boxes are best fixed as high as possible in a sheltered wind-free position, exposed to the sun for part of the day.
They can be fitted to walls, other flat surfaces or trees
A clear flight line to the entrance is important

This design has been developed by Kent Bat Group

Mitigation and enhancement of the site due to the presence of foraging and commuting bats, recommends 2 external bat boxes attached to trees within the grounds of the site in order to provide additional crevice roosting potential. Bat boxes can be erected prior to commencing works and choice of bat box includes either a purpose built Shweglar bat box or an easily constructed Kent Bat Box of untreated timber – information relating to construction is included within in Appendix 2. The bat boxes are to be located at a height of approximately 4m at a south east and south west elevation.
