BAT AND BARN OWL SURVEY

THE OLD FARMHOUSE, STONEHAUGH

OCTOBER
2015

FINAL

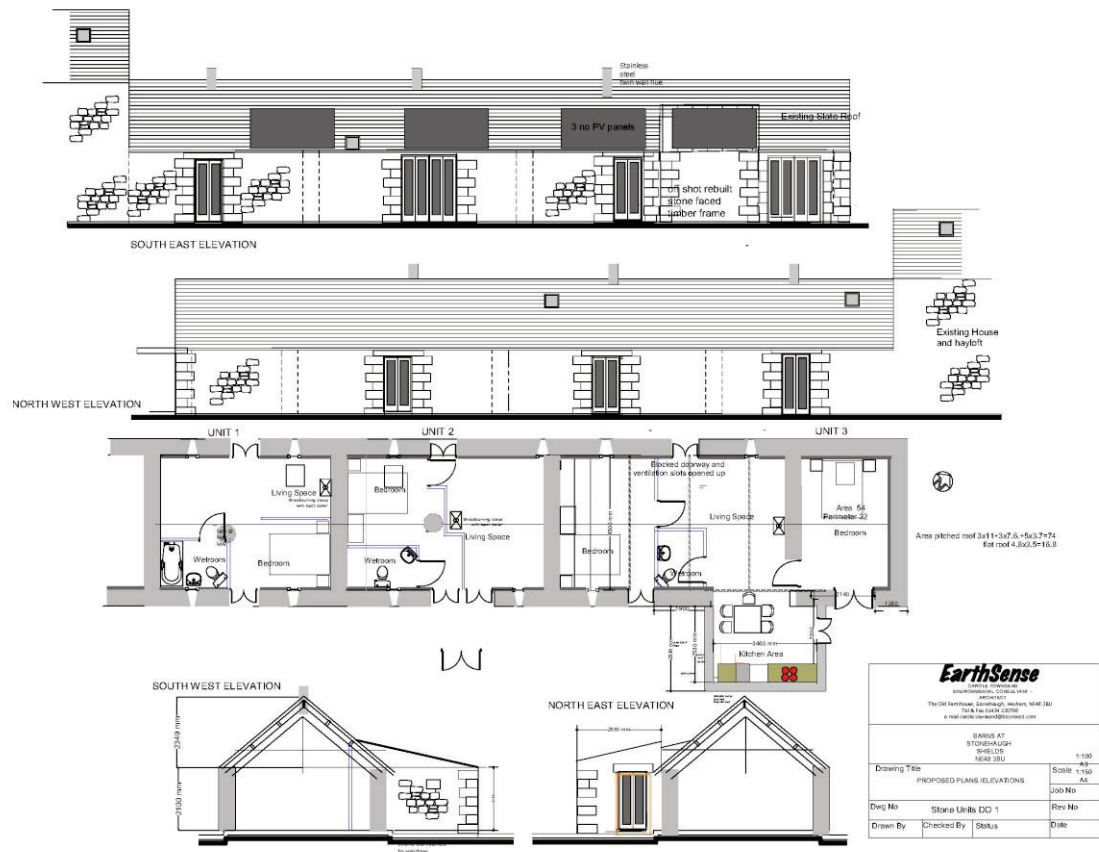
FIGURE 2 – DEVELOPMENT PROPOSALS (PROVIDED BY EARTH SENSE)

Figure 2 below illustrates the currently available plans (the dark blocks on the roof are solar panels):

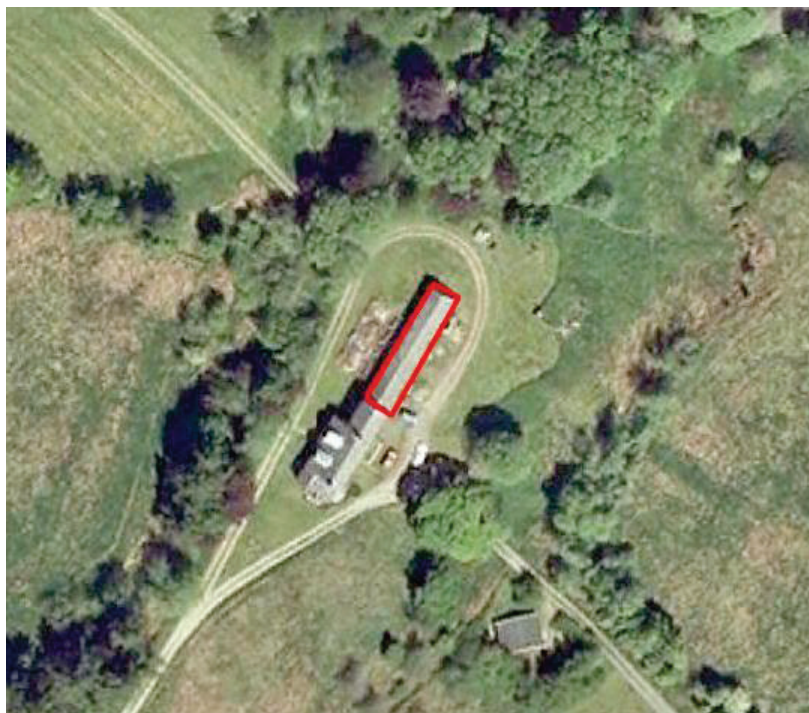
**FIGURE 3 – AERIAL PHOTOGRAPH OF THE SITE
ILLUSTRATING ITS EXTENT WITH A RED LINE BOUNDARY
(Reproduced under licence from Google Earth Pro.)**

Figure 3 illustrates the site boundary whilst Figure 4 illustrates the broad habitats present on site and within an approximate 500m buffer zone.

The most recent aerial photograph of the site available (Figure 3) indicates that habitats on site are dominated by the buildings onsite, surrounding by associated landscaping and hard standing. Historic imagery suggests that habitats on site have remained the same since at least 2002.

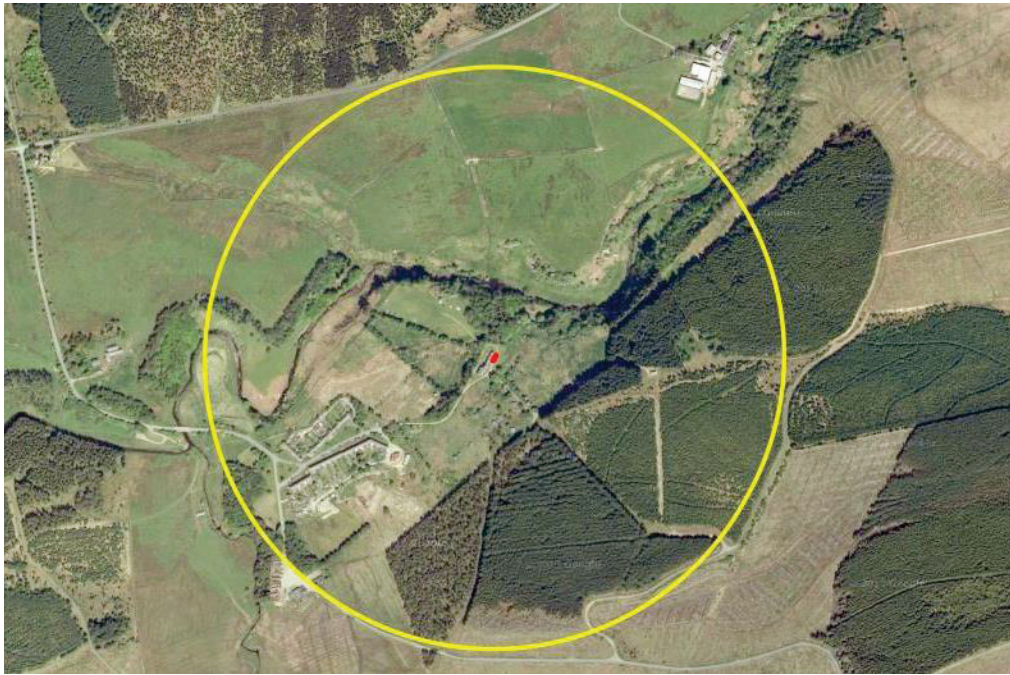
**FIGURE 4 – AERIAL PHOTOGRAPH CENTRED ON THE SITE
WITH A 500M RADIUS ILLUSTRATING THE SETTING AND THE
HABITATS IT SUPPORTS
(Reproduced under licence from Google Earth Pro.)**

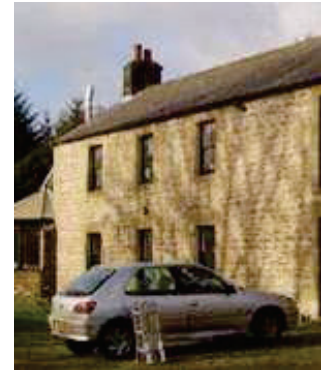
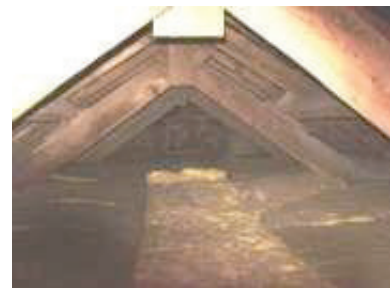
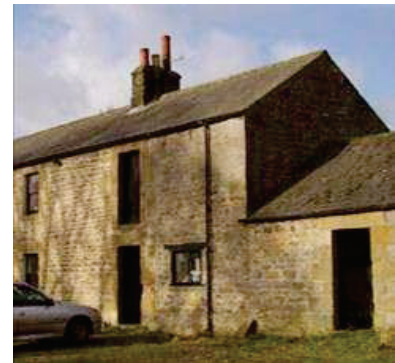
- Stone and slate.
- Loft small and cluttered loft void, approximately 1.5m to the ridge, running the length of the farmhouse. Internal gable walls exposed stone. Roof unlined. Insulation present throughout.
- External stonework well sealed.
- Slate roof sound but small number of gaps at the ridge tiles and associated with the flashing around the chimneys.
- Internal gables within loft are well-mortared, occasional gaps at the eaves.
- Roof timbers sound, ridge board cobwebbed for much of length.
- Internal survey conditions good, loft void dry.
- Small number of old Myotis/BLE droppings scattered below the ridge. No accumulations that would indicate a breeding site, likely to be individual bats roosting at times. Droppings in 2007 of an age that would suggest use pre-2006 season.

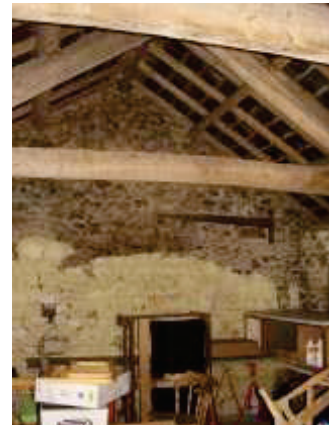
- Stone and slate.
- Unlined roof, single sarking board either side of ridge board.
- Single ground floor room, single upper floor room open to the ridge.
- Small number of crevices within the internal stonework in the upper floor where purlins enter the gable walls.
- External stonework generally sound.
- Roof timbers sound.
- No loft void.
- High light conditions throughout.
- Internal conditions dry and relatively clean but not swept.
- Used for storage, hindering survey in places.
- Scattered butterfly wings, old swallow nests present.

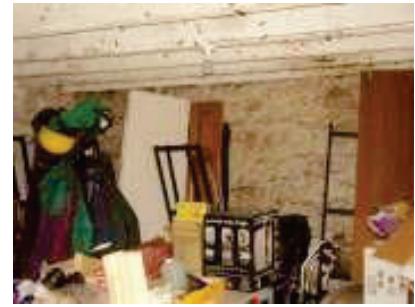
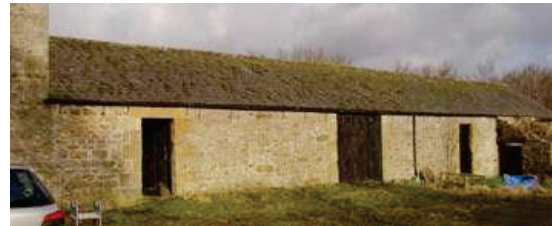
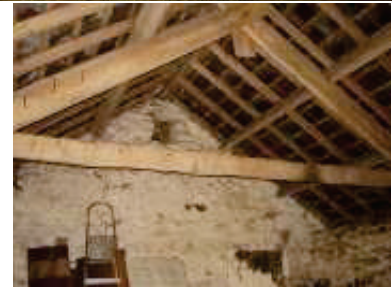
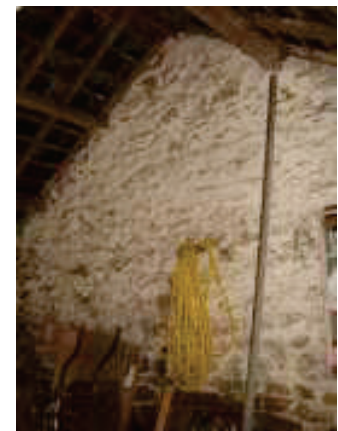
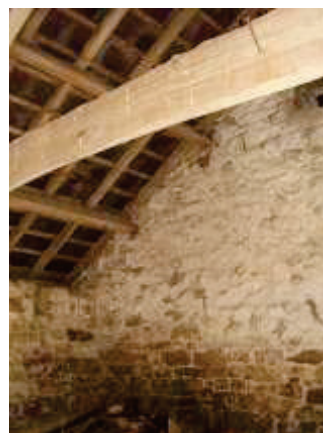
- Stone and slate, split into four small sections internally, all of similar structure.
- Unlined roof, single sarking board either side of the ridge board.

- No loft voids, all sections open to the ridge.
- Externally stonework in moderate condition, however, numerous crevices particularly toward the eastern end on the southern elevation.

- The roof is primarily sound with no slipped or missing slates.
- Internal stonework generally well-sealed apart from section 3 where there are numerous gaps and section 4 where ventilation slits give access into the rubble fill. Within the remaining sections there are a small number of gaps at the eaves particular where the purlins enter the stonework.

- Roof timbers sound.
- High light conditions throughout.
- Interior of each section likely to be too small and cluttered to be used as pre-emergent light sampling areas.

- Survey conditions poor due to the stored goods throughout.
- Section 1 - No field signs recorded.
- Section 2 - Scattered butterfly wings, old swallow nests.

- Section 3 - No field signs recorded.
- Section 4 - Old swallow nests.

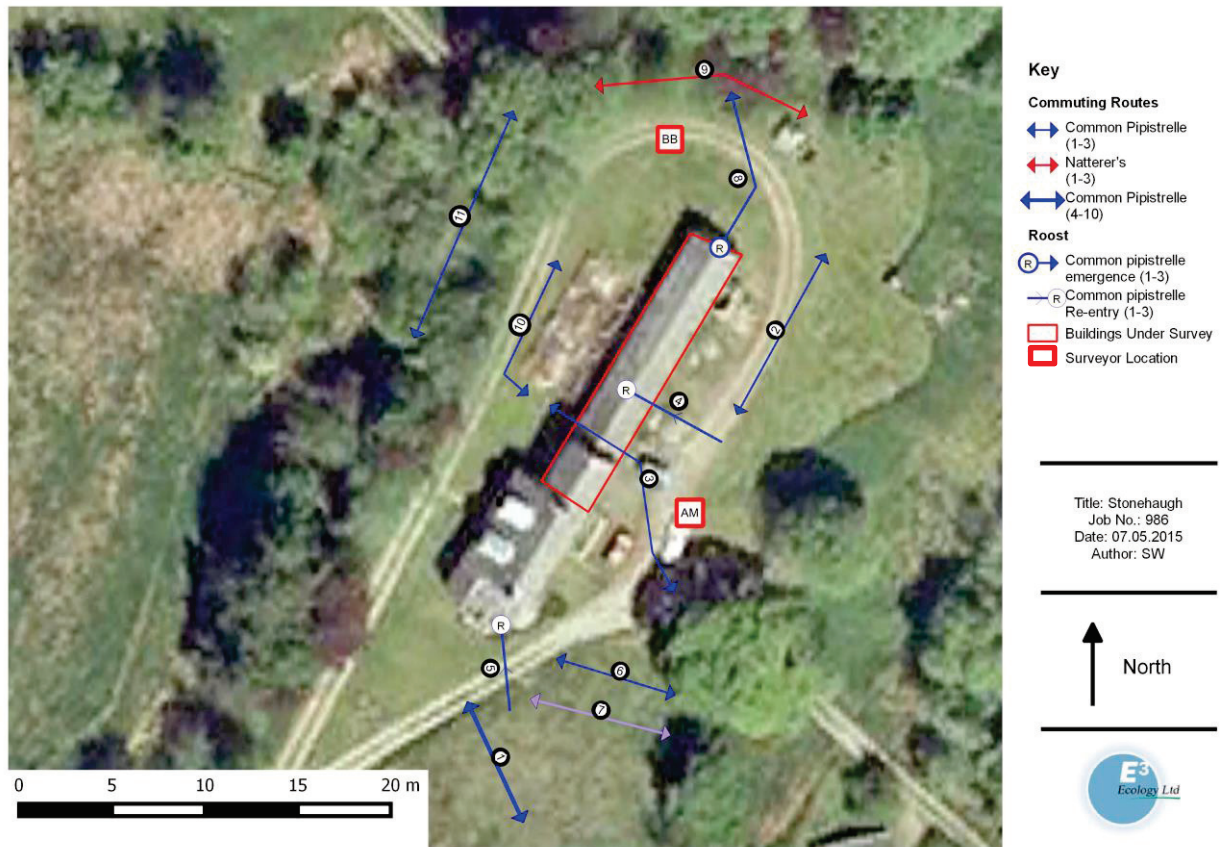
FIGURE 5 – DUSK VANTAGE POINT SURVEY 7TH MAY 2015

Dusk emergence survey on the 7th May 2015 (figure 5 below) recorded moderate levels of bat activity, a single common pipistrelle was recorded emerging from the northern gable end of the single storey section (section 4). Two bats were recorded returning to the roost towards the end of the survey, probably due to the drop in temperature. One was within the ridge tiles of section 1 of the area to be renovated, whilst the other was within the farmhouse, which will be unaffected during the development. Other species commuting and foraging on site included Natterer's and soprano pipistrelle. Common pipistrelle bats were seen emerging, and swarming around as temperatures fell, the leadwork near the chimney on the farmhouse.

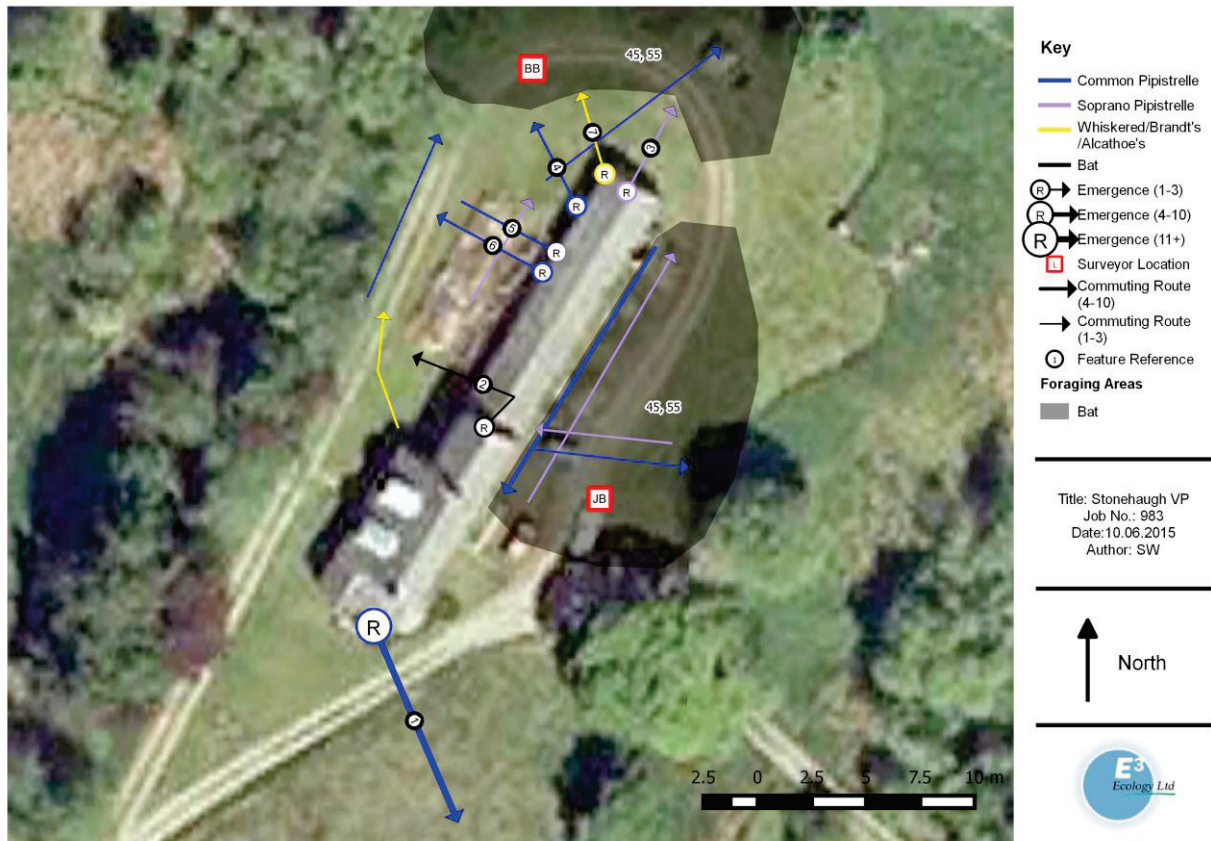
FIGURE 6 – DUSK VANTAGE POINT SURVEY 10TH JUNE 2015

Dusk emergence survey on the 10th June 2015 (figure 6 below) was conducted on a warm (16-8°C), dry and still evening and 7 roost locations were confirmed. A likely common pipistrelle maternity roost is located on the southern gable of the 2 storey, main house (30+ bats), with a single bat seen emerging, but not echo locating, from the northern gable. Five further individual day roosts were recorded on the single storey section. A single soprano pipistrelle, three common pipistrelle and a single whiskered/Brandt's or Alcaethoe's. These emergences were primarily associated with gaps between the wall tops and roof. Activity across the site was high for the majority of the survey with the three species mentioned above commuting and foraging around the site.

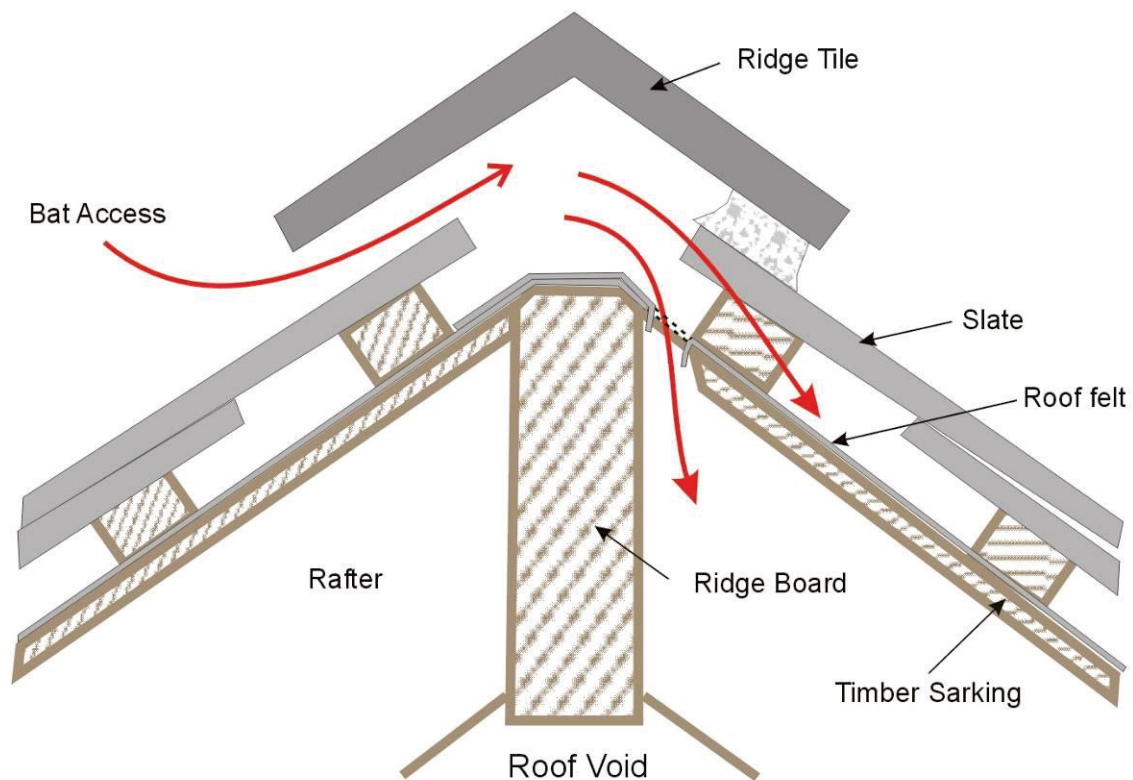
Ridge Tile Access

Ridge tile set on top
allowing bat access

- A total of 5 purpose designed “bat slates” will be incorporated into the new roof of the renovation.
- Access to the underside of the ridge tiles will be provided in 10 locations through 20mm diameter gaps in the pointing.
