Project - Proposed works to roof ridge, roof light window and replacement of boundary fence (retrospective).

Otterburn Hall Farm, Otterburn Hall Estate, Otterburn. NE19 1HE

Listed Building Consent (LBC) is sought for the replacement of the roof ridge tiles, replacement of the roof light window to the east elevation and new boundary fence and entrance gate to the property (retrospective).

Heritage Statement - Northumberland County Council conservation team guidance.

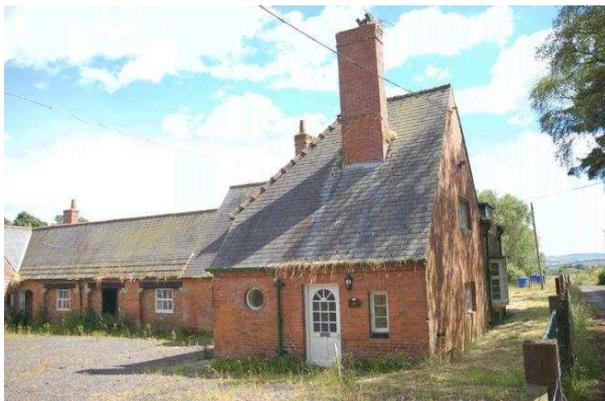
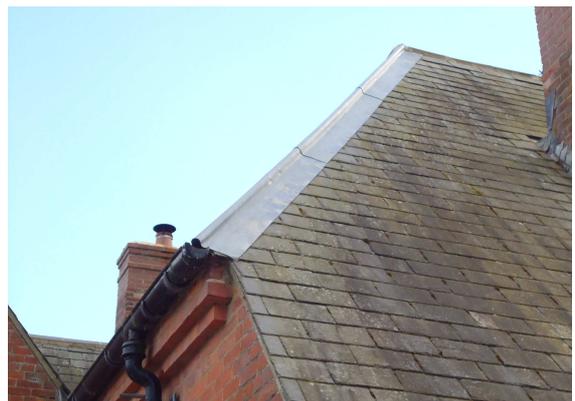
The replacement of the roof ridge and hip tiles was carried out just after the applicant purchased the property in December 2014. The photograph below shows the dilapidated state the property was in at the time of purchase.

Photograph of the property (left) taken around 2014 showing the significant amount of vegetation growth within the roof gutters. Photograph right showing the new code 4 lead roof hip.

The applicant has indicated that the existing roof ridge and hip tiles needed rebedding as significant amounts of the bed joints were defective plus a number of the existing ridge and hip tiles were damaged. Matching hip and ridge tiles were sought at the time however none could be found in a timely manner. The applicant made the decision to replace the existing ridge tiles in a flat grey tile with the hip tiles replaces in a code 4 lead hip with a roll top detail.

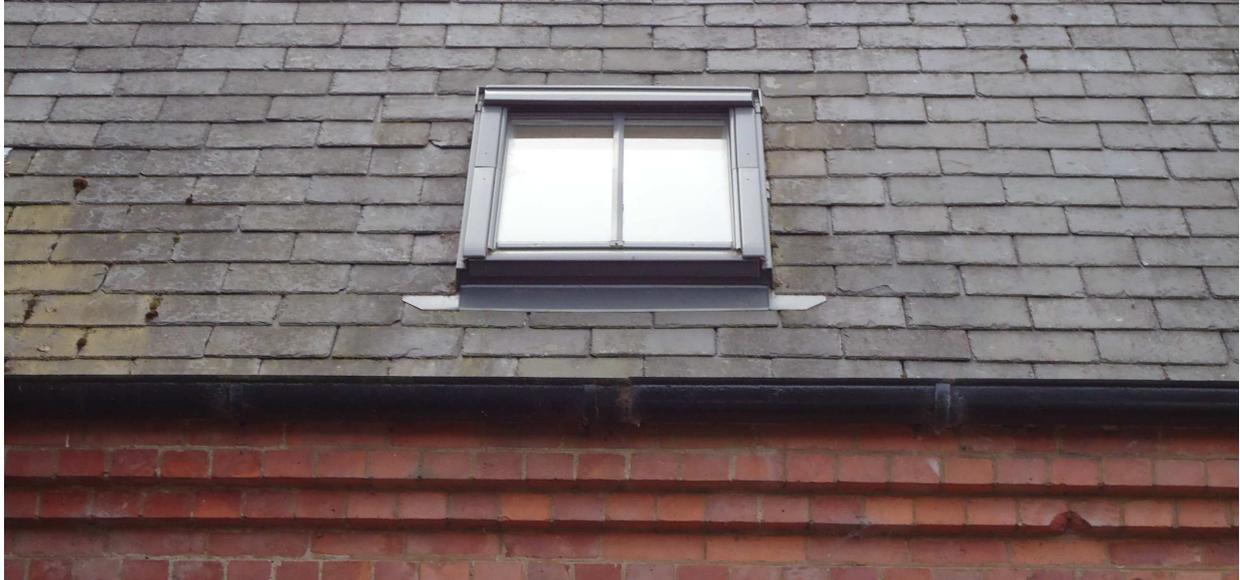
Photograph above of replacement roof light component to east elevation (within the courtyard).

The existing roof light window was replaced as part of the initial refurbishment work carried out shortly after the applicant purchased the property in 2014. This was replaced as the existing roof light windows had been leaking, thereby causing internal damage to the property. The applicant has confirmed that the existing roof light window was a modern velux style roof light and that the replacement was carried out on a like-for-like basis.

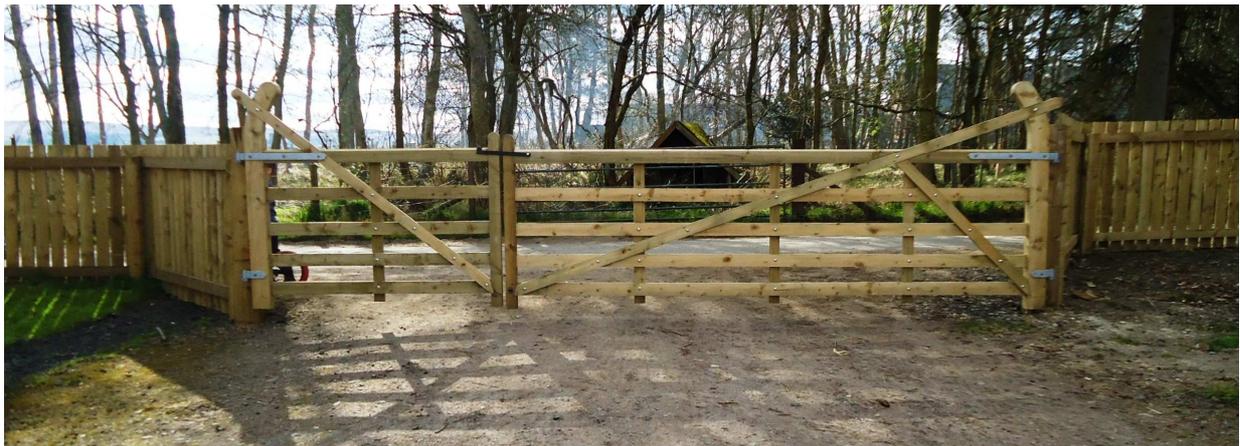
The applicant has erected a new close boarded fence (1.20m high) to the exposed perimeter of the property and as indicated on the submitted site plan drawing. The fence incorporates a traditional farm style pedestrian and vehicle access gate to the garden and parking area of the property. The images below indicate the fence and gate style.
