**GREYSTEAD INSTITUTE - PROPOSED RENOVATION  
BAT AND BARN OWL SURVEY– SUMMER 2017**

**SECTION 1 BACKGROUND AND SUPPORTING INFORMATION**

- Greystead Institute was inspected and surveyed to inform a planning application. The present building is derelict, partially two storey, stone built with a slate roof with a wood sarking and is presently unused.

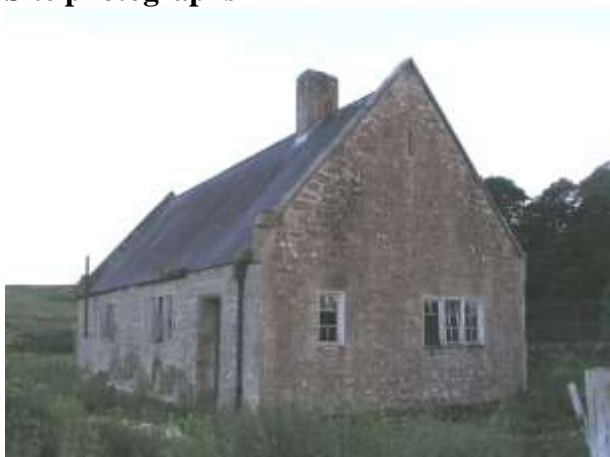
**The west aspect from the northwest**

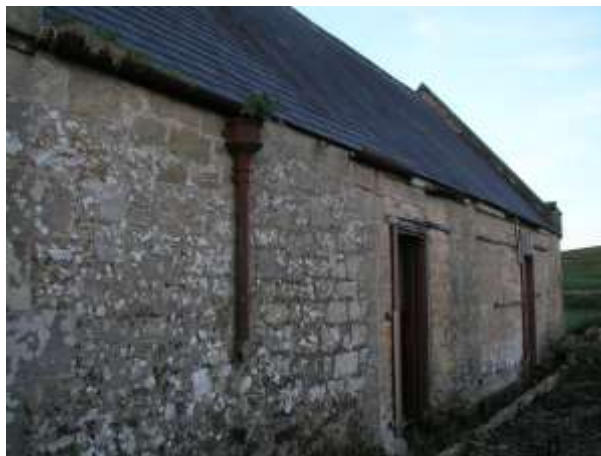
**Greystead Institute from the northeast**

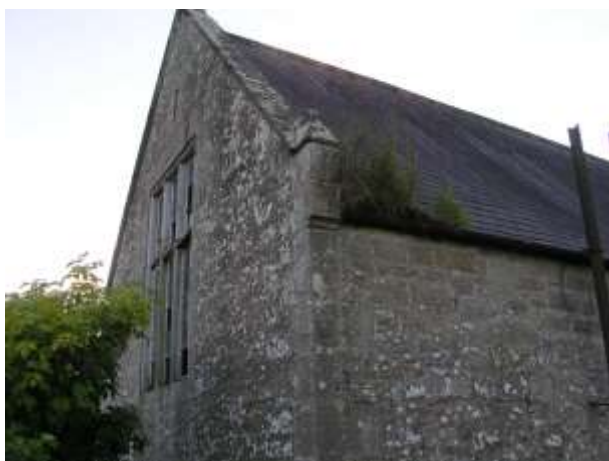
**South gable from the southeast**

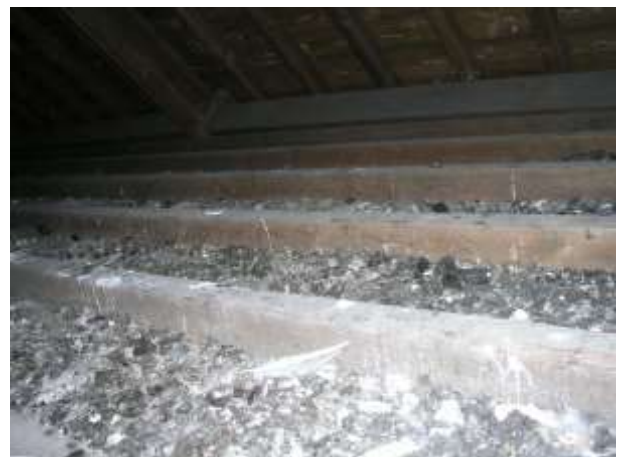
The Greystead Institute is derelict, two storey stone built with a slated roof that has a wood sarking (Scottish method) and is presently unused. Internally the hall walls and ceiling are plastered and a small loft, 1m high, is present above. There is open access through the broken windows, vents and doorways. No traces of bats were identified however the hall floor and upper floor and balcony is heavy covered by barn owl pellets of mixed ages. A dead owllet was found on the ground floor during the first survey that had been trapped in the doorway by its wing. The loft was examined from the side of the chimney and photographed. A large jackdaw nest is present at the south gable end and on examining the photographs later it was confirmed that barn owls are nesting behind the chimney in the loft.

**Loft with barn owl pellets**

- A barn owl loft to be retained in the building and a nesting box to be provided.

In the converted building Barn Owl access through the south vent in the gable wall will be retained to the small loft area. An access point on the east aspect measuring 12x25cm at least and 40cm above the floor of the loft is required to prevent the young owls from falling out. Floor room will measure 50 x 50 cm at least. A loft hatch for cleaning out is also required. Please see references for further details.

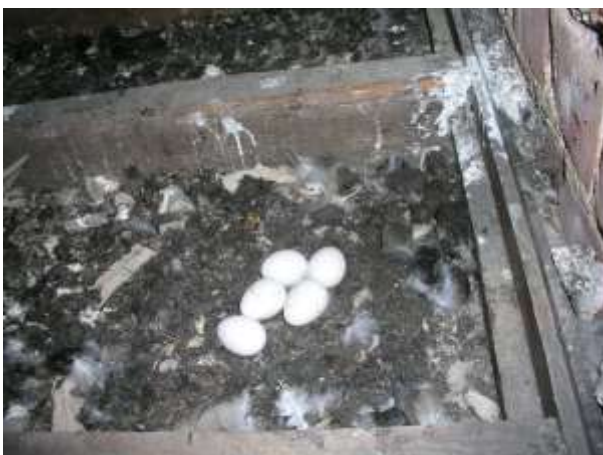
**Eggs behind the chimney**

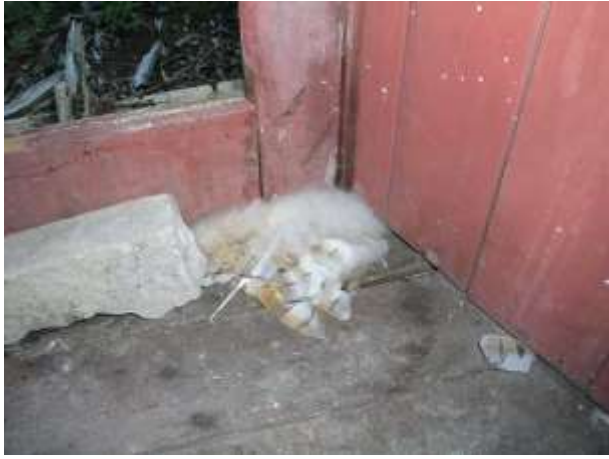
**Dead owlet trapped in door**

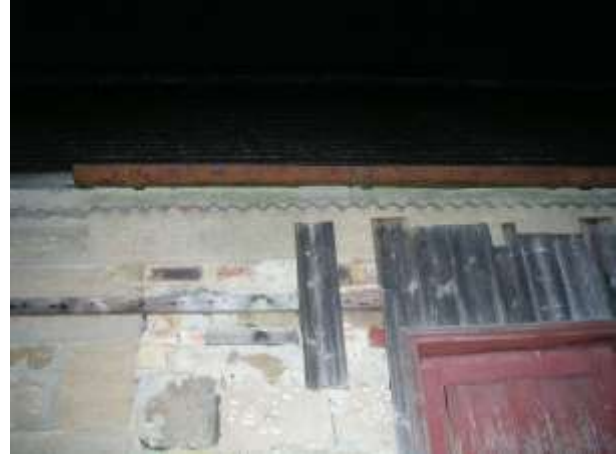
At dusk the activity was mainly Pipistrelle 45kHz bats during the July survey with one Pipistrelle 55kHz bat emerging from above the doorway on the west eaves, this bat was also present in August. In August a second Pipistrelle 55kHz bat flew from the north vent (chased by the owl) and 2 Pipistrelle 45kHz bats were also present, emerging from the base of the chimney.

**Eaves where Pipistrelle 55kHz bat emerged.**

Ruth Hadden or a suitable ecologist will brief the contractors and carry out a watching brief when the roof coverings are removed in the region of bat roost potential as necessary, or fit an exclusion device to the west eaves to exclude the bat.

An eaves crevice will be created at the west eaves of the renovated building. This can simply be a slit 20mm by at least 20mm creating a gap that will be in the form of the required ventilation gap with **no insect mesh** present or a notch in the wall plate/batten on that section of the eaves, **with access to the gap between the roofing felt and slate**. The position will be checked to ensure that the bats can access further that the first batten and a notch cut if necessary. Please see plan at C1.4 for locations and Appendix 1 for details.

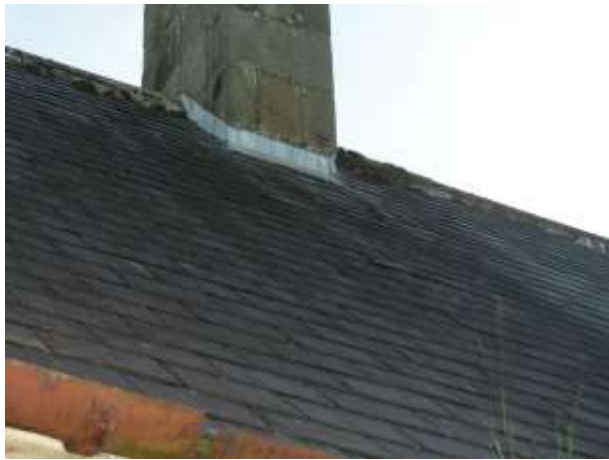
**Chimney base with a few raised slates and crevices around, two Pipistrelle 45kHz bats emerged from this location**

- Retention of crevices near the base of the chimney as at present.
- External lighting will be on a relatively short timer, directed away from bat roost access points and flight paths and motion-sensitive only to large objects.

The crevices at the ridge near the chimney will be retained as at present.

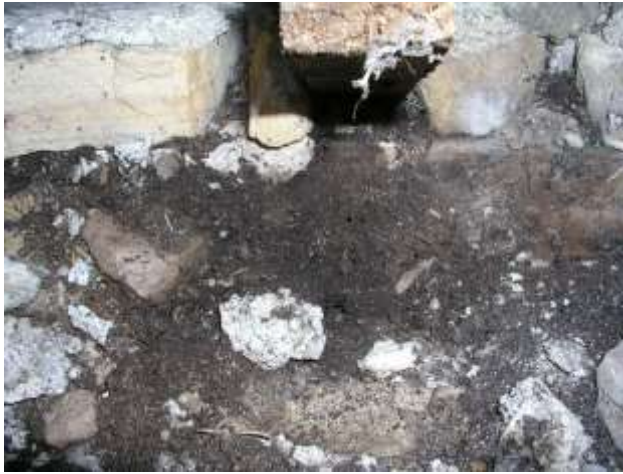
**Photo showing disintegrated bat droppings beneath coping stones. If examined carefully, in the black dust exoskeletons of insects can be seen shining.**
