ILDERTON DOD, POWBURN, PROPOSED DEVELOPMENT
BAT AND BARN OWL REPORT – SUMMER 2017

SECTION 1 BACKGROUND AND SUPPORTING INFORMATION

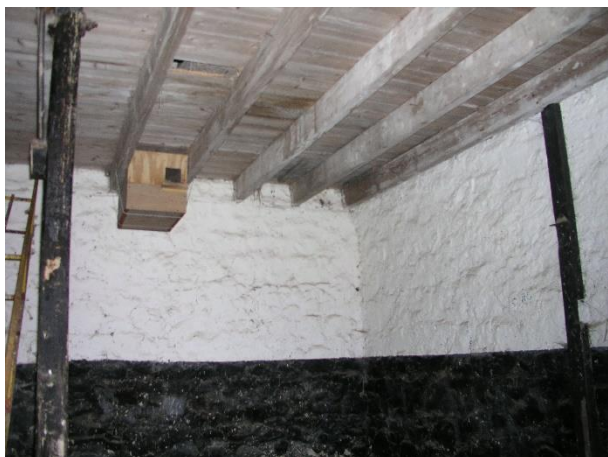
Barn Owl nesting box in Section 3

The present barn owl nesting box will be relocated into a barn immediately to the north of the present site with a flight path to the east if possible.

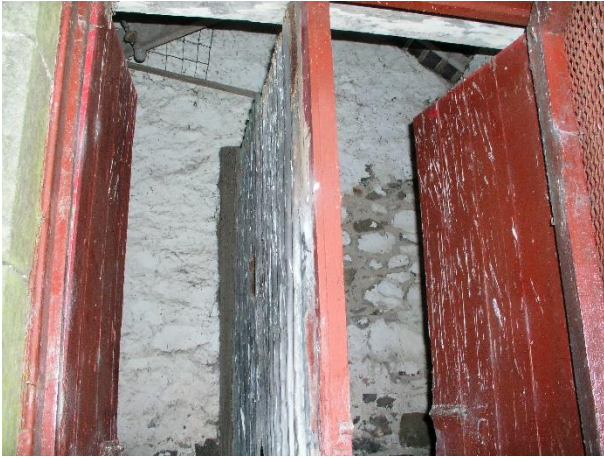
Upper floor of Building 3.

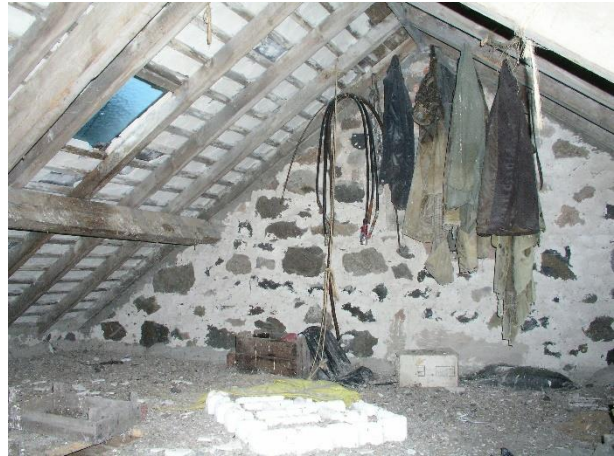
Section 4 used by Swallows

Either suitable features for swallows will be created in the design of the buildings or alternative buildings will be made available to swallows or appropriate nesting boxes (at least 3) will be placed in convenient sheltered positions at 2.5 to 3 metres in height.

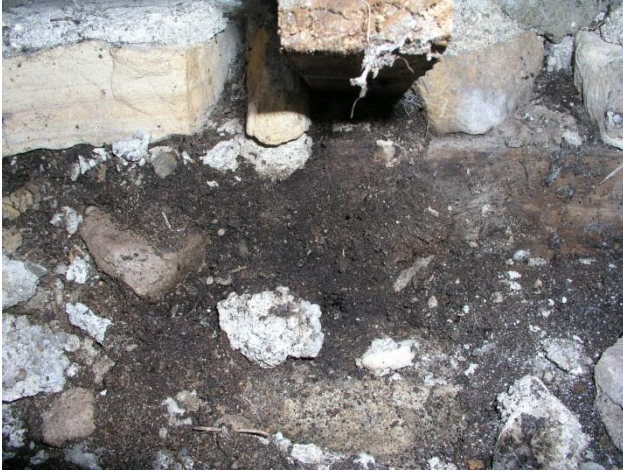
Photo showing disintegrated bat droppings beneath coping stones. If examined carefully, in the black dust exoskeletons of insects can be seen shining.

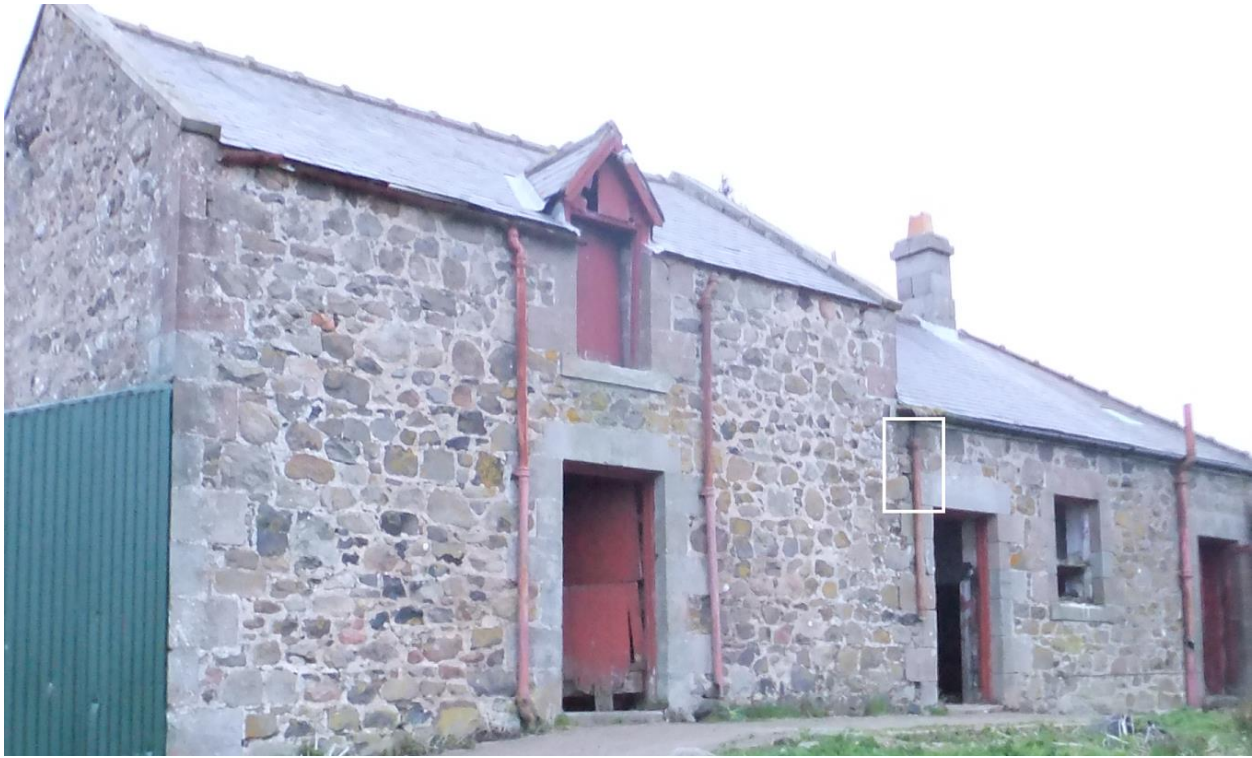
Retention of bat crevice identified in Building 2/3 on the east aspect in a crevice near the door as at present. Please see photograph below for location.

- Retention of bat crevice identified in Building 2/3 on the east aspect in a crevice near the door as at present.
- Sensitive timing of any roofing works in spring to autumn to avoid hibernating bats.
- Provide Method Statement to contractors.
- Advice given for the safe removal of any bats found from harm during the development under different weather conditions.
- Any external lighting will be on a relatively short timer, directed away from bat roost access points and flight paths and motion-sensitive only to large objects.
