# PROTECTED SPECIES SURVEY REPORT

Redmire Bridge, Tarsset, Northumberland

*Northumberland County Council*

*October 2020*

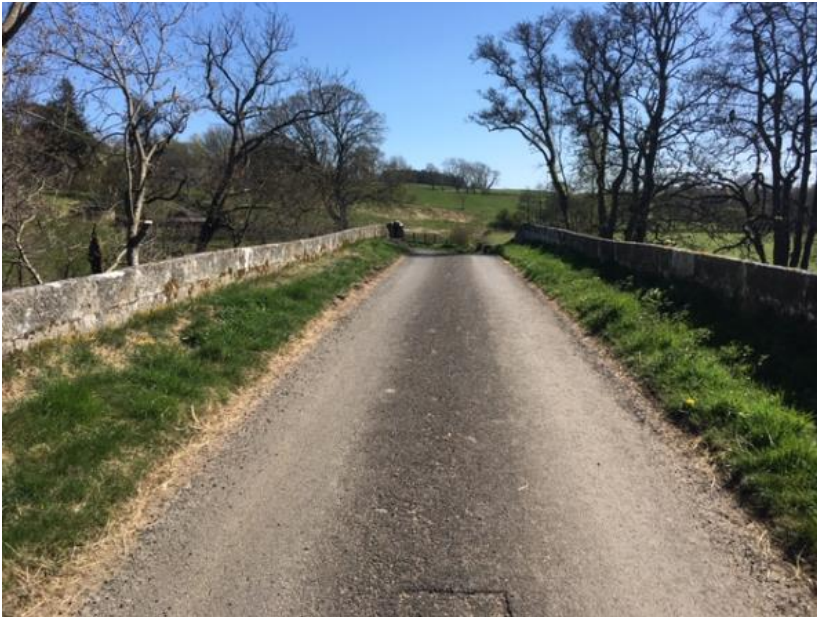
**Photograph 1** – Single track, unnamed road over Tarsset Burn.

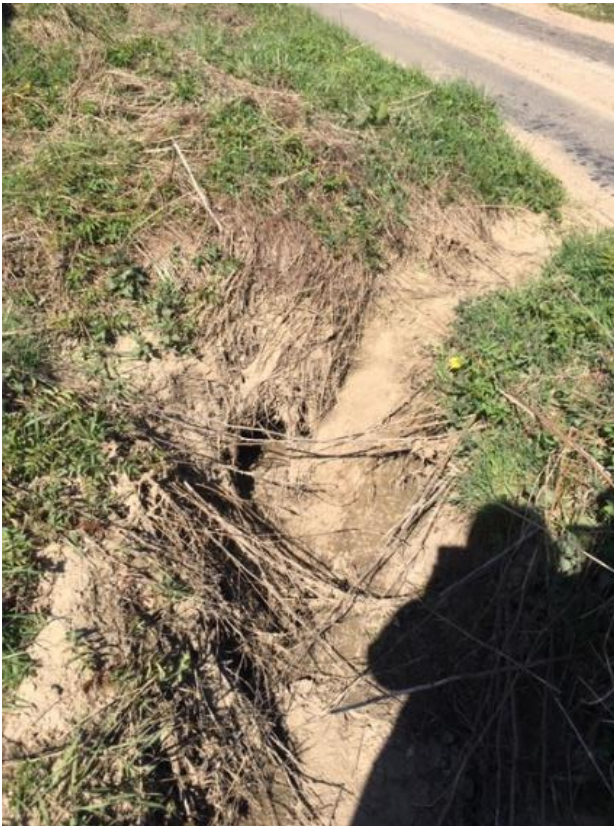
Evidence of badgers has been noted around the site on several separate occasions. Field signs have included both latrines and snuffle holes/signs of foraging and a partially active outlier sett was discovered just off the road approximately 60m north of the site. However, upon later visits to the site this sett appears to have been completely overgrown by tall ruderal vegetation, suggesting it has not been active for some time.

**Photograph 4** – Partially active outlier badger sett, approx 60m north of bridge (inactive during later visits).

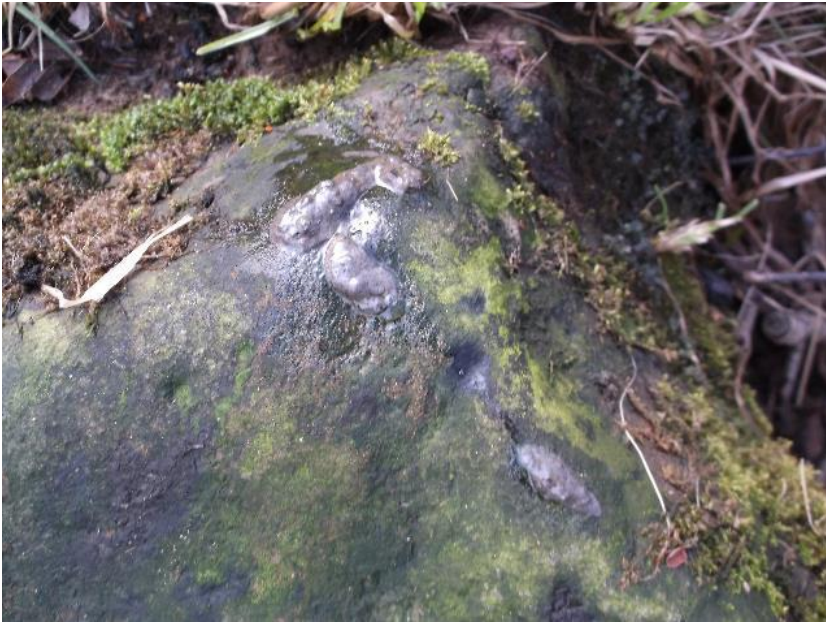
Otter footprints and spraints were found beneath the bridge as well as upstream on rocks, however no holts, or other signs of Otter presence was observed. Burrows of the right size and shape were not found, nor were latrines or feeding remains which would suggest Water Vole presence. In regard to Otters, given their highly mobile nature, a precautionary approach to the works is recommended and vegetation immediately within the area of work should be checked and cleared before works commence.

**Photograph 5** – Otter spraint on rock on western bank of Tasset Burn.

Given the highly mobile nature of otters, it is recommended that the vegetation around the immediate area of work be searched for any new signs or presence of otters and carefully cleared before commencement of the planned works.
