Swindon Kennels Bridge
Hepple

Ground Investigation Report

20031-01

Northumberland County Council

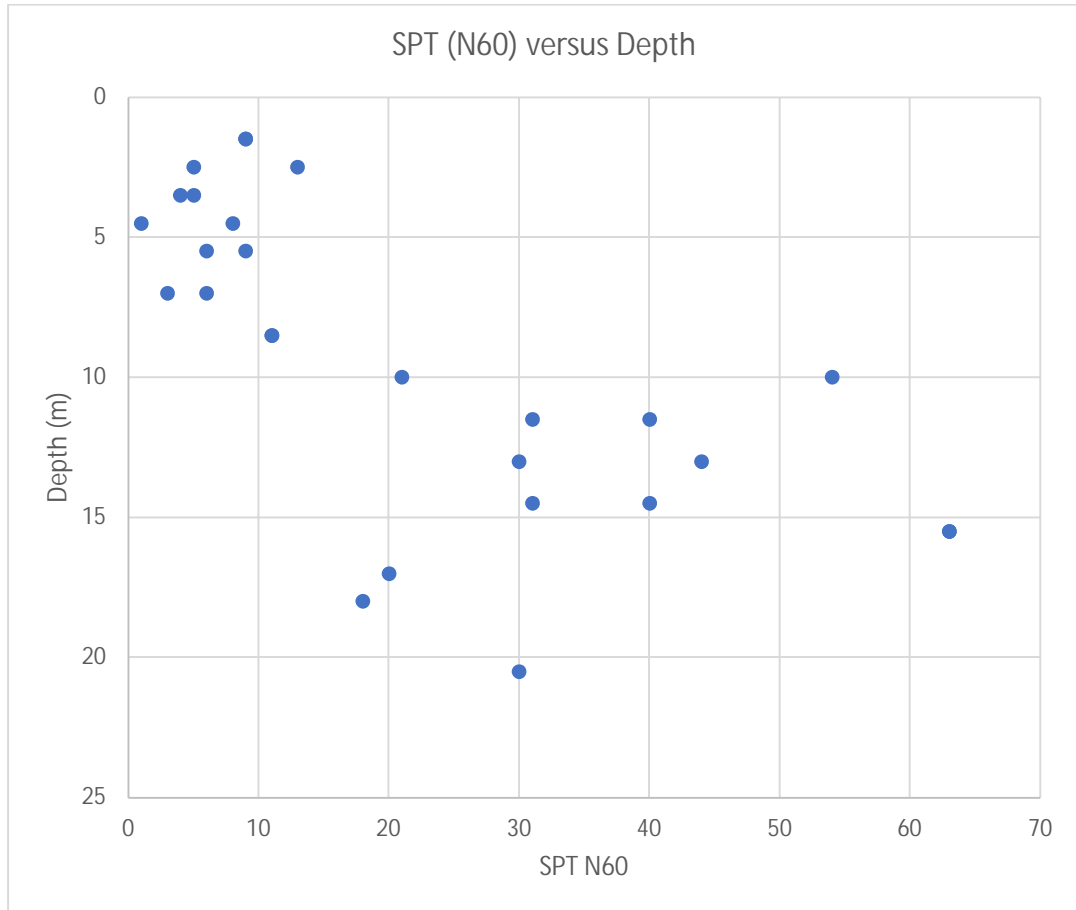
A graph of SPT N60 versus depth is provided below.

SPT N values were corrected to N60 values based on the energy ratio of the testing equipment, recording values in the range between 1 and 13 with an average of 7.

SPT N values were corrected to N60 values based on the energy ratio of the testing equipment, recording values in the range between 18 and 63 with an average of 37.
