From: Ann Deary Francis, MCIEEM, Ecologist
To: Siddiquir Rahman, Senior Assistant Engineer.
Date: 9th May 2024. Minor amendments 14/05/2024.

Repairs to Kennels Bridge, Grasslees, Hepple.
Updating Ecological Walkover.

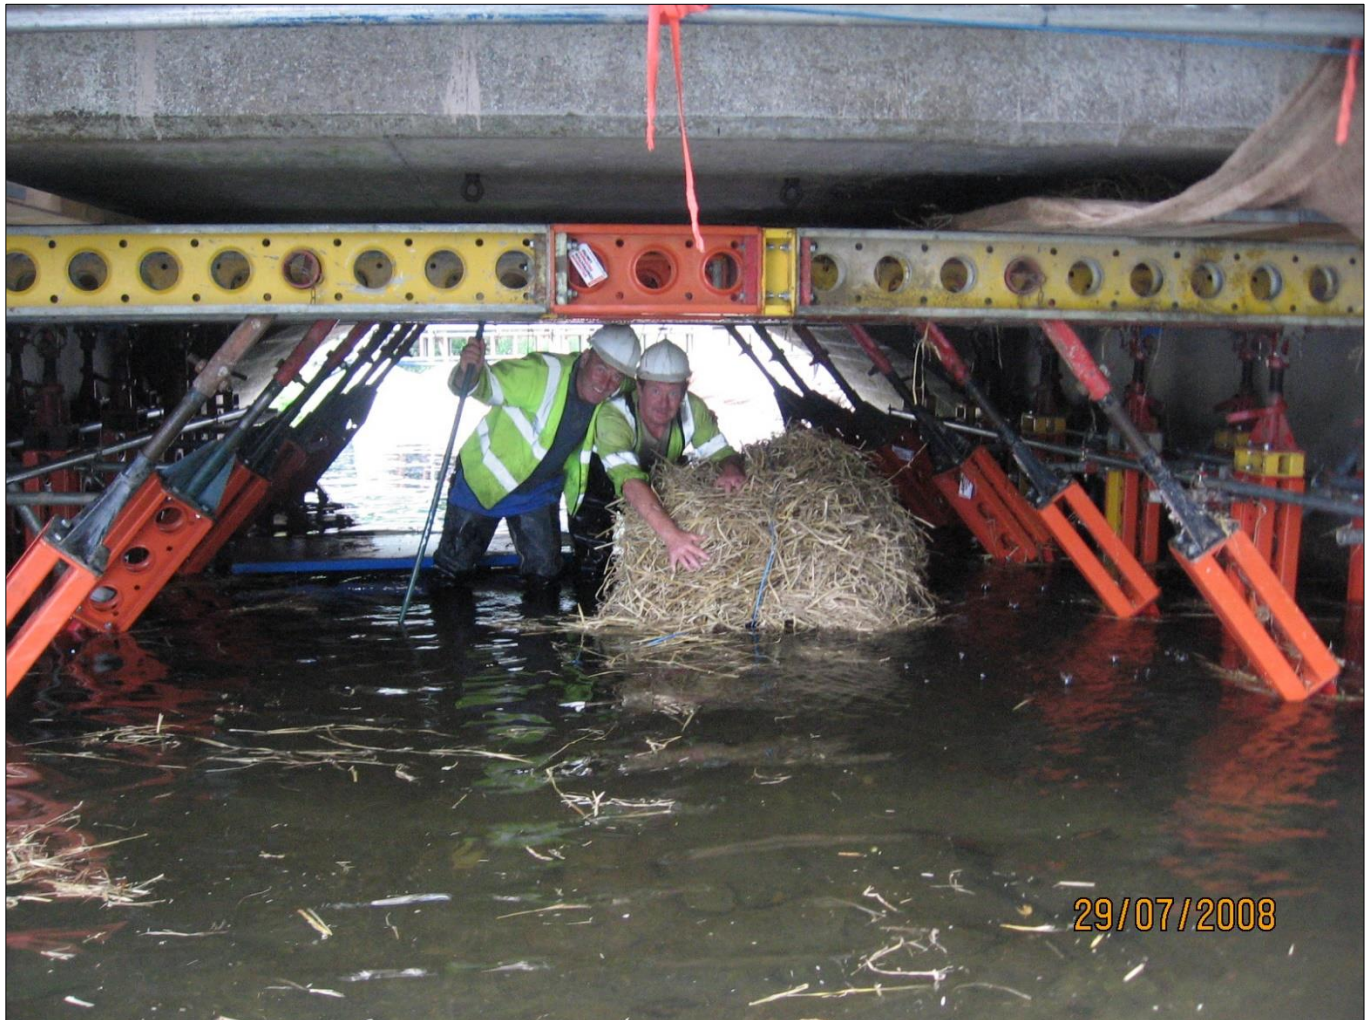
Figure 1. Example of crash deck

A crash deck will be installed below the bridge which will include temporary access into the watercourse. This is pre-assembled to minimise the amount of disturbance to the watercourse during installation. Some disturbance of large stones under the bridge is required to install the crash deck. The crash deck will be covered with a membrane to collect any debris from the break-out and construction. An example of a similar structure is shown in Figure 1.

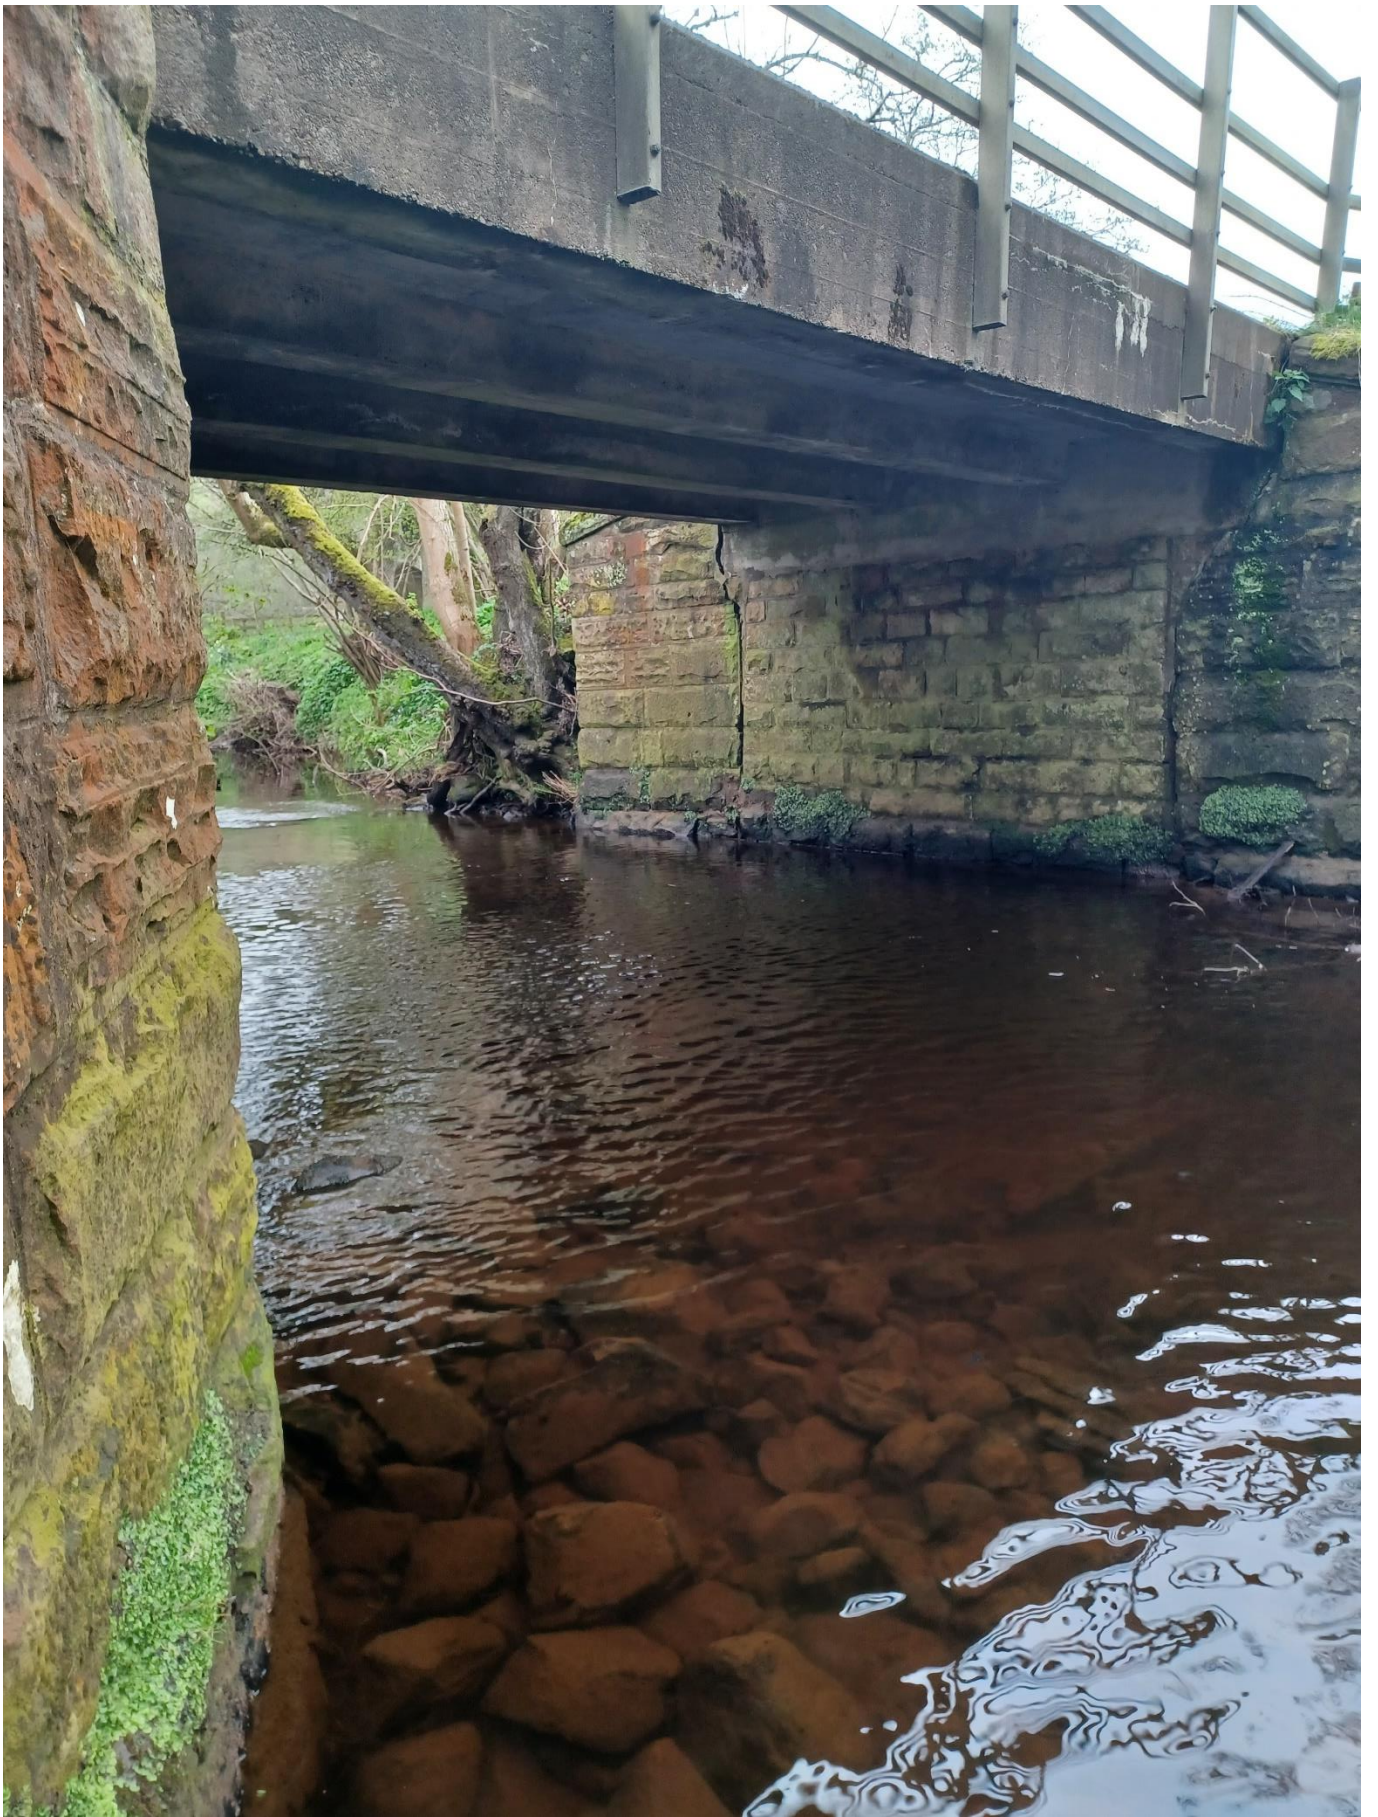
No evidence of white clawed crayfish was noted in 2019, 2022 or 2024. The water in 2024 was notably coloured by peat run-off.

Figure 8. Underside of bridge showing coloured water and stoney substrate.

There is no suitable spawning substrate in the vicinity of the works with the stream bed being characterised by large stones.

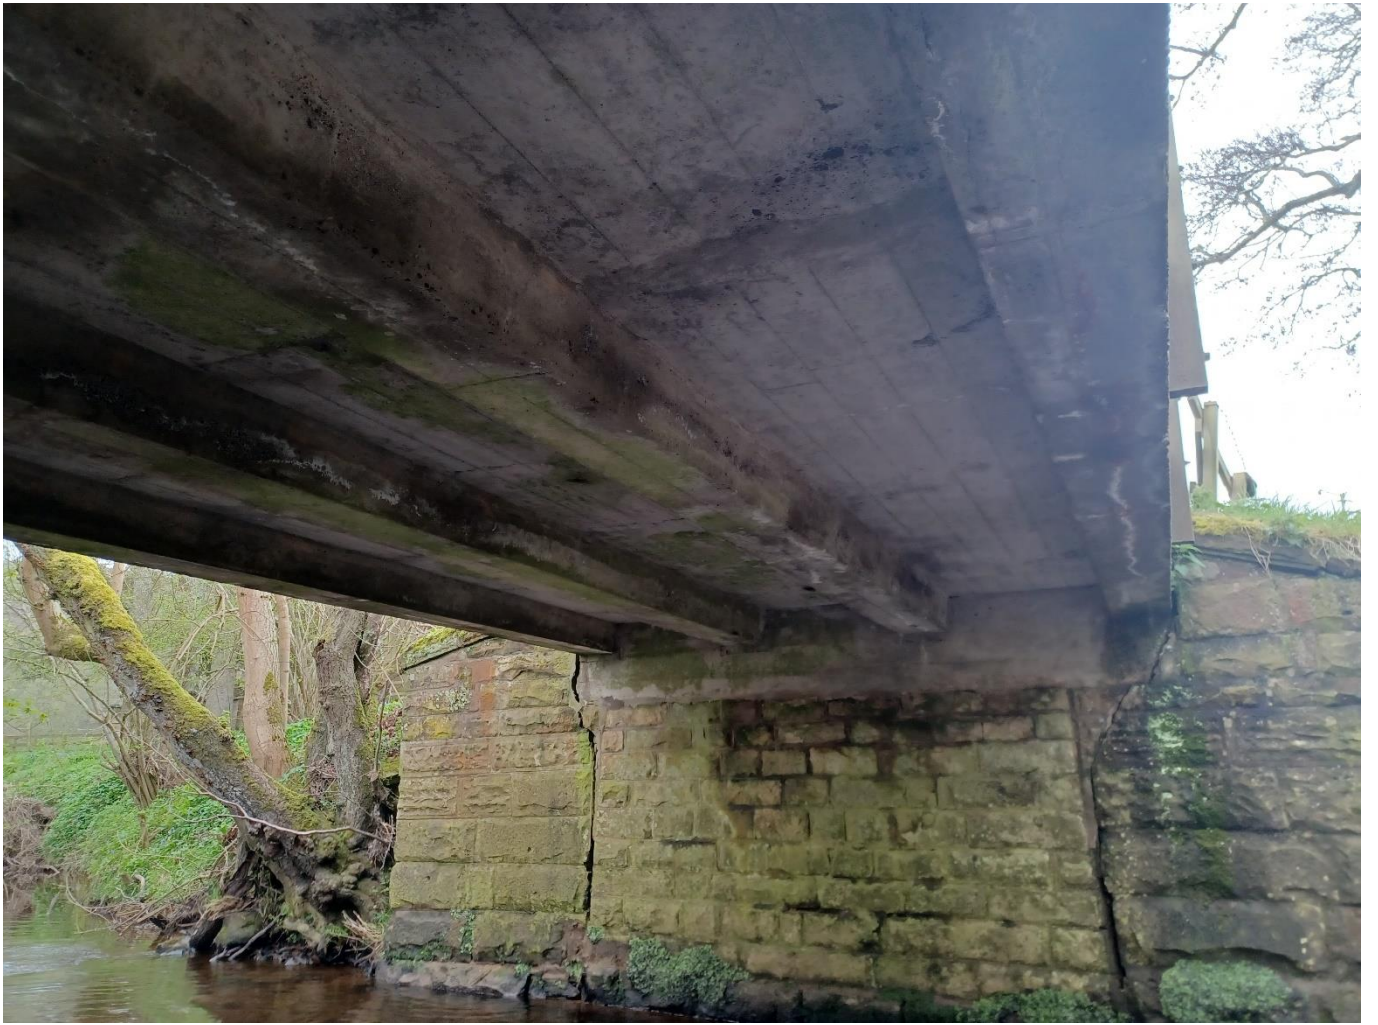
The updating walkover survey took place within the bird nesting period but no evidence of nesting birds was noted. Dipper are common in the Coquet catchment but the underside of the deck of the bridge lacks suitable ledges for nesting.

Figure 9. underside of bridge deck

1. An Ecological Clerk of Works (ECOW) will be appointed to carry out pre-start checks and deliver a toolbox talk to operatives working on site.
2. The ECOW will supervise the periods of in-river working when silt prevention measures and the crash deck are installed and removed.
3. Fish passage will be maintained at all times.
4. The ECOW will supervise construction compound set up including placement of track mats on verges.
5. The ECOW will check masonry with endoscope prior to any works.
6. Pollution controls including membrane over crash deck, straw bale and hessian silt traps, fuelling areas and training in the use of spill kits.
7. A dipper nest box will be affixed to the underside of the deck after completion.

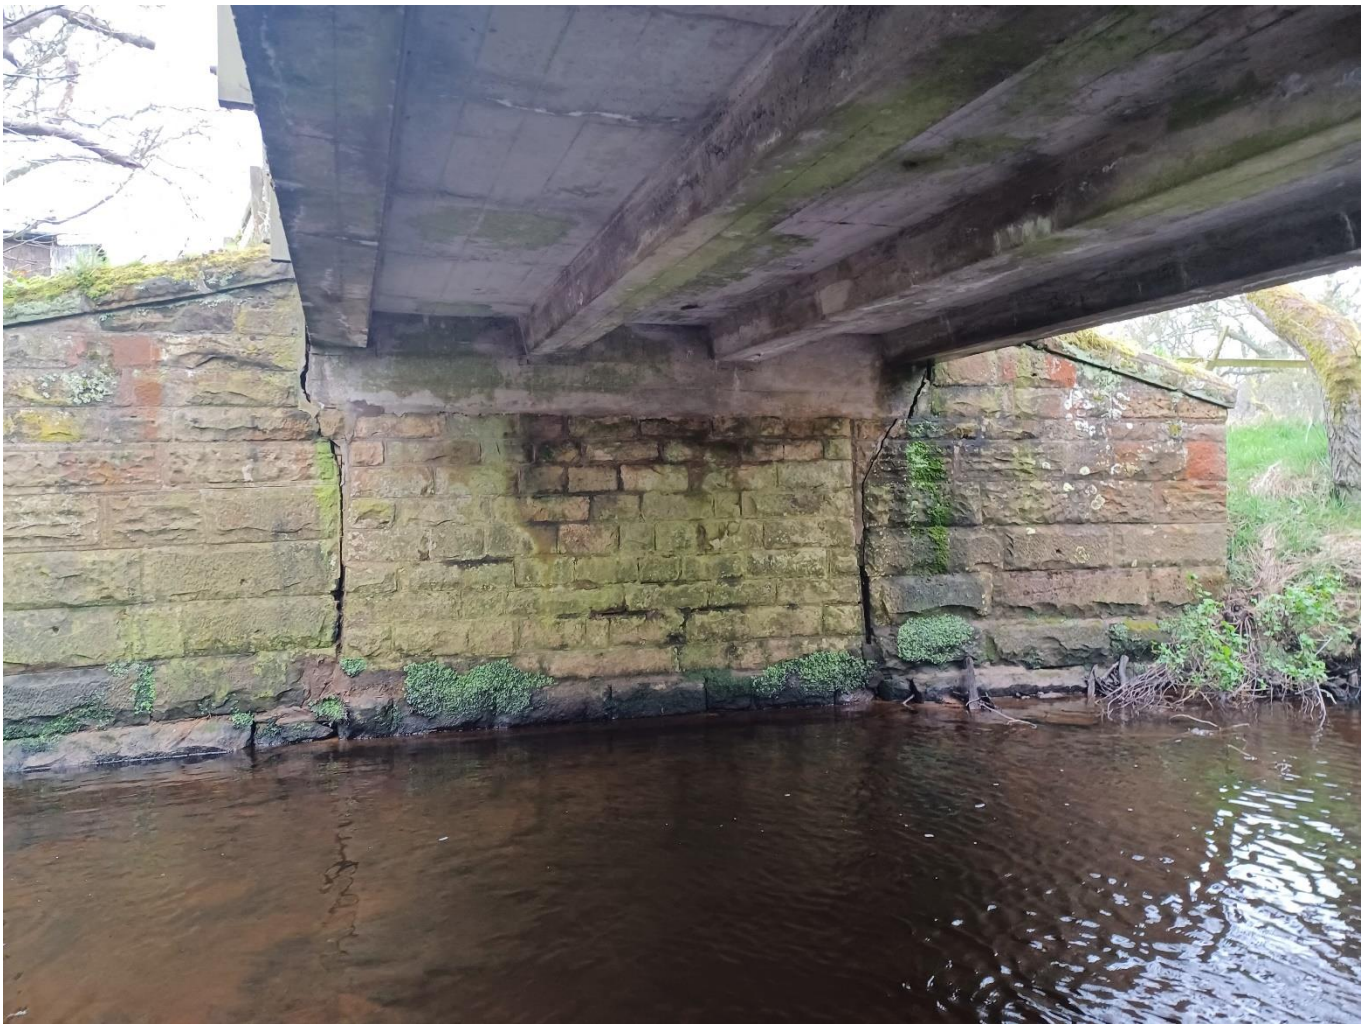
Torch inspection of the cracks in the wingwalls and masonry abutments are large and draughty and are not considered likely to support roosting bats.

Figure 10. cracks in existing abutments and wingwalls (these will only be minimally impacted and gaps will be left in the masonry)

Minimal impact on the existing abutments is planned but where there are temporary impacts the masonry will be removed, stored and replaced in *situ*. There is no requirement to completely repair gaps and crevices in the existing masonry.

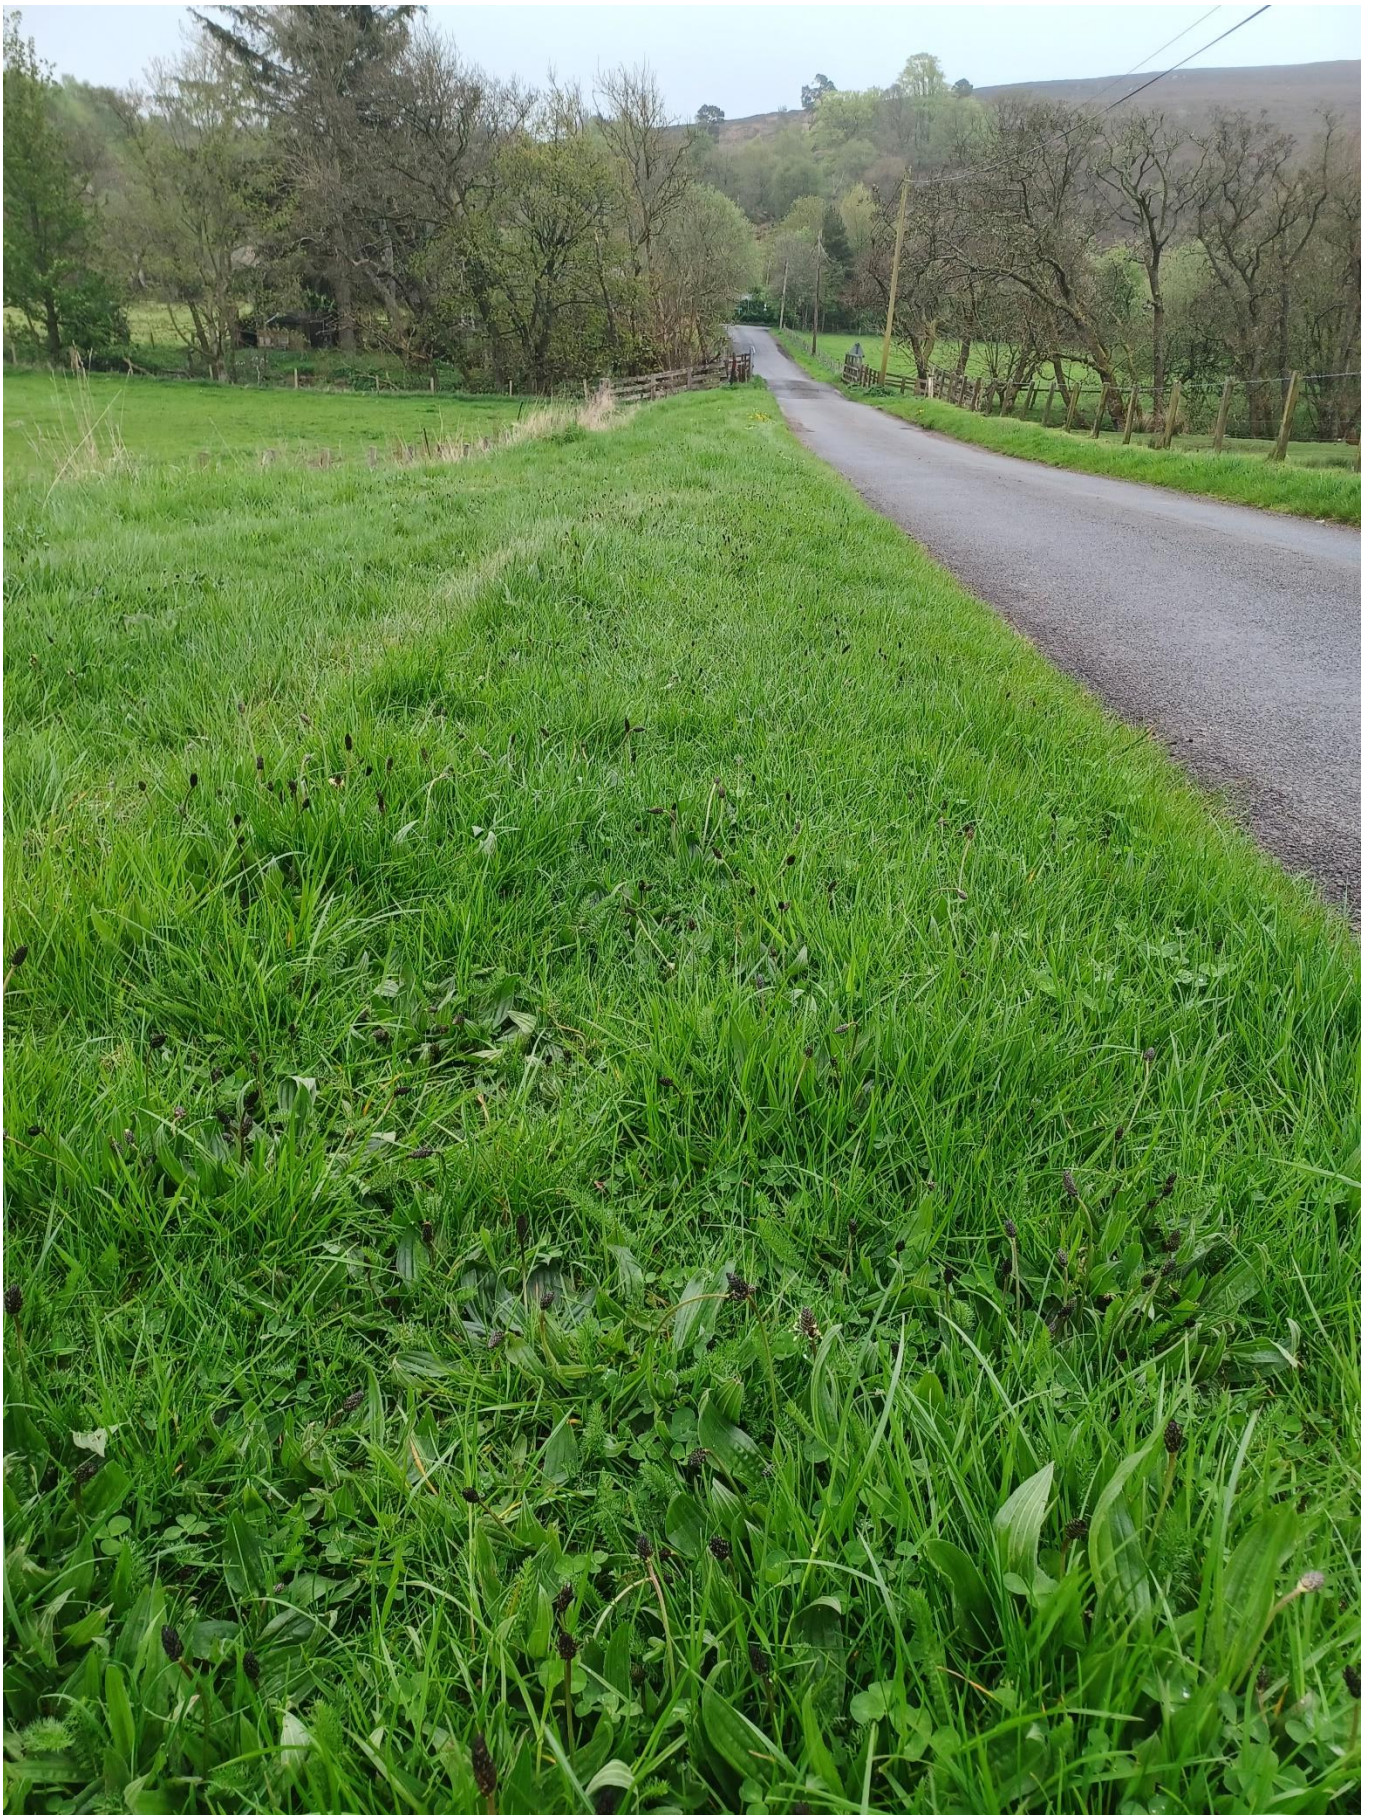
The highway verge is closely mown and is characteristic of other neutral grassland (UK Hab g3c), dominated by perennial ryegrass, with frequent ribwort plantain, white clover and dandelion species, occasional yarrow and rarely occurring field wood rush. Good quality semi-improved grassland is mapped in grazing fields to the east and west of the road.

Figure 12 verge along highway – other neutral grassland

As the works will take place in September and the verge will be mown (and cuttings removed) and protected by trackmats no impact on grassland habitats is predicted. This will be monitored

closely and if restoration is required this will be by over-sowing of a local grassland mix from Coquetdale.
