## **BAT SURVEY REPORT**

**Beeswing Lodge**

*July 2019*

Beeswing Lodge, Elsdon, Otterburn NE19 1AP

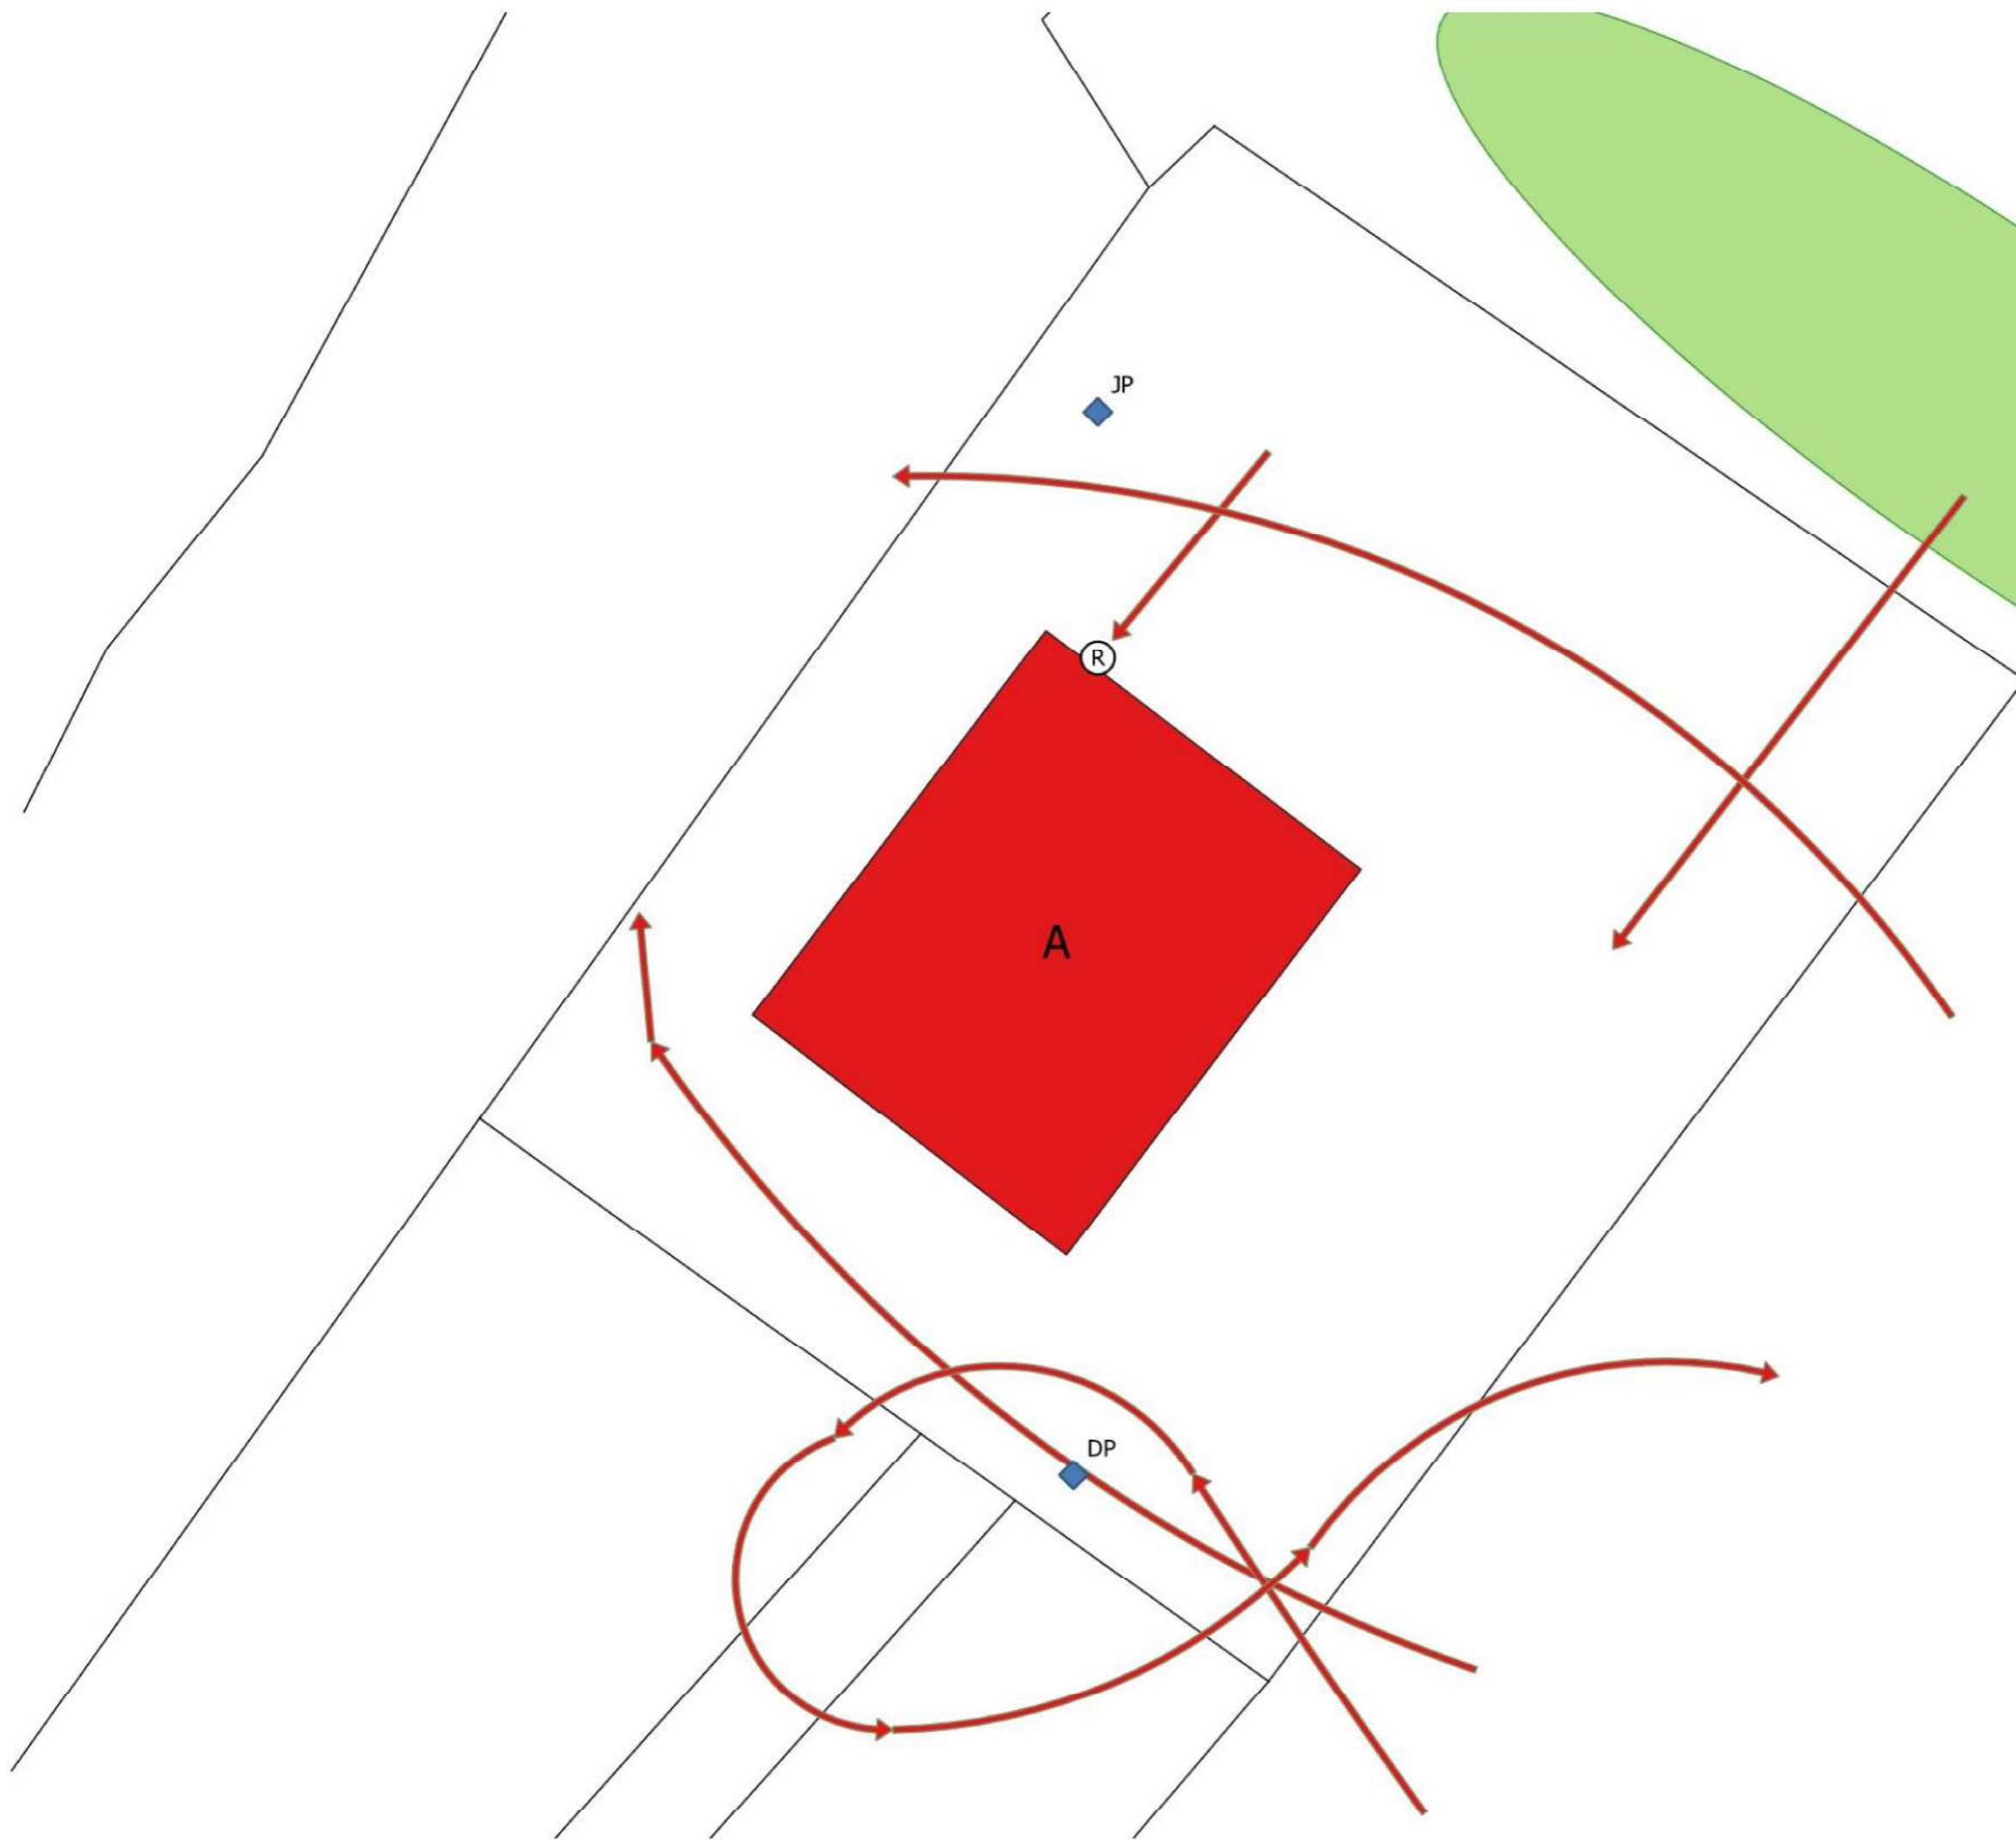
Activity was lower on this survey than the previous dusk survey, with just 22 bat passes but one roost was recorded. A single common pipistrelle was observed re-entering the northern elevation of the building (Building Reference A, Figure 3, Appendix A) at 04:16, this was into a gap, of missing concrete, situated between the gable end stone work and the slate roof (Figure 5, Appendix A; Photograph 11, Appendix B).

5.2.1 The proposed works to renovate and extend the building do not impact the observed roost. This is true as long as the identified gap in the building is not re-pointed or affected in any way (Figure 5, Appendix A; Photograph 11, Appendix B).

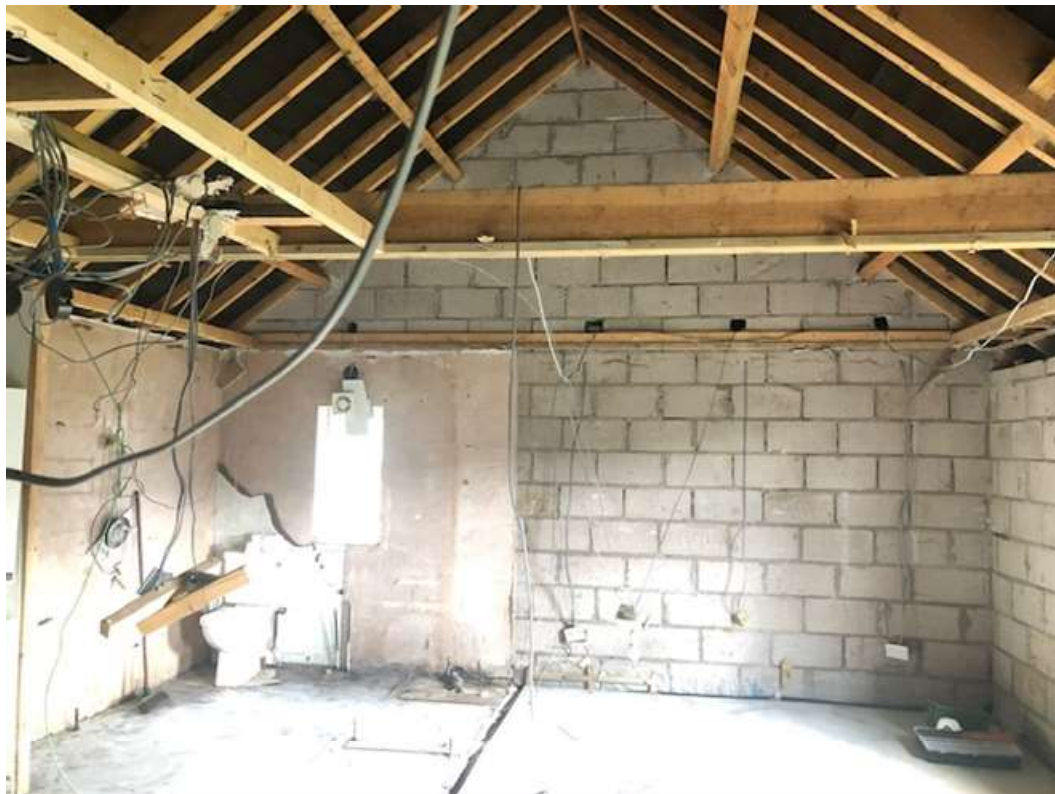
**Photograph 4** – Building reference A, interior south face of northern gable end.

Building Code (Figure 3, Appendix A)	Building construction details	Structural features present						Other structural features of note	Potential bat access and roosting points (Photographs 4-10, Appendix B).	Internal features (Photographs 4 and 5, Appendix B)	Evidence (Photographs 4-6, Appendix B)
		Gables	Barge boards	Soffit Boards	Fascia Boards	Flashing	Roof void				
<b>A</b>  <b>Photographs 1 – 3, Appendix B</b>	Single storey stone-built cottage with a pitched slate roof.  uPVC doors and window frames were present.	✓	X	X	X	X	✓	None noted.	Some gaps between the ridge tiles and slates (Photographs 9 and 10).  Some minor gaps between slightly raised roof slates (Photographs 9 and 10).  Some access to wall tops (Photograph 6).	Part-way through renovation, no ceilings throughout (Photographs 4 and 5).  Single load-bearing wall with slope following roof (Photograph 5).  Previous loft void not present at time of risk assessment (Photographs 4 and 5).	Multiple bat droppings found at top of internal northern gable end wall (Photograph 4).  Multiple bat dropping found at top of interior dividing wall (Photograph 5).  Few droppings found on exterior below guttering (Photograph 6).

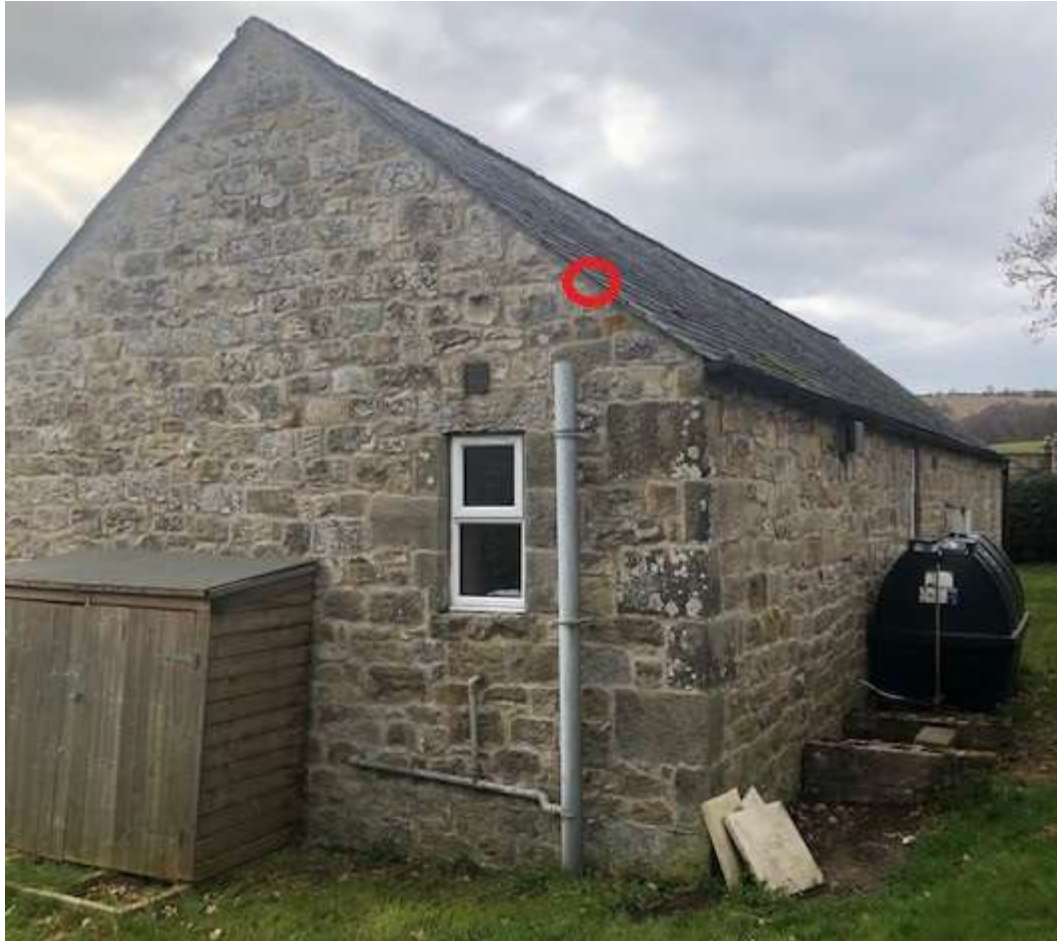
**Photograph 11** – Building reference A, northern gable end with bat re-entry location circled.

- 6.1.3 A single common pipistrelle roost was identified across the three nocturnal surveys, with a bat observed entering a gap in the northern elevation gable end on survey 3 (Figures 5, Appendix A). (Photograph 11, Appendix B).

- 1.0.8 No re-pointing works will take place on the gable end where the roost is located. If re-pointing works are required any other aspects then existing crevices will be maintained by inserting a roofing lath into the crevice and then mortaring around it, the lath can then be withdrawn leaving an access point. If the lath is angled downwards this will prevent water ingress.
