FARM BUILDINGS AT LANGLEEFORD, Northumberland

An Historic Building Assessment

July 2018

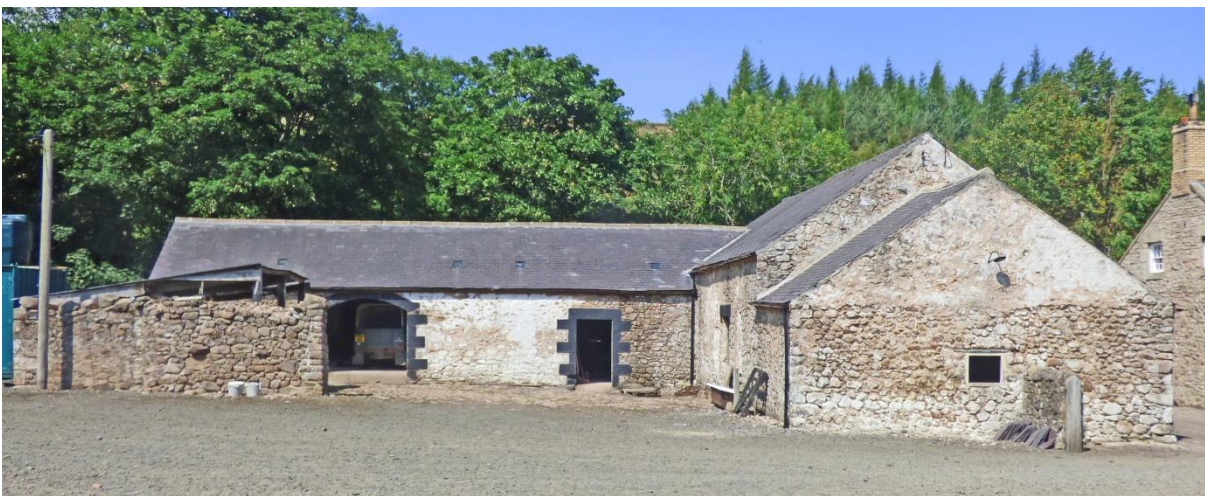
The Buildings from the South

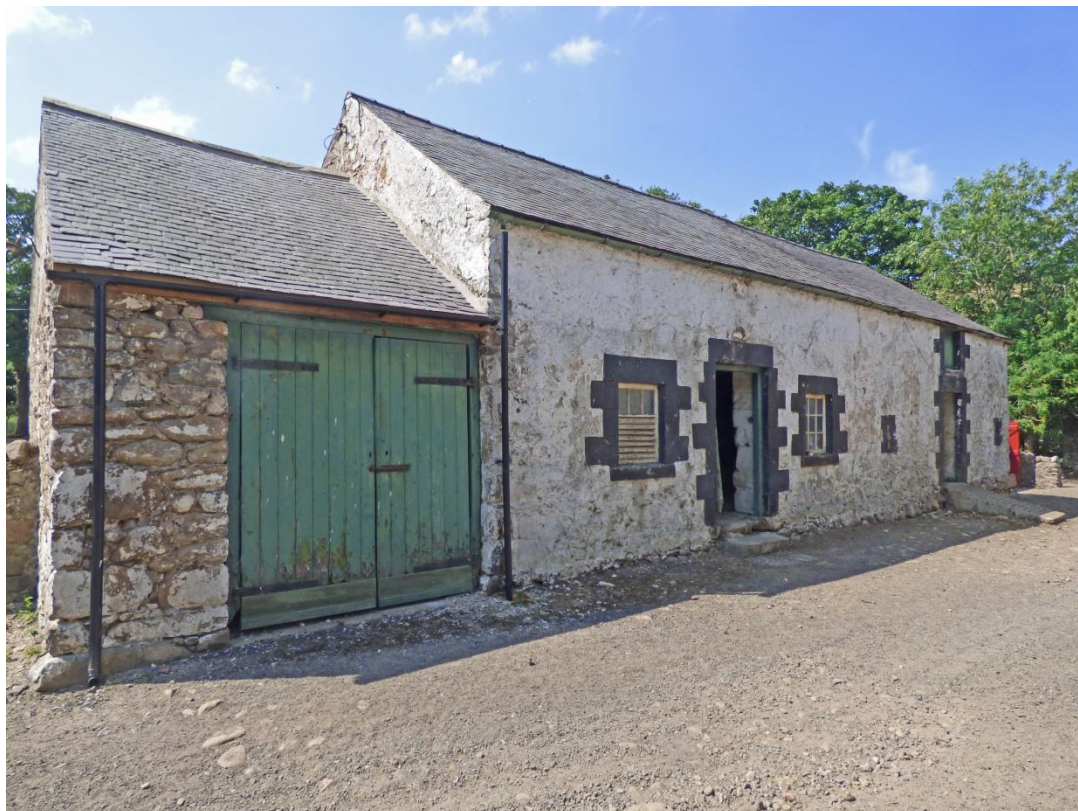
The Main Range from the south-east.

On the front (east) elevation the stable has a central doorway flanked by two square windows, the southern part-slatted and the northern a 9-pane fixed casement, all in alternating-block surrounds. The byre/granary to the north has a central boarded stable door, above a concrete ramp (the ground falls away to the north, and there is an exposed boulder plinth towards this end of the range). At either end of the byre is a blocked slit vent, with the render painted to simulate a cut-stone surround. Directly above the byre door is an almost square pitching door into the granary, again with an alternating-block surround and a timber lintel at the level of the eaves.

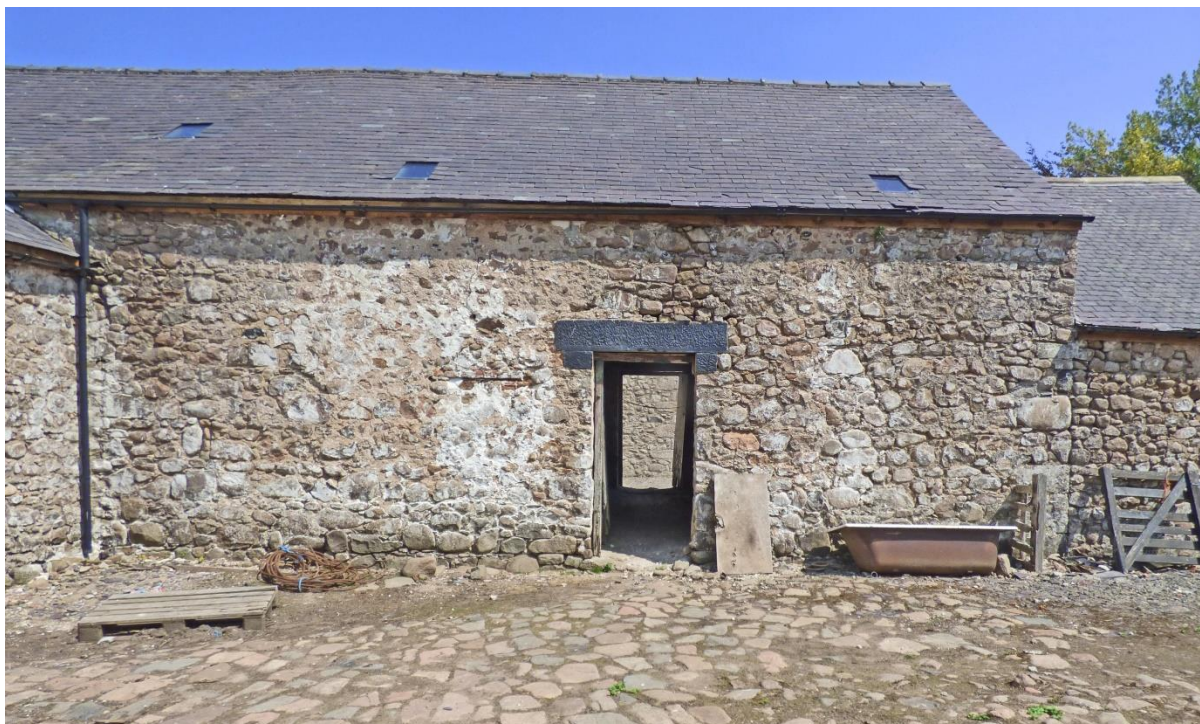
The Main Range (south part) from the west

On the west, towards the yard, the major part of the byre/granary is covered by the Cartshed Range within which there is a doorway (in line with the entrance on the east) with a rebated alternating-block surround (in red sandstone, unpainted) which was presumably originally external; there is a small wall locker adjacent to its south jamb, To the north is a blocked slit vent and there is another slit vent to the south, now just outside the wall of the Cartshed Range, opposite their counterparts in the east wall. The central passage of the Stable has a doorway, probably an insertion, which has a single cut block at the head of each jamb and a cut lintel; a little to the north of it is a thin horizontal timber in the wall 1.8 m above the ground, with a little brickwork both above and below it; it might be the lintel of a small blocked opening, but heavy mortaring in this area makes this unclear. Just above the lintel of the doorway, around a metre below the eaves, is a level course that may mark an earlier wallhead.

The south end of the range, above the Shed roof, shows evidence of an earlier steeper gable (probably for a heather-thatched roof), which probably relates to the apparent wall head visible on the west wall.

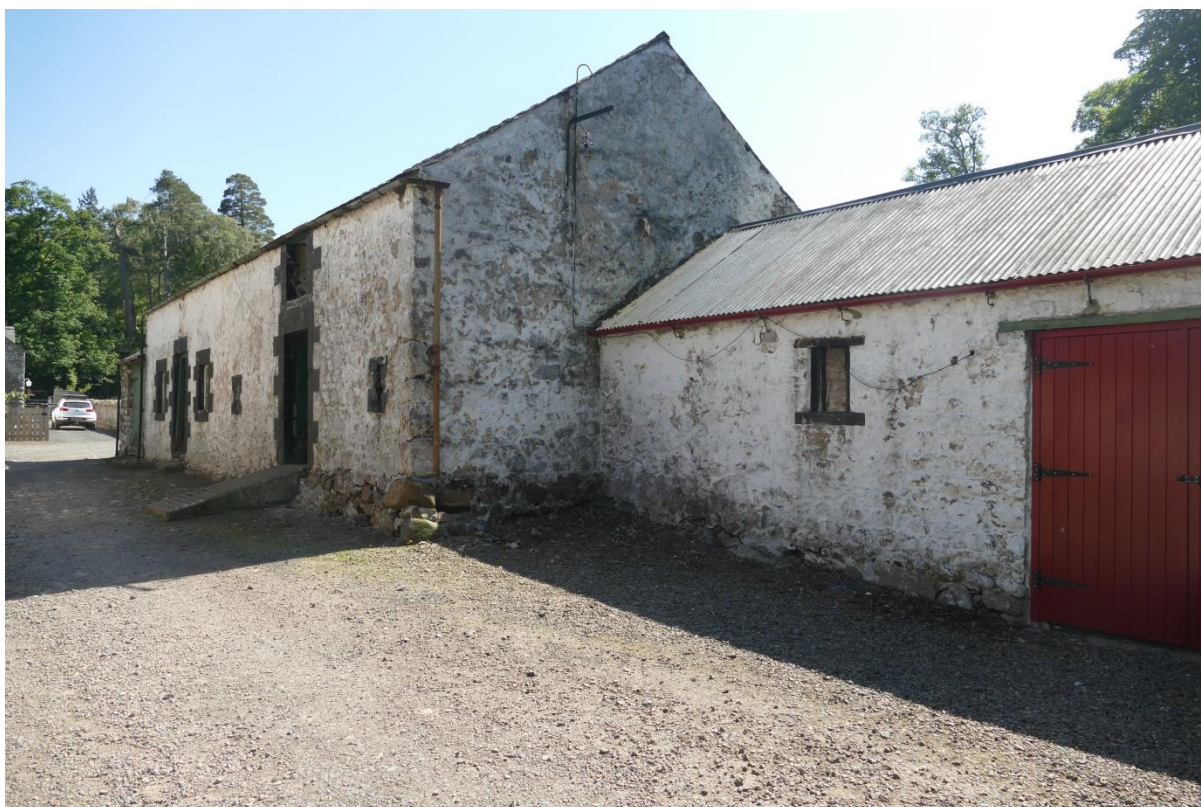
Set back at the north end of the Main Range is the lower Store and Generator House building, built of rubble (whitewashed) with a modern corrugated metal roof. On the east it has a single window with a timber lintel and cut stone sill, and at the north end of the wall a pair of modern boarded doors under a timber lintel, opening into the Generator House.

Main Range from north-east, with Store/ Generator House on right

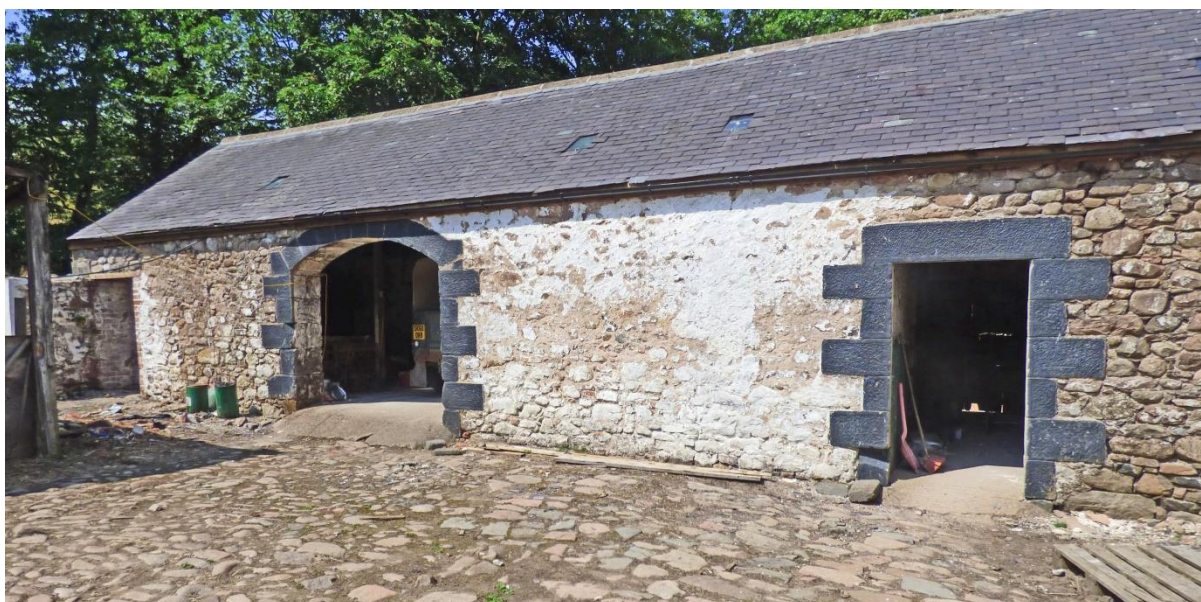
This fronts south onto a yard, and is built of rubble (lightly whitewashed in parts) with some painted sandstone tooled-and-margined dressings and a blue slate roof. The front elevation has an inserted doorway with a timber lintel at its west end, midway along a segment-arched cart entrance with a good alternating-block surround, and towards the east end a doorway with a rebated alternating-block surround.

The Cartshed Range from the south

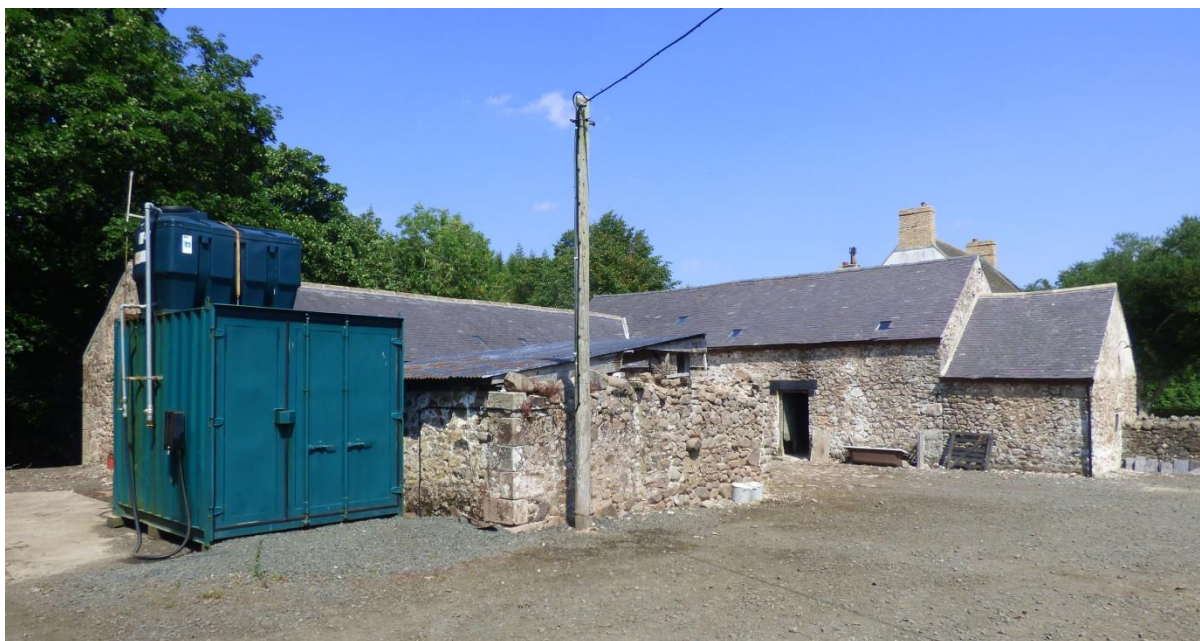
The west wall of the yard, c 1.8 m high, continues the line of the west end of the Cartshed Range to the south for just under 10 m (with a plain opening, now without any lintel, close to the range), then returns east for c 7 m. A modern lean-to open shed has been built inside it. There are alternating quoins (like those at the north-west corner of the Cartshed Range) at the south-west corner, but part of the south wall seems older, built of larger cobbles and slightly curved in plan. Late 19th and early 20th century maps show this as forming the rear wall of a kennel block, now demolished. To the east this wall lines up with the south end of the Main Block, but any continuation has been completely removed.

The group from the south-west – Southern Yard Wall, incorporating remnant of former kennels, in centre

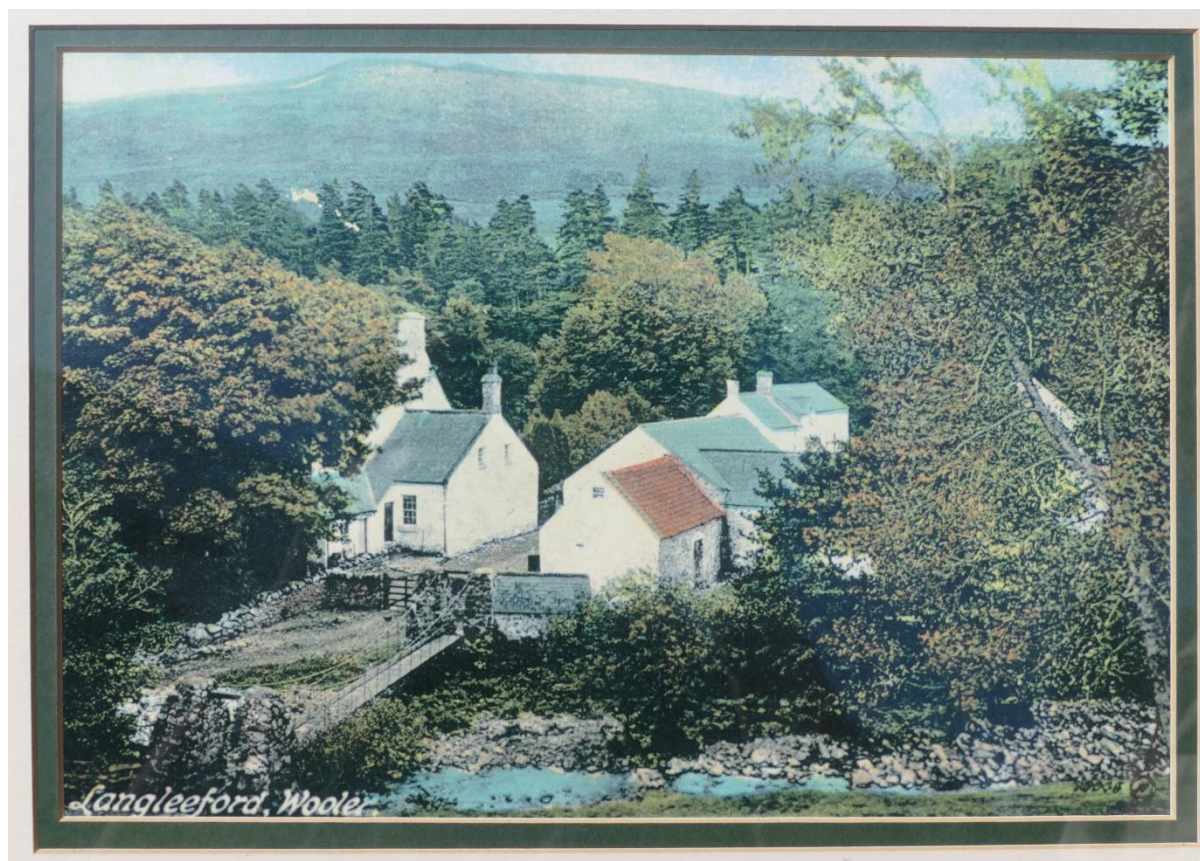
Old postcard, late 19th or early 20th century, showing the Store/Generator House range before its latest re-roofing, and the former footbridge.

In the 19th century the Main Range was remodelled, its side walls being raised and roof pitch reduced, so that it was covered by slates (as at present) or perhaps pantiles. The openings on the east (and Byre doorway on the west) were re-formed and given tooled-and-margined sandstone dressings. Possibly at the same time the block to the north (Store/Generator House) was heightened and given a pantile roof, as shown by a late 19th or early 20th century postcard.
