Byre at Carrawbrough Farm

An Historic Building Assessment

September 2018

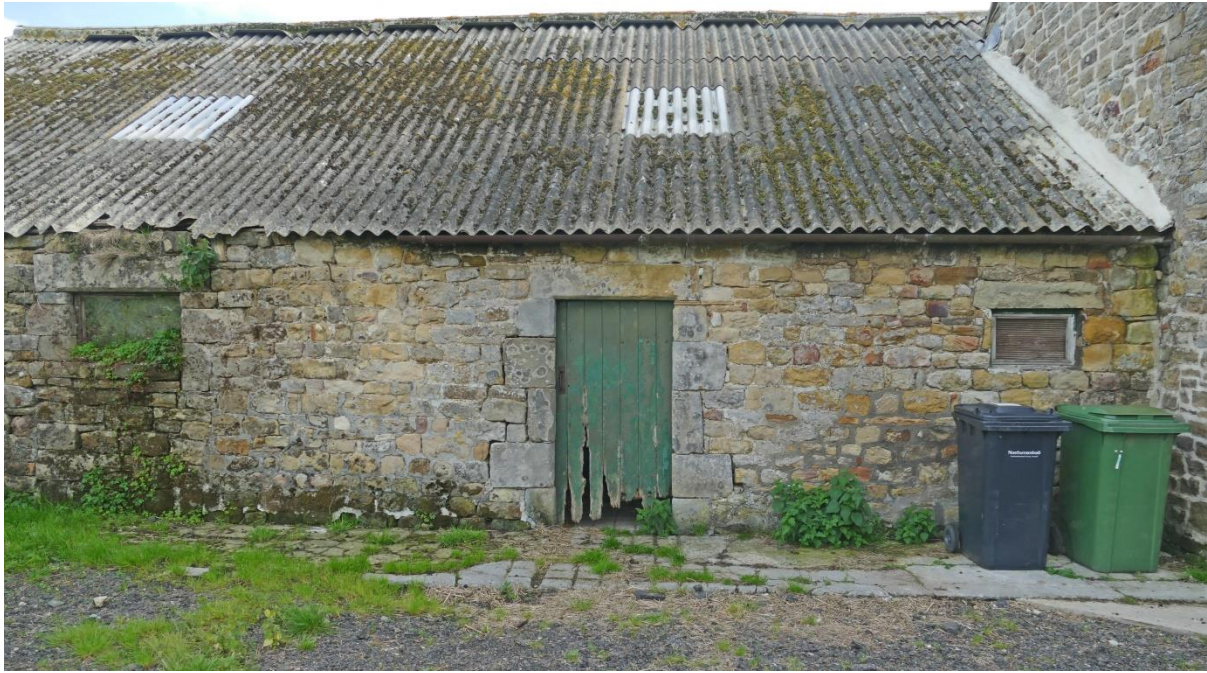
North Elevation

The building measures c 12 x 8.2 m internally, with walls c 0.60 m thick and a modern roof of corrugated asbestos. The north elevation, towards the road, is of coursed roughly-squared stones, many almost square blocks indicating that, hardly surprisingly in this location, they are re-used Roman material. There is a

doorway set right-of-centre with a chamfered alternating block surround. Further east has been another doorway, without cut dressings, now blocked and with a rather narrower window (with a cut lintel) inserted; there is a similar but smaller window towards the west end of the wall. The east end is partly of coursed roughly-squared stone like the north side, but has an area of rubblier and more yellow fabric in its northern part; the top of the gable is ragged, as if it has been cut down, or a coping has been removed. There is a doorway set a little left-of-centre, with a timber lintel on the external face of the wall but a chamfered alternating-block surround on the internal (west) face, indicating either that it has been re-set or that there was an additional contemporary structure at this end of the range¹. The internal jambs of the doorway have a shallow bar socket on the south and what looks like a drop-bar socket on the north. Above and set central to the gable is a pitching door with a stop-chamfered surround of ashlar blocks, with each jamb consisting of two horizontal blocks with a single upright between them. Structural movement has resulted in a major crack close to the south-east corner.

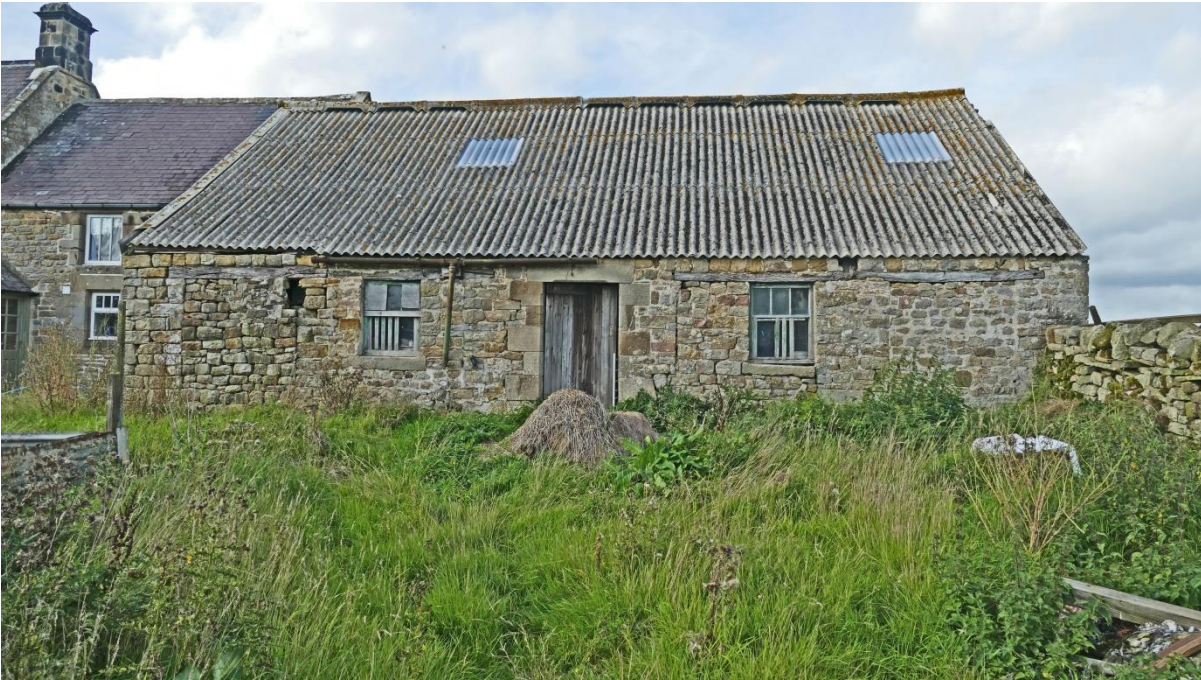
South Elevation

The south elevation is the most complex. The fabric is again of roughly-coursed stone, although with more elongate blocks than on the north and east. There is a central boarded door in a stop-chamfered alternating-block surround of pecked-and-margined grey ashlar. On either side of it have been a pair of cart entrances, all under timber lintels. Those closest to the ends are completely infilled with roughly-squared and roughly-coursed stone, whilst the inner two have blockings with part-slatted windows, their heads formed by the timber lintels of the older cart entrances, and with cut stone sills.

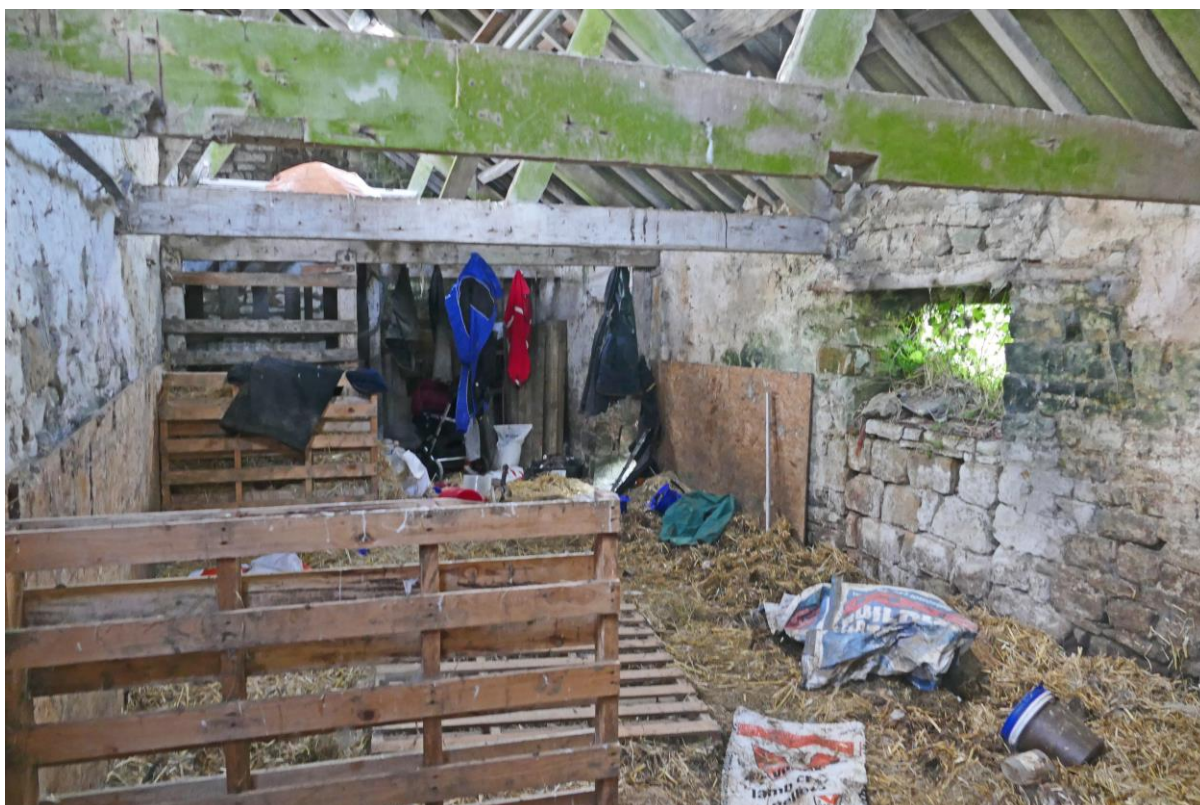
North Part of Byre looking West

In the west wall of the northern compartment of the building are a vertical pair of blocked openings; this was originally the external face of the east wall of the down house. Above the top of the axial wall is a large shaped block which appears to be the kneeler of the south-west corner of the downhouse, prior to its later heightening. In the west wall of the southern compartment are remains of a small window (?) with splayed jambs, and towards the east end of the axial wall one jamb of a blocked opening is visible through the plaster and whitewash which obscure much of the internal fabric.

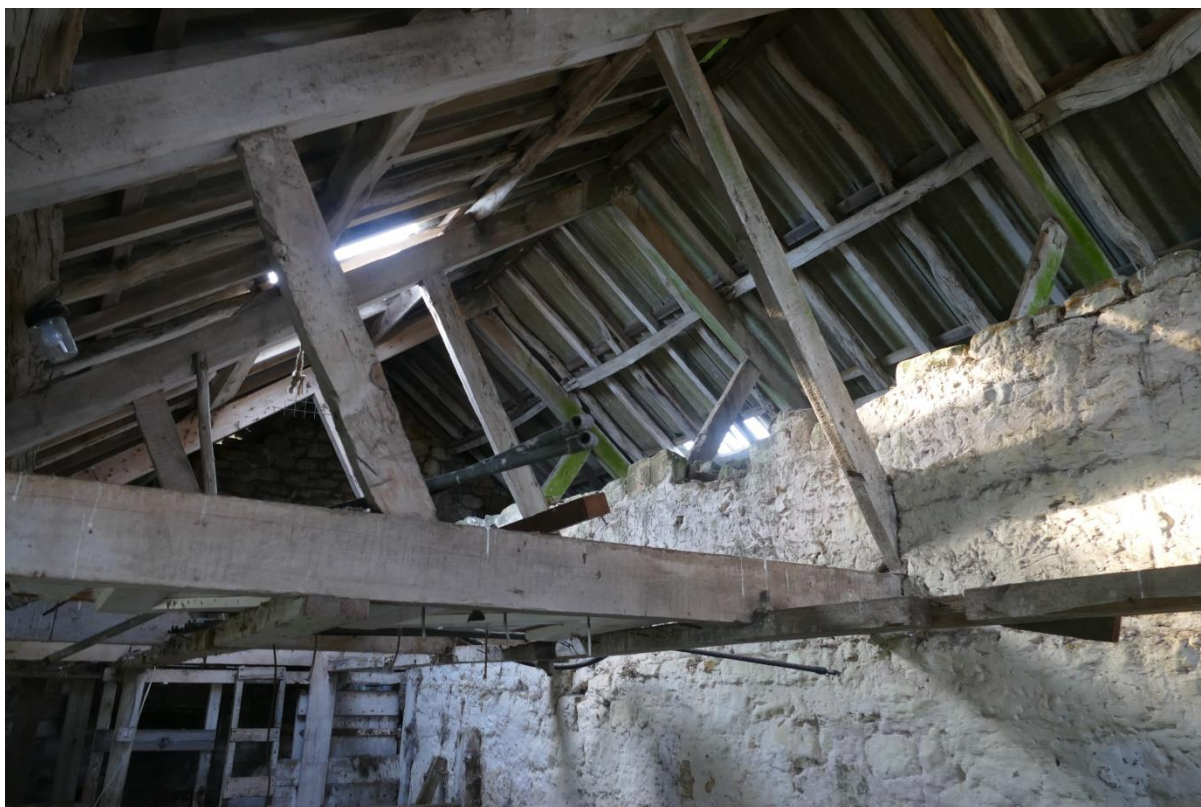
Roof Structure, looking North-West

The roof structure of the byre is of five bays, and perhaps of the early 19th century; the trusses are of sawn timber, morticed together without pegs or bolts, and each have two pairs of raking struts from tie-beam to principals, the springing of the central pair being concealed within the medial wall, which rises c 0.75 m above the ties. There are three levels of purlins – mostly (along with many of the rafters) older timbers re-used – and a diagonally-set ridge carried between the overlapped ends of the principals. Evidence of an earlier phase of the roof is seen in cut-outs in the upper face of the timber lintels of the original cart entrance in the south wall, which appear to indicate a previous generation of tie beams set a little to the east of their successors.

Then there is the matter of the original form of the roof of the building. The present trusses may be no older than the earlier 20th century. They must be later than the alterations when the southern cart entrances were blocked up, and the south and east gable pitching doors inserted, which probably took place in the later 19th century, to judge from the character of their stop-chamfered ashlar surrounds. The positioning of the pitching door shows that there were still lofts at this stage; the cuts in the upper faces of the lintels of the cart entrances on the south are probably for their floor beams. It is not clear when the axial wall was heightened, to divide the roof space and carry the ridge of the new broader roof. The present roof structure is clearly later than this – its diagonal struts would have impeded use of any lofts – and is probably contemporary with the removal of the loft floors. The pitch of the roof may have been reduced at this stage (the gable ends seem to have lost a coping) and the present roof material, is clearly quite recent, presumably replacing either Welsh slates or pantiles - or even heather thatch; the shape and positioning one or two elongate shaped blocks at the foot of the southern roof slope are reminiscent of coping to thatched buildings.

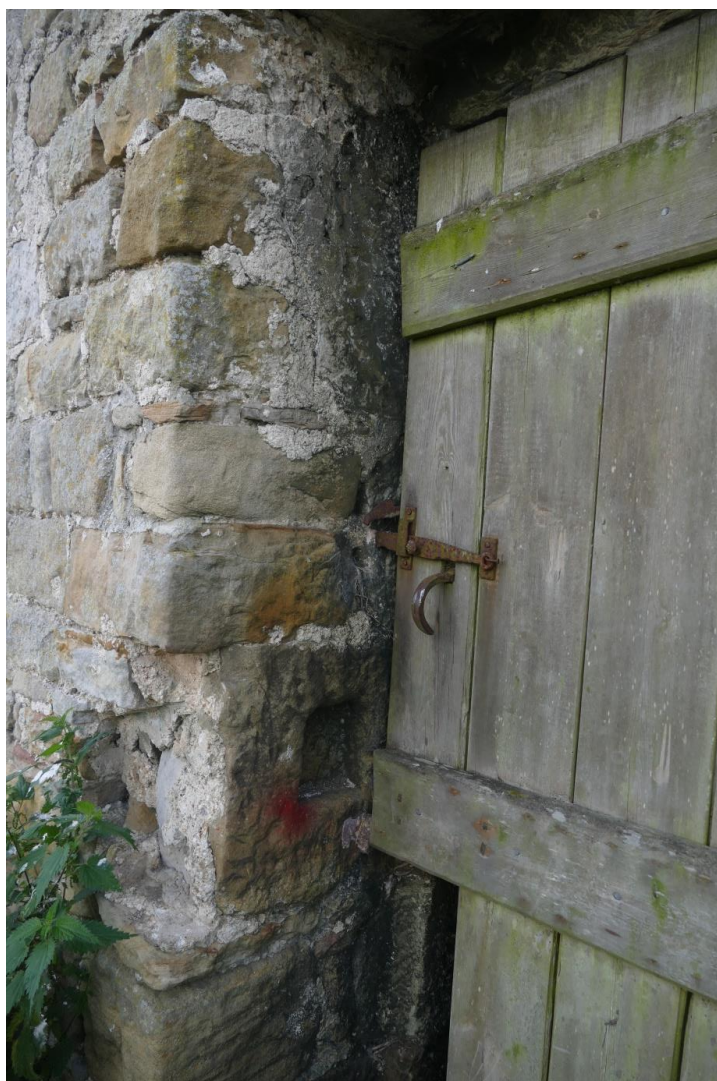
There are a number of enigmatic features. The ground-level doorway in the east wall looks of 18th-century character, but is both situated in the southern extension and set ‘the wrong way round’ as regards the present building. Is it re-set? Until recently it opened inside a Dutch Barn, which first appears on the 1895 OS 25”:1 mile map; the 1st edition OS 6”:1 mile map of 1866 shows no additional structure here.

Doorway in East Wall, Inner (south) jamb, now external, with socket for draw bar

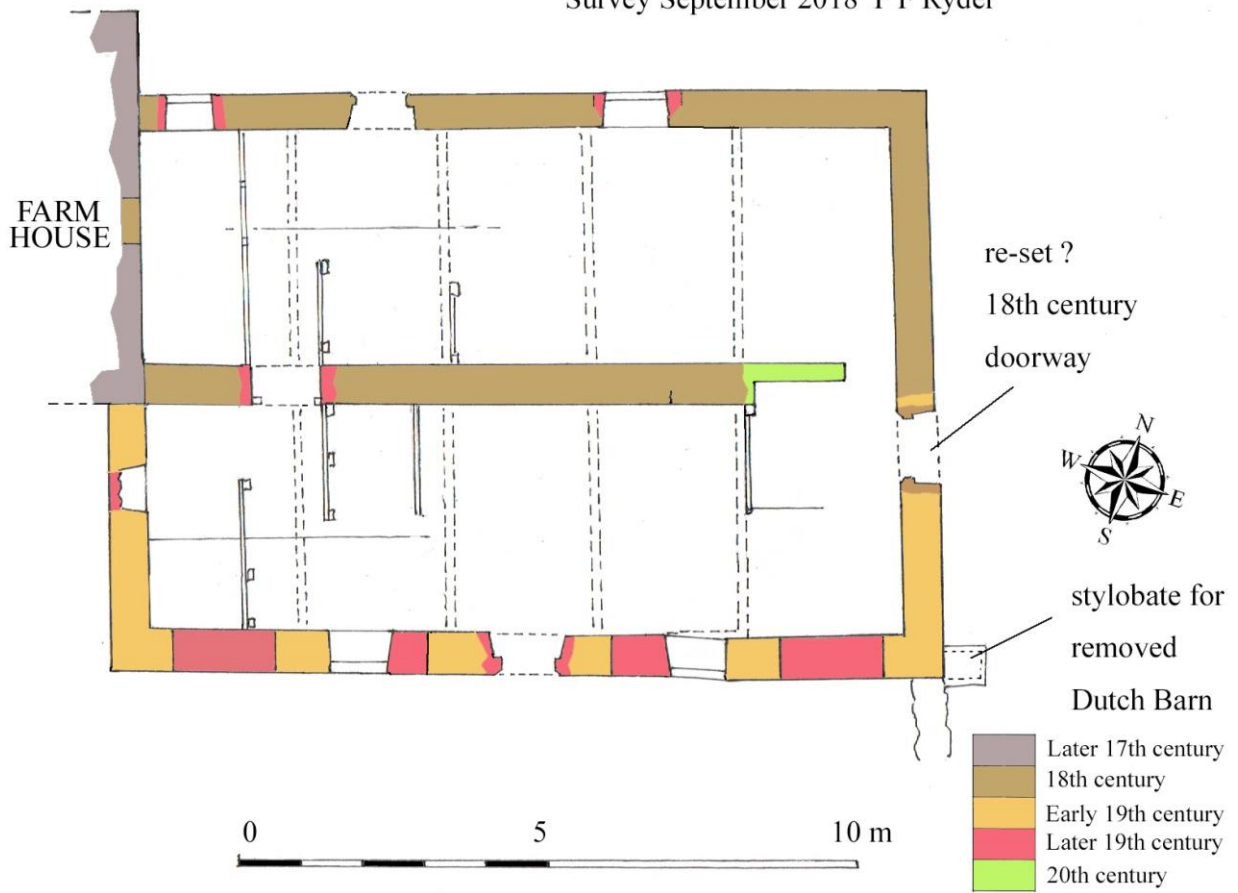
BYRE AT CARRAWBROUGH FARM

The interior of the building is divided into two equal east-west compartments by an axial wall, 0.60 m thick and rising to a level a metre or so above the side walls; this wall seems in fact to have been the south wall of the original building, which was later doubled in width. The wall has a small horizontal offset on its south face, at the level of the side-wall eaves.

There is a doorway near the west end of the axial wall, with a timber lintel but without cut dressings, and an opening 2.3 m wide at the east end, which has been partly closed by a thinner brick wall leaving a gap 0.8 m wide against the east wall. Ragged tothing on the end wall shows that the axial wall originally
