SEWING SHIELDS

NORTHUMBERLAND

FARM BUILDING ON THE EAST SIDE OF THE YARD

AN HISTORIC BUILDING ASSESSMENT

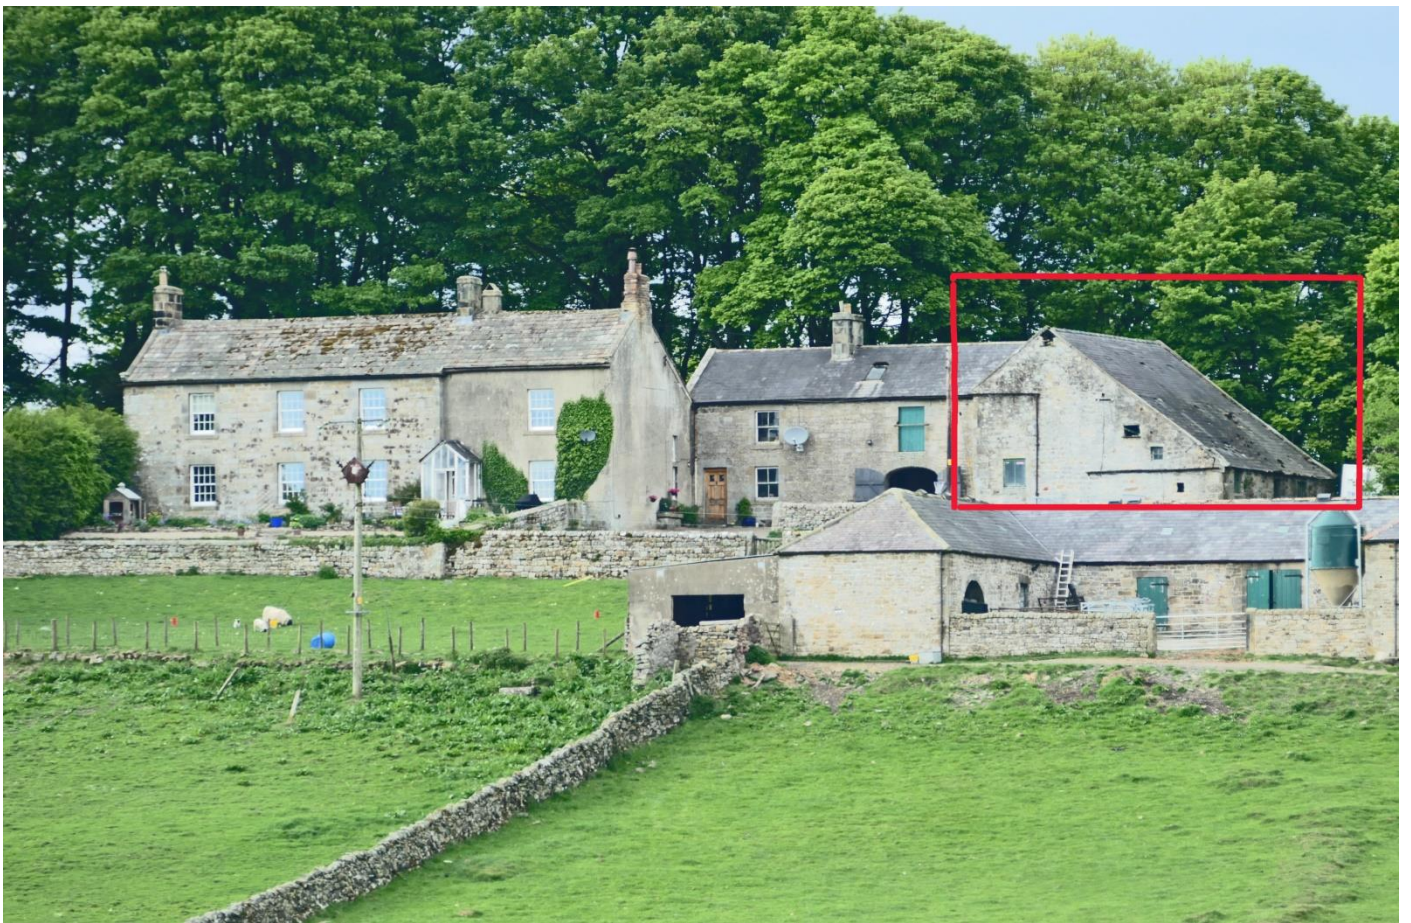
Distant South View, the building outlined in red.

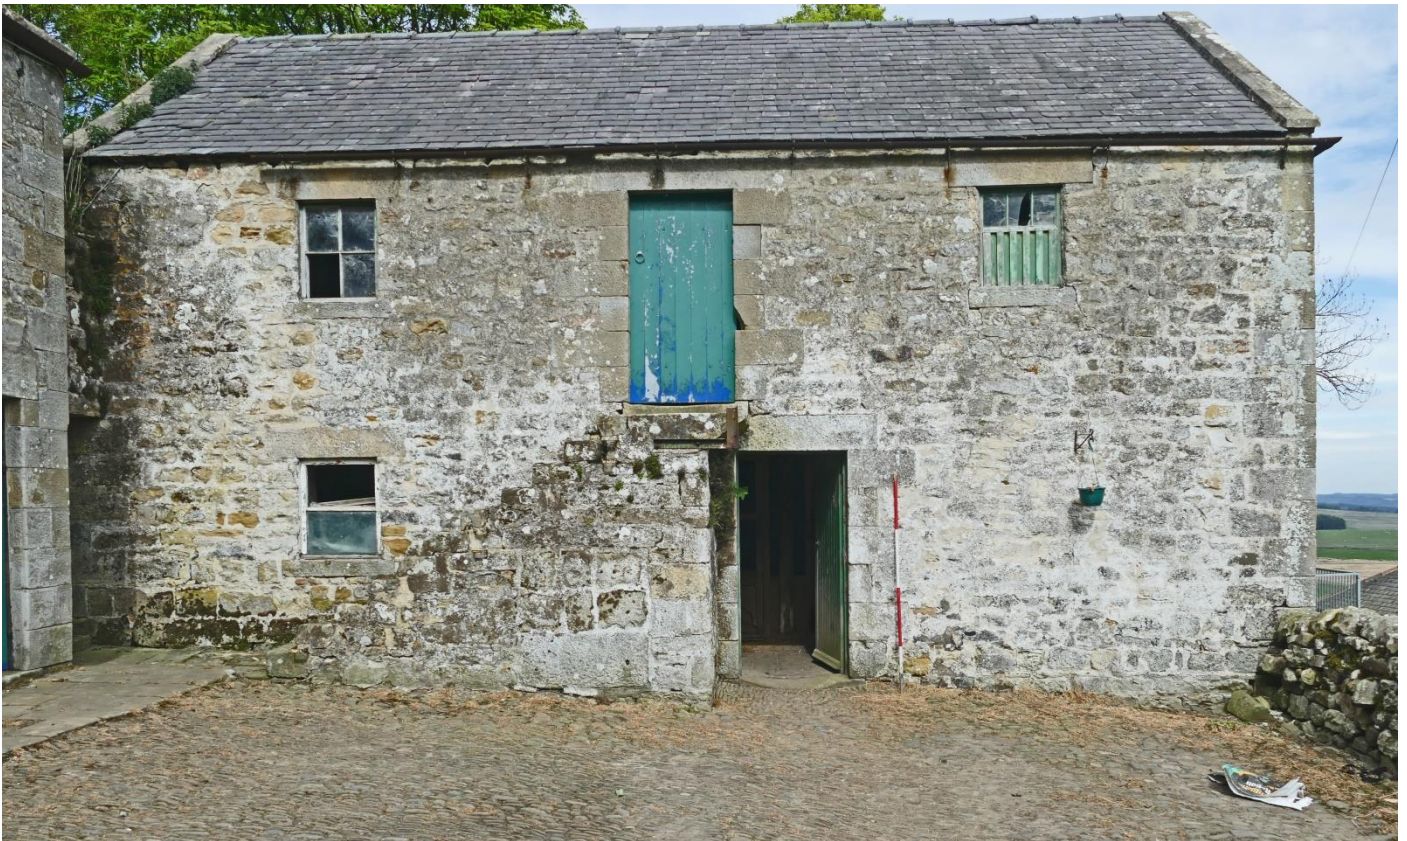
The west elevation, towards the yard (above) has a boarded door in an alternating-block surround, immediately to the south of an external stone stair, in the west face of which is a blocked opening hard to interpret. North of the stair is a window with a cut lintel and slightly-projecting sill; the stair rises to an upper doorway into the granary, similar to that below, with on either side a window, that on the south of traditional part-slatted form -the other windows all have relatively recent glazing. The gables have a cut stone coping.

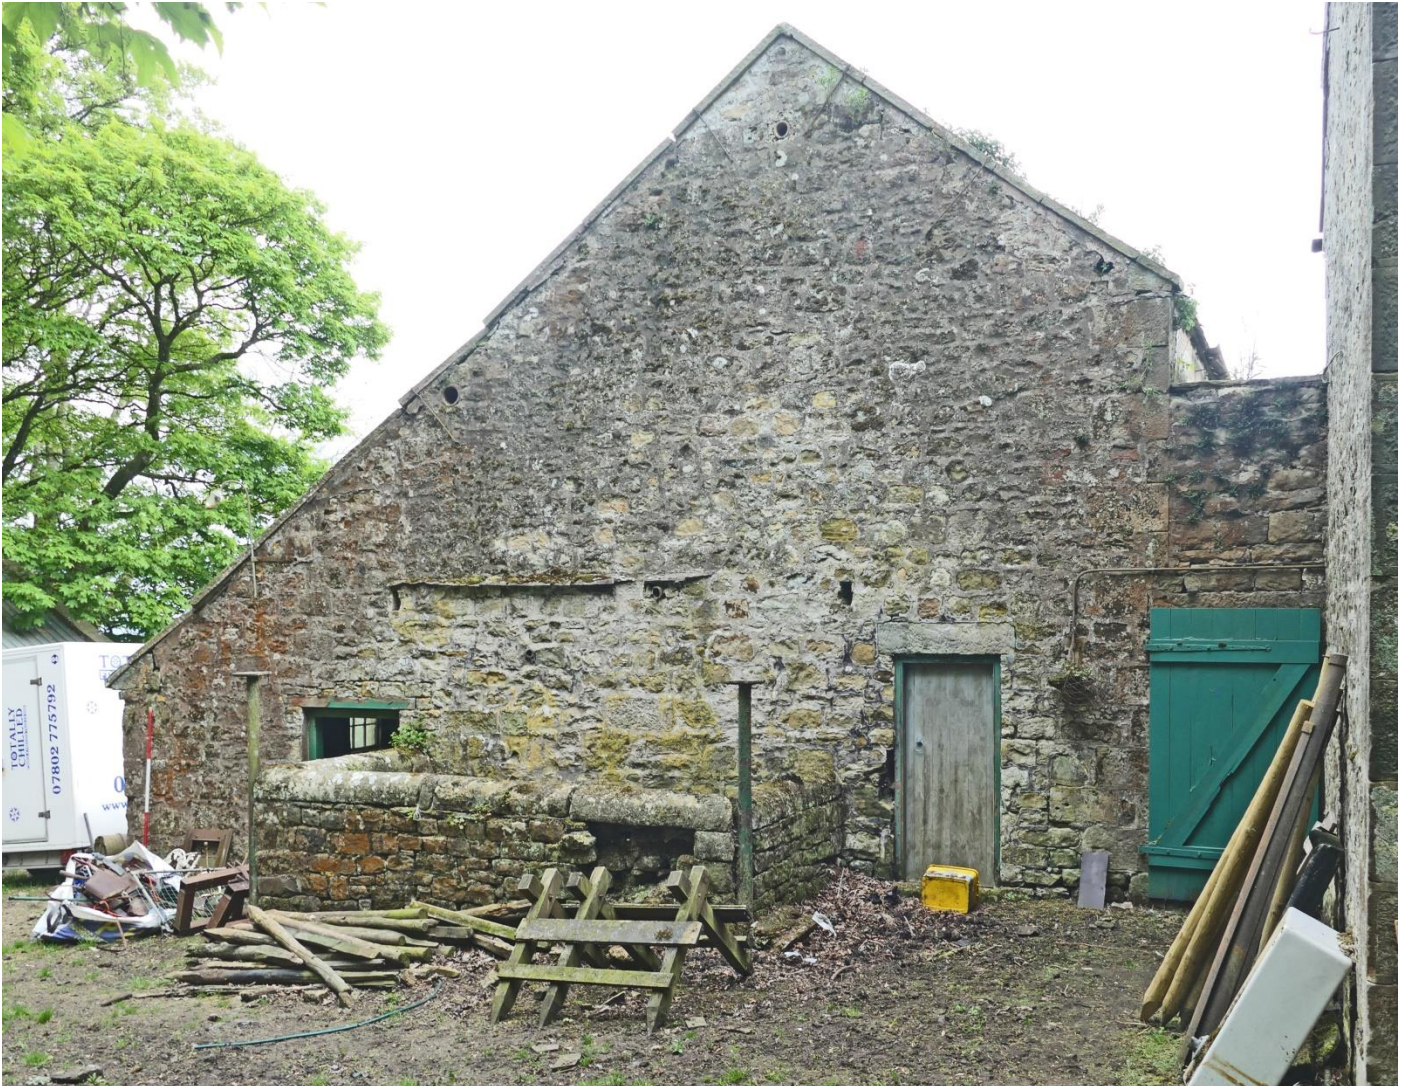
The north end of the building (above) has a pair of boarded doors, one at the west end into the main body and one further east into the outshut; both have the look of being secondary insertions. In between them a small enclosure is set against the wall, with stone walls c 1.4 m high that have an arched coping, without any openings; this has at one stage been covered by some sort of pent roof, the line of which is traceable, with sockets for timbers surviving at each end. There are no openings to the upper floors, other than one or two pipe vents.

The two doorways in the north end of the building both look to be insertions, perhaps relating to changes in function of the various parts of the structure, and most of the window and door carpentry has clearly been renewed. It is not clear whether the roof structure is original – the roofing material, Welsh slate, only became popular in the mid-19th century (with the development of the railway network) so if the building is older than that one would expect some other material – stone slates, pantiles or heather thatch – to have been used. However there is no sign of any of the features – raised gable copings for instance- that usually accompany these – so perhaps the structure was relatively new when depicted on the c1860 Ordnance Survey map.
