# LOW TOWN, GREENHEAD NORTHUMBERLAND

## Historic Buildings Assessment

## Historic Buildings Record & Archaeological Watching Brief

**PROJECT:** Historic Building Recording and Assessment  
**LOCATION:** Greenhead, Northumberland  
**CLIENT:** Mr & Mrs Forwood  
**SITE GRID REF:** NY 6836 6632  
**FIELDWORK:** June 2019  
**OASIS REF:** thearcha2-  
**PLANNING REF:** 17NP0051LBC

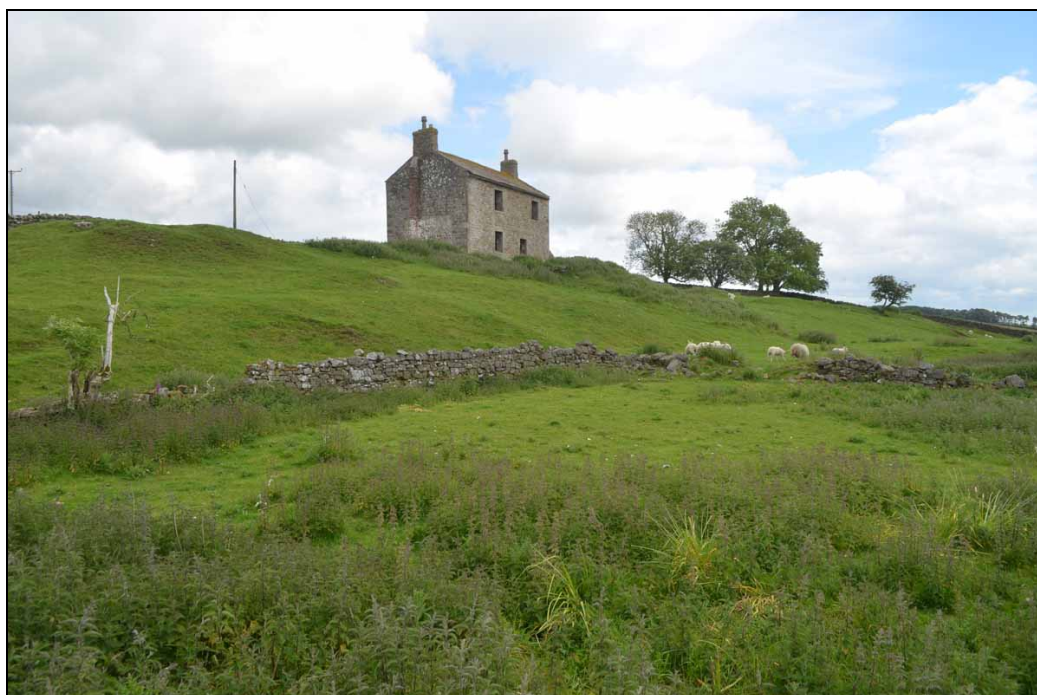
***Frontispiece:** View from the south-west showing the farmhouse sitting on a prominent position with associated earthworks.*

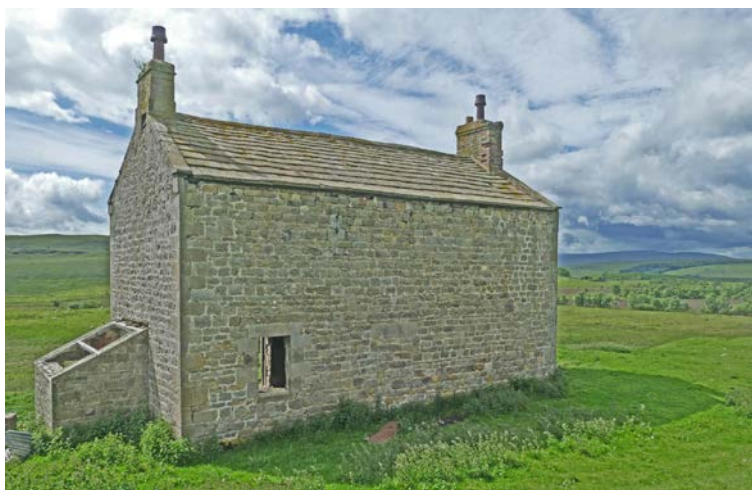
*Illus. 08: North-east view of the farmhouse.*

The south elevation is of two irregular bays, with a shallow plinth increasing in depth with the fall in the land to the south-east corner; the western has a vertical pair of windows, whilst right-of-centre there is a doorway and further right again a single first-floor window. The windows all have alternating-block jambs, with a raised border on all four sides; their carpentry has now been removed. The doorway has a raised alternating-block surround with in the centre of the lintel (now cracked) a raised oval panel with faint remains of an incised inscription; the date '1800' is visible and the letters below might be discernible with oblique lighting. The angles have neatly-cut alternating quoins, and the gable ends have a cut coping, briefly returned on its footstones in a manner quite common in buildings of this period; the right end has a stepped stone stack and the left end a similar one rebuilt in 20th century brick.

The east end is featureless; the small outbuilding set against it has a plain square-headed doorway on the south. The west end has an attached stack, rising slightly left-of-centre to die into the base of the present end stack; it rises from a 20th century brick boiler with its fireplace in a canted angle facing south-west, and a circular set-pot.

The rear elevation is of similar fabric to the others, except it has a single course of thinner stones at mid-height; the northern angle quoins below this are rather larger. There is a plain blocked doorway with a roughly-shaped lintel, but jambs of plain walling stones, set a little

right-of-centre, and a ground-floor window near the left end, with an alternating-block surround of cut blocks but no raised border. There are no first-floor openings but immediately below the eaves three larger blocks, corresponding to two normal courses, mark the positions of the roof trusses.

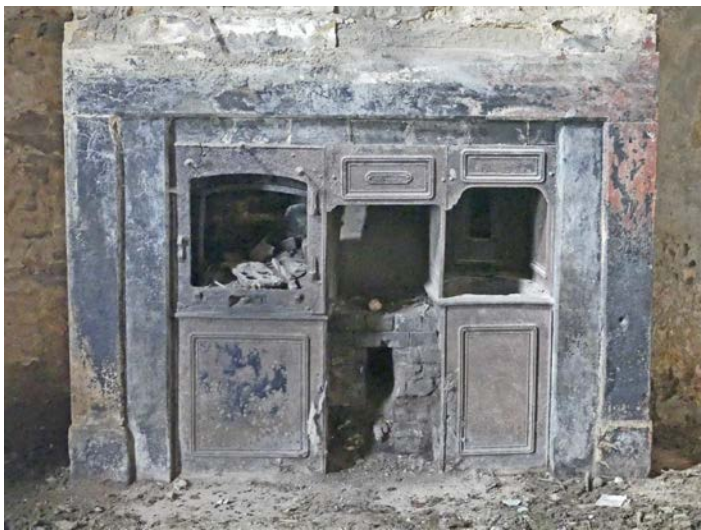
*Illus. 09: First-floor fireplace at west end, and its maker's plate*

On the ground floor only the larger western room has been heated; a bold projection from the east wall holds a large fireplace with a narrow chamfer to jambs and lintel, within which is a 19th or early 20th century range with a maker's plate for 'JOHN LIDDELL & SONS, HALTWHISTLE'. Above the projection reduces in size and there is a smaller first-floor fireplace with 19th century ironwork with a beaded frame and a shaped hood ornamented with a foliate loop; there is a timber strainer above. At the east end there is only a fireplace to the upper floor, carried on two substantial stone corbels. The plain stone fireplace retains two quadrant-plan cheek plates of cast iron, with raised foliate cross designs. Again there is a timber strainer above.

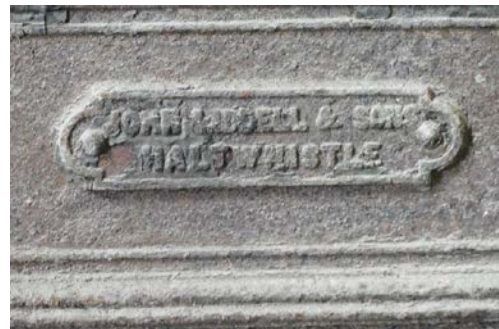
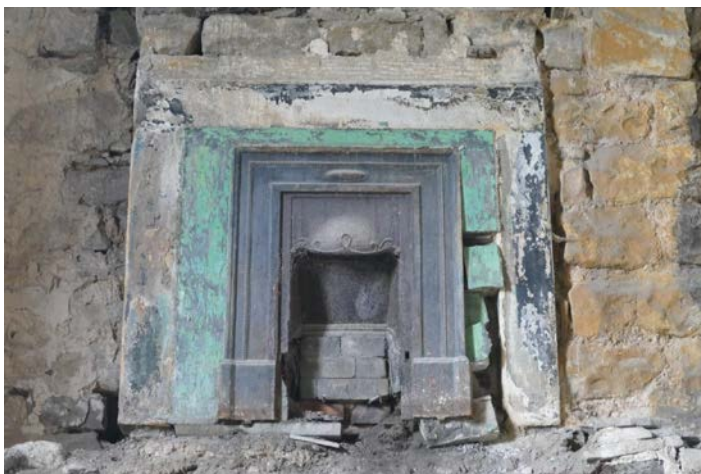
*Illus. 10: First-floor fireplace at the east end.*
