**TWEED HOUSE, BELLINGHAM, PROPOSED DEVELOPMENT
ECOLOGY, BAT AND BIRD RISK ASSESSMENT– OCTOBER 2019**

SECTION 1 BACKGROUND AND SUPPORTING INFORMATION

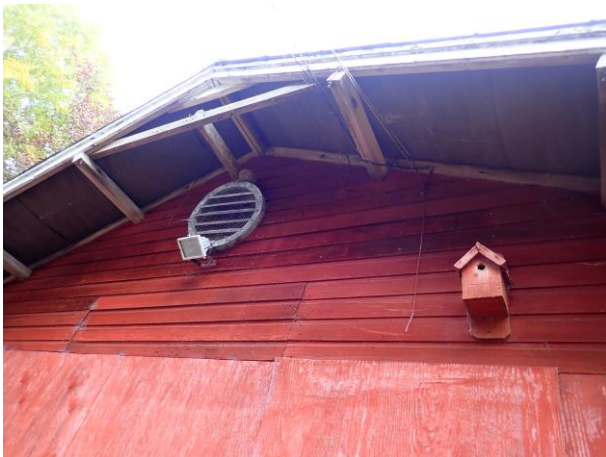
The buildings are timber built with pitched tiled roofs with a bitumen felt/wood sarking. The lofts are shallow being less than 1.2m in height. No bat traces or good bat roost potential was noted externally or internally. Please see Table 1 for details.

Building	Description	Notes
Tweed House	Wood clad bungalow, with loft area well insulated and a timber sarking with tiles nailed on directly.	No evidence of bats within the loft. Overhanging eaves used by swallows
Wansbeck House	Timber clad hall with overhanging eaves and bitumen felt sarking. Well insulated with Kingspan. Shuttered vents present at gable end, meshed. Solar panels on the south aspect.	No bat roost potential or bat traces noted. Swallow nest on top of the vent at the west gable wall beneath overhanging roof.

Interior of Wansbeck House loft

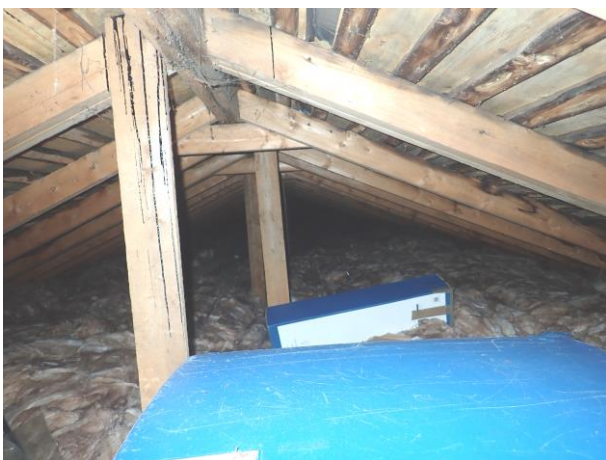
Loft of Tweed House

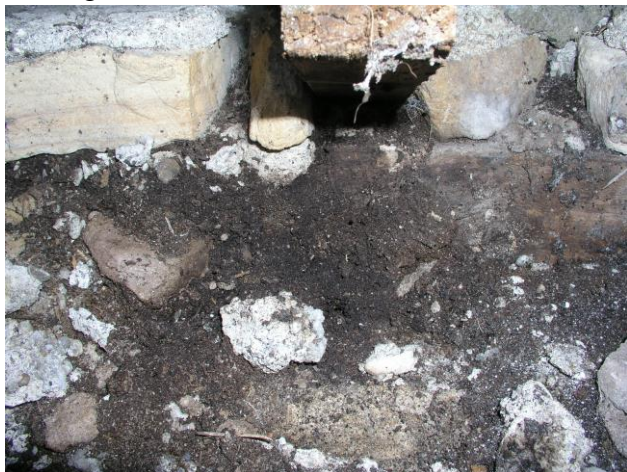
Photo showing disintegrated bat droppings beneath coping stones. If examined carefully, in the black dust exoskeletons of insects can be seen shining.
