Highgreen Manor: Danish Barn

Design and Heritage Statement

TO BE READ IN CONJUNCTION WITH
PREVIOUSLY SUBMITTED HERITAGE
STATEMENTS FOR HIGHGREEN
MANOR, LISTED BUILDING APP
Decision Notice_18NP0093LBC

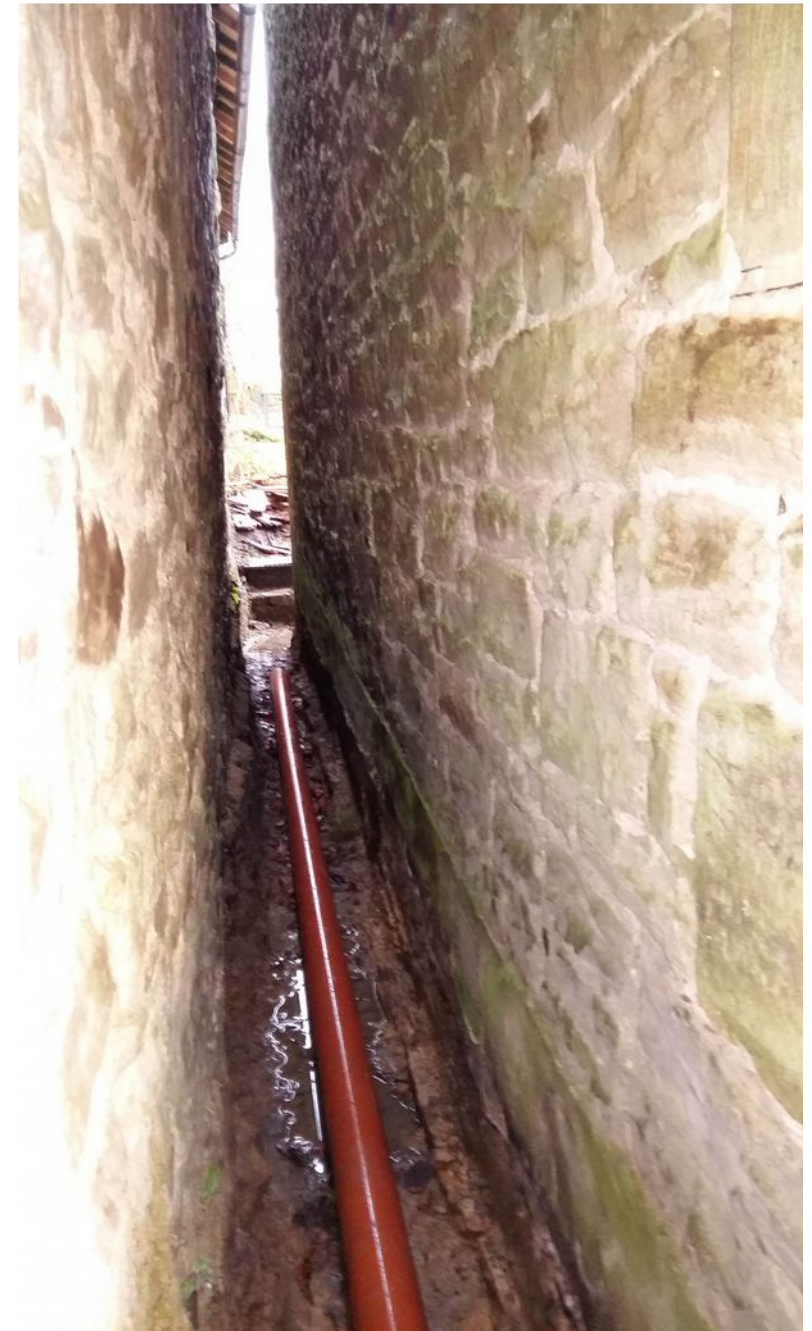
Area of stonework to be removed to the left of the photo to enable better access to Unit 3 and to reduce the risk of damp

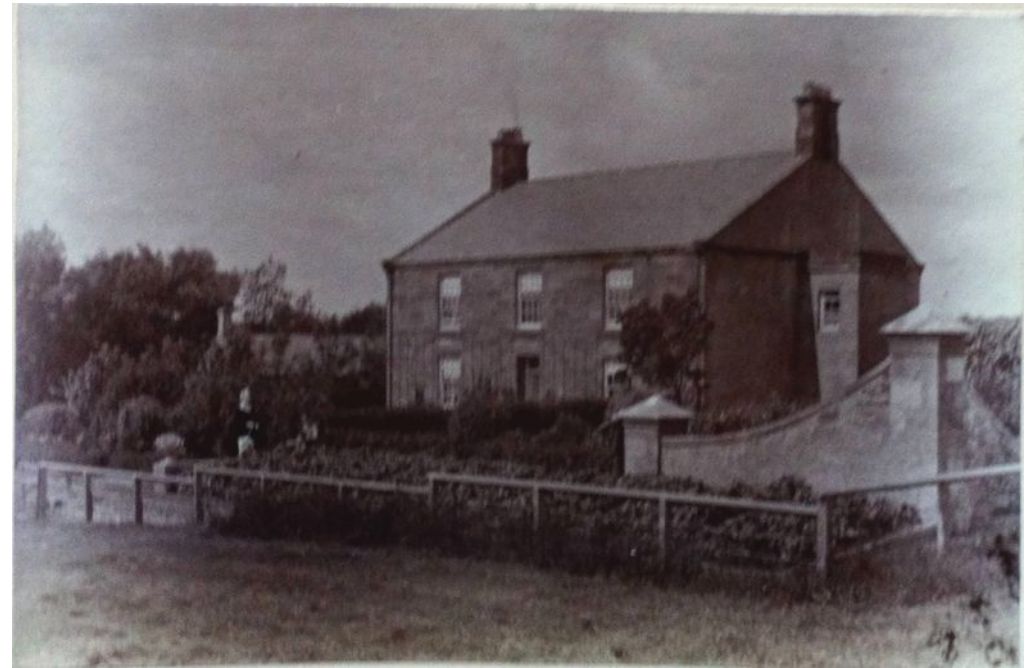
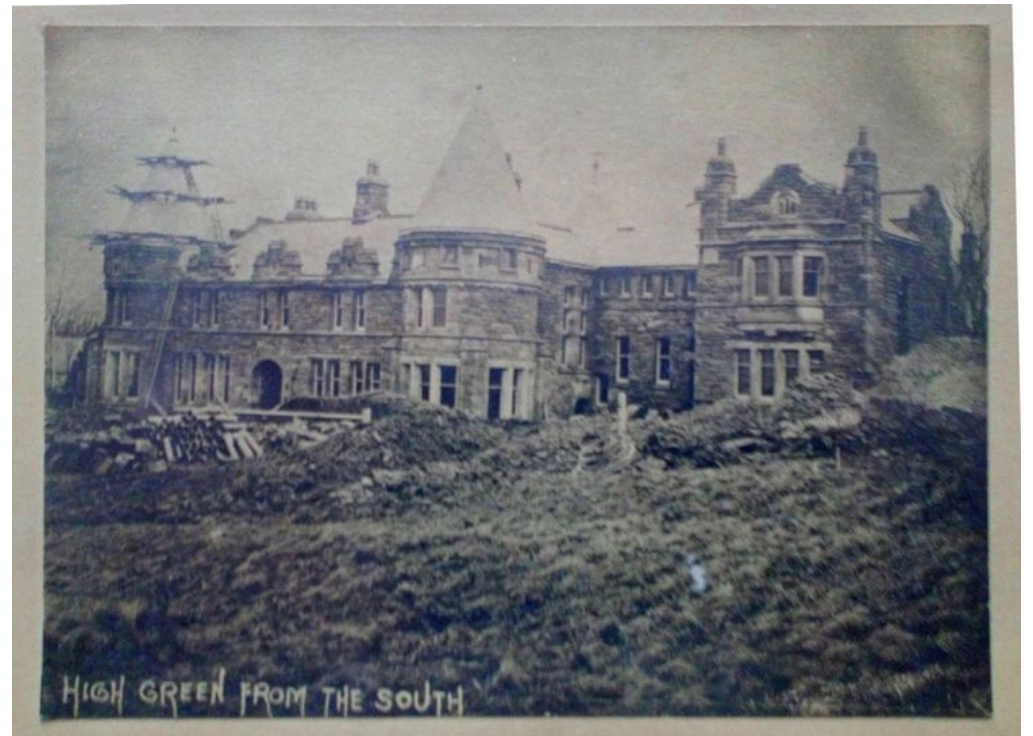
The main section of the manor; the baronial part was built from rock face stone. The earlier 19th century farmhouses which are partially exposed in east wing and to the north side of the main Manor building are coursed random local sandstone with dressed stone quoins. The later early 20thC additions are finely dressed ashlar stone.

When first built, the Manor was known as 'the orange house' due to the colour of its newly quarried stonework and the way it 'jarred' with the landscape and the local vernacular.

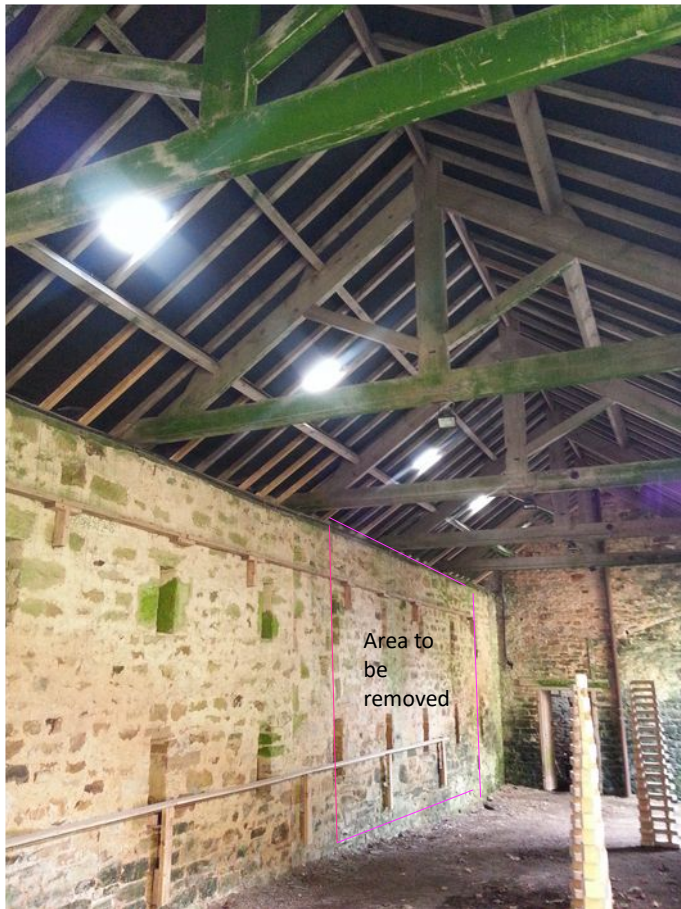
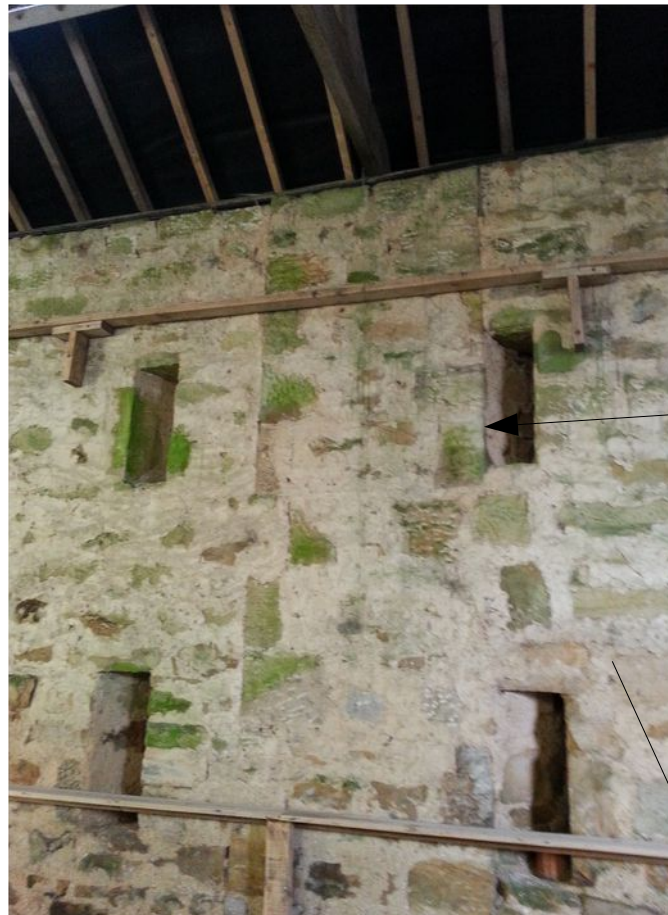
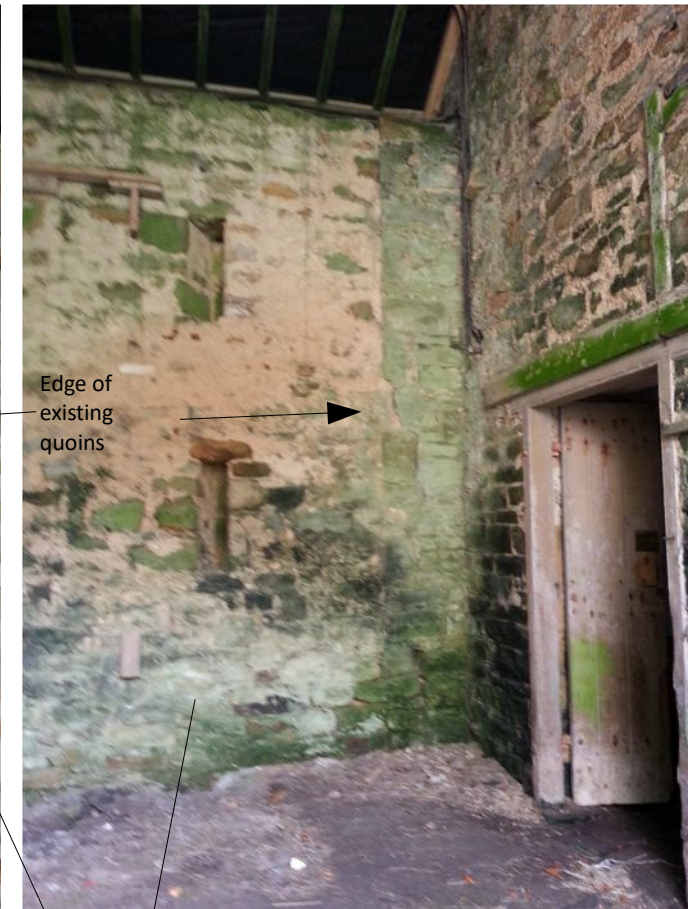
The Following drawings below show the extent of the works, and the photos illustrate the issues.

It is only proposed to remove the area of stonework adjacent to Unit s (The Cottage). The area of Unit 3 has historically suffered from damp and moisture issues which is degrading the fabric of the building. Recent opening up of the floor and removal of plaster off the walls in an attempt to dry the building out has only served to emphasise the extent of the problem.

Due to the close proximity of the Danish Barn to The Cottage it is virtually impossible to excavate the gap between in order to insert a French drain to lower the water table and begin to dry the wall out. Refurbishment work cannot be carried out until the moisture content of the wall is lowered.

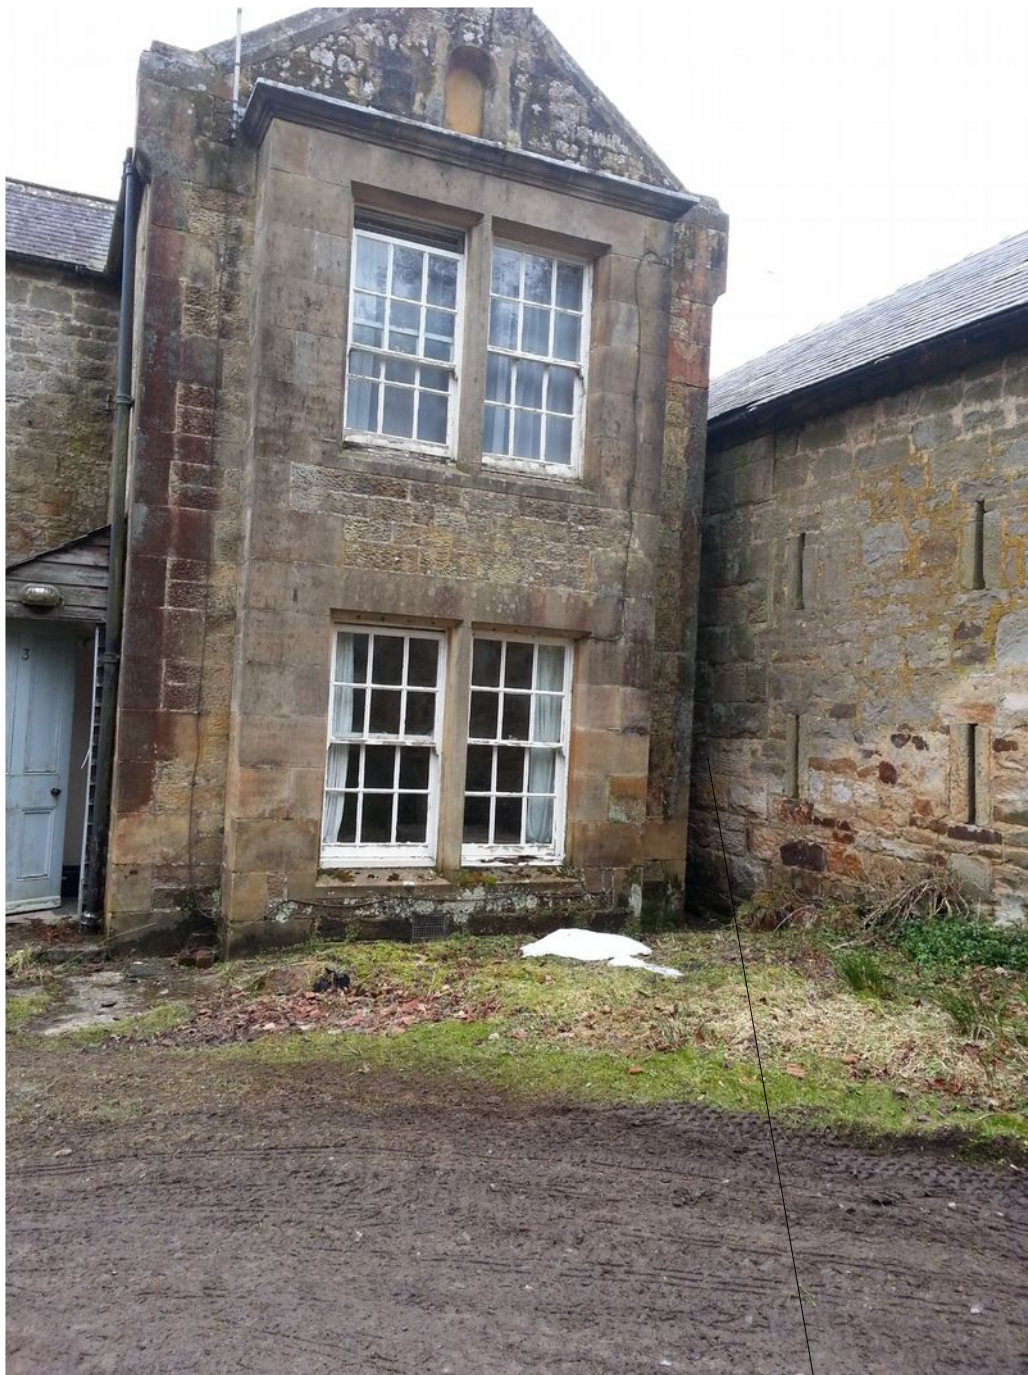
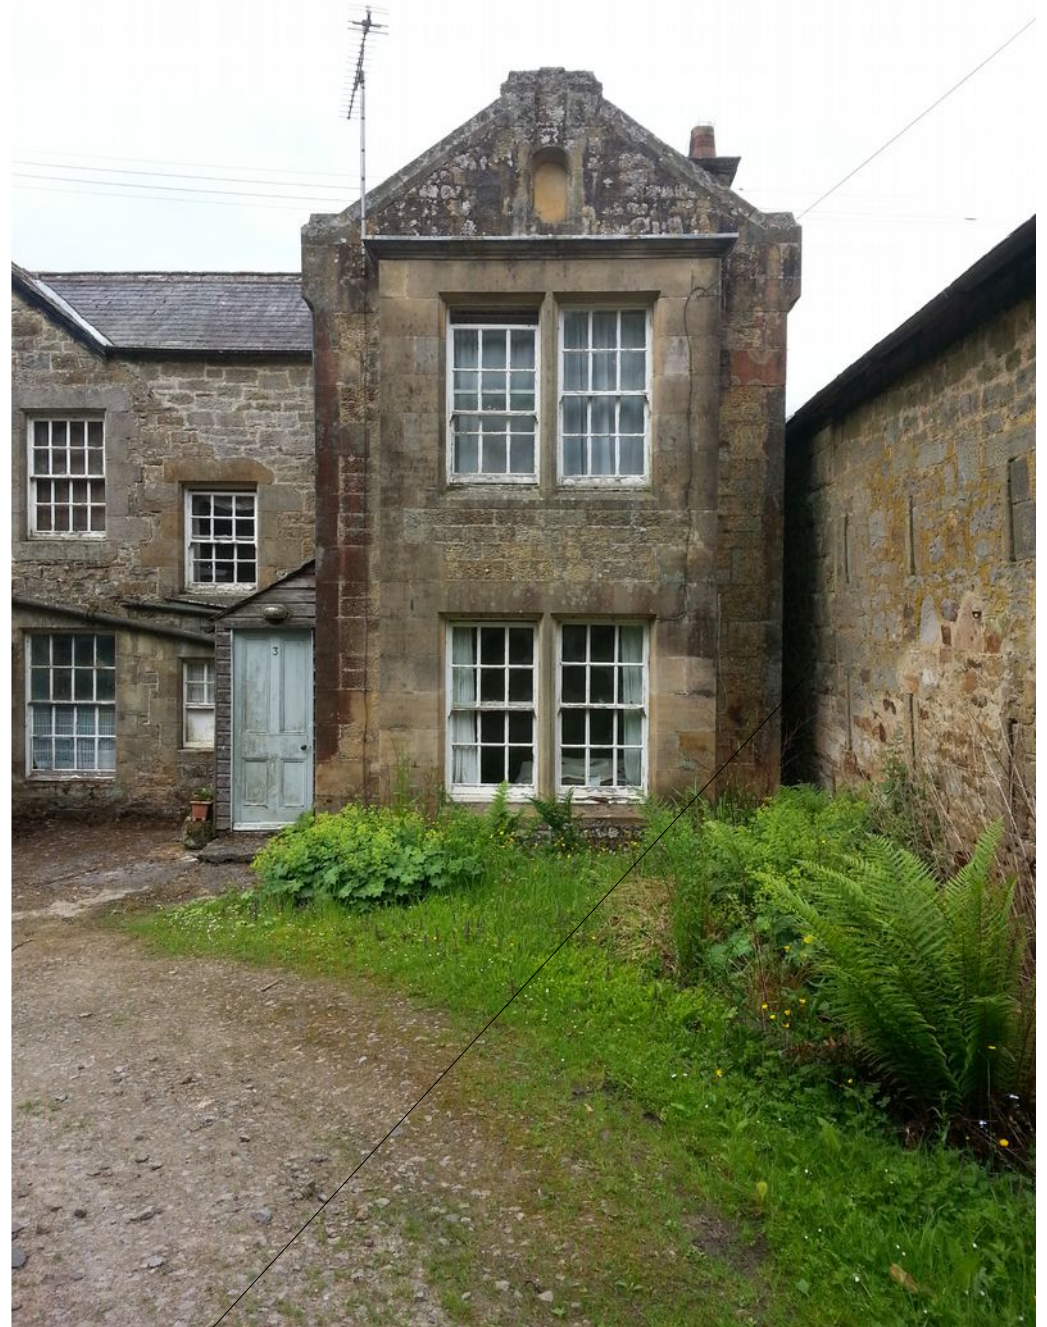
Area of stone to be removed hidden down side of unit 3

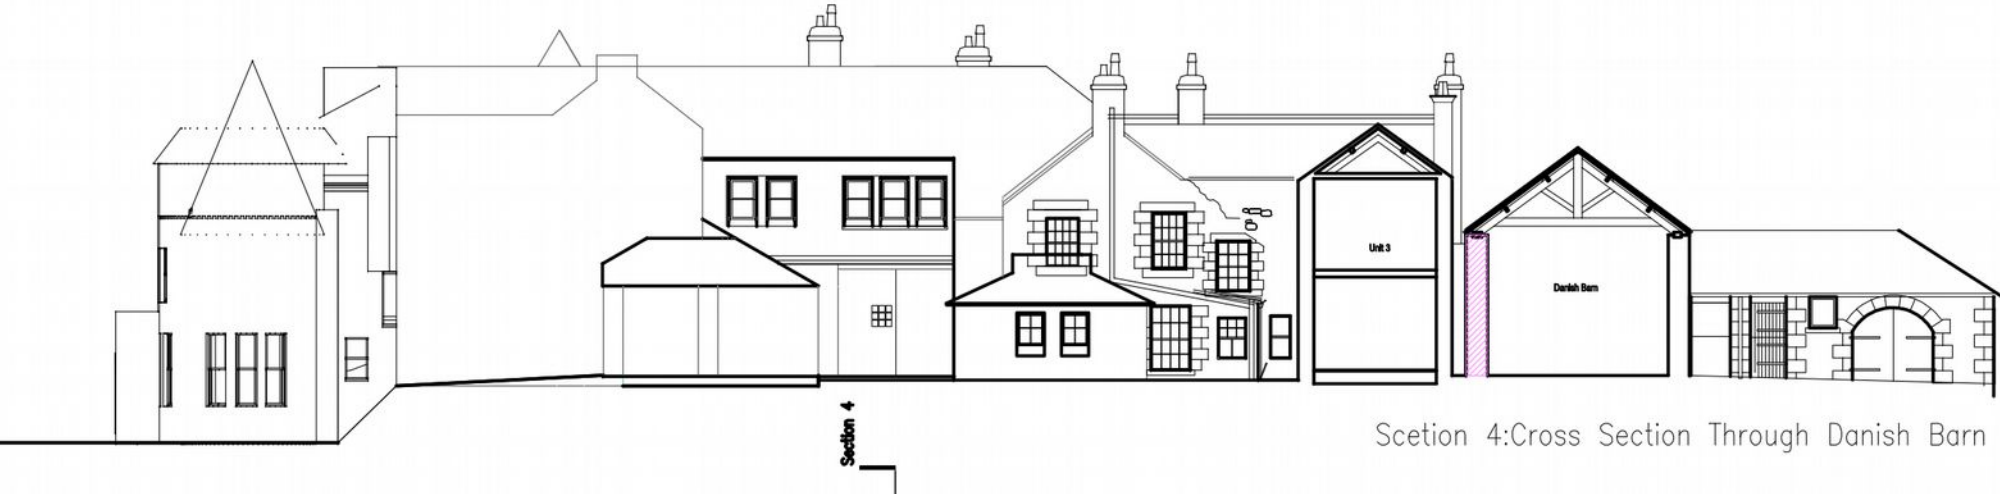
Section 4: Cross Section Through Danish Barn

Sections showing area in pink of part of the Danish barn to be removed

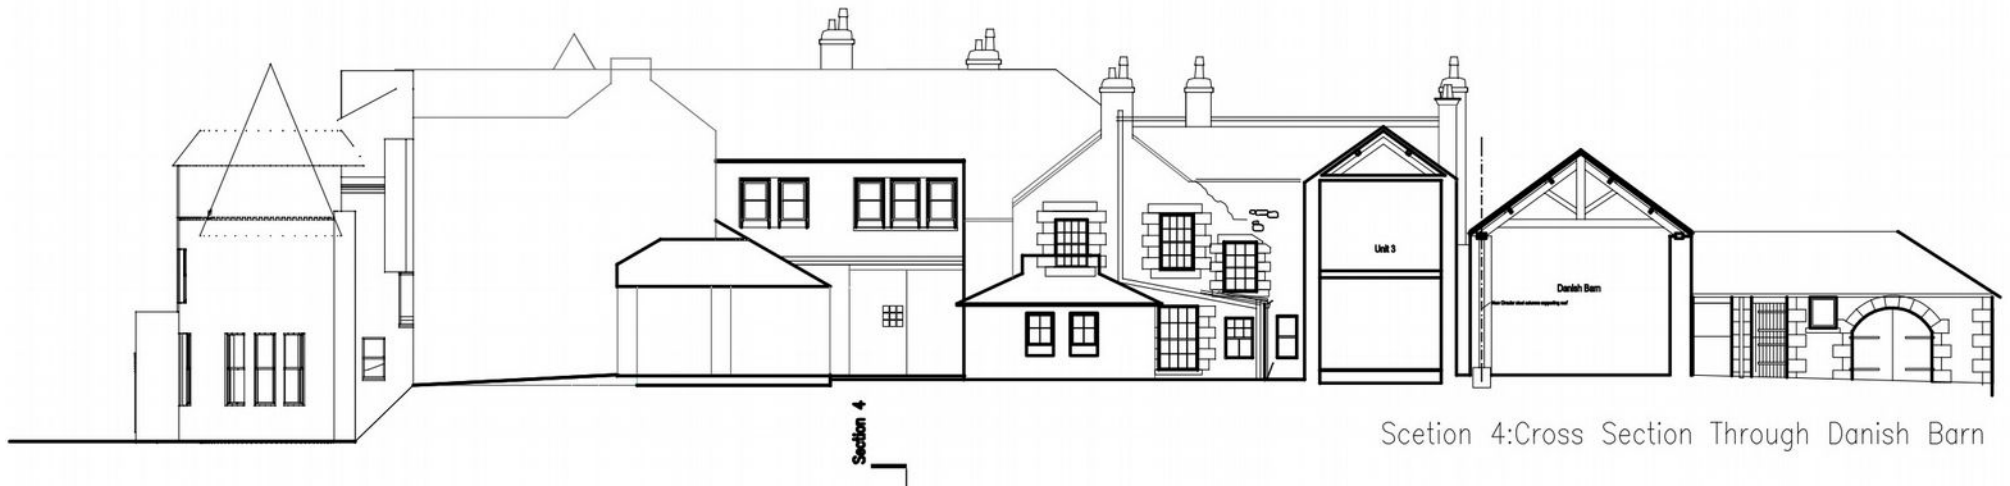
Section 4: Cross Section Through Danish Barn
