## ADDENDUM TO BAT SURVEY

## HIGHGREEN MANOR, TARSET

January 2020

Client	Revision	Status	Date	Author	Proof Read	Checked
Newton Architects	R01	Addendum	17.1.20	MEM		ADM
Job No. 3833

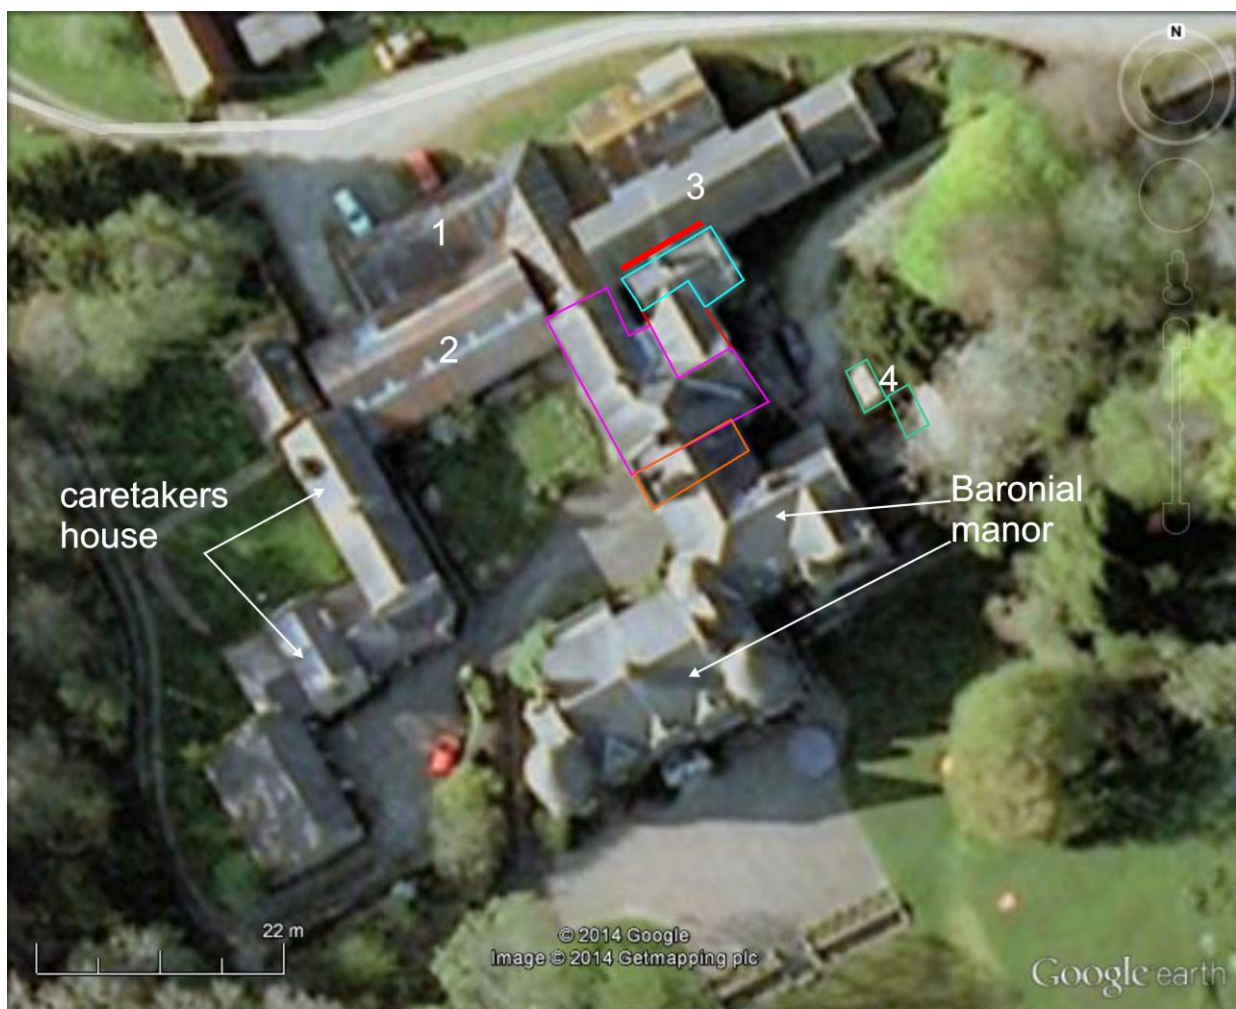
Figure 1 – Aerial photograph illustrating the extent of the site with a key buildings outlined (Reproduced under licence from Google Earth Pro.)

A section of wall (approx. location marked by a red line below) will be removed from building 3, to allow access to the cottage and minimise damp.

Cottage
 	Cottage link to farmhouse
 	Farmhouse
 	Single storey barn
 	Archway
1-4	Barns

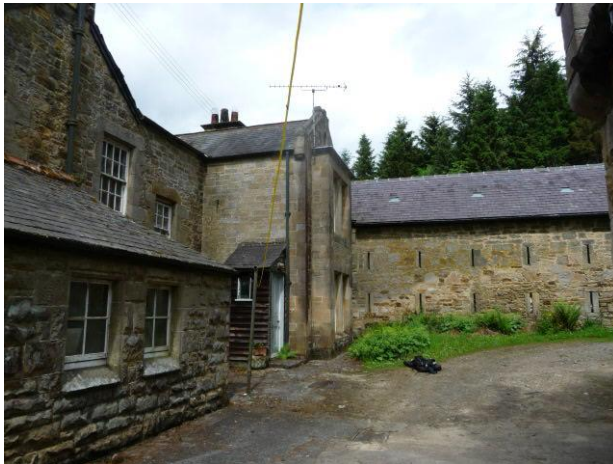
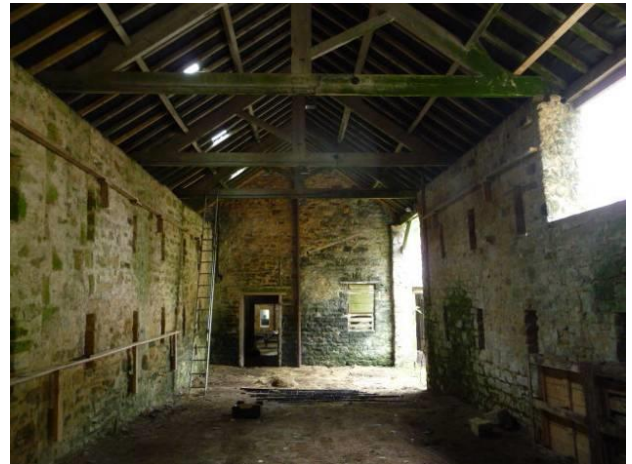
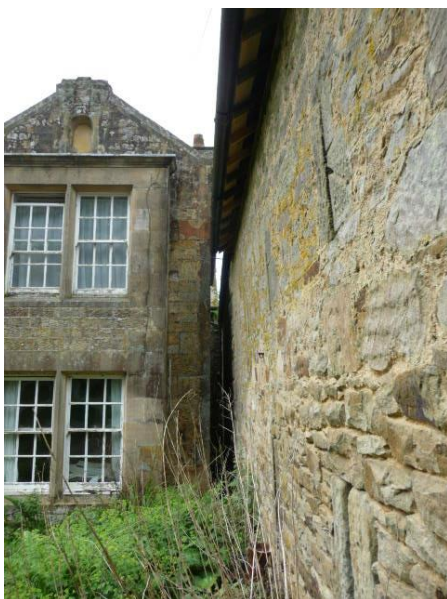
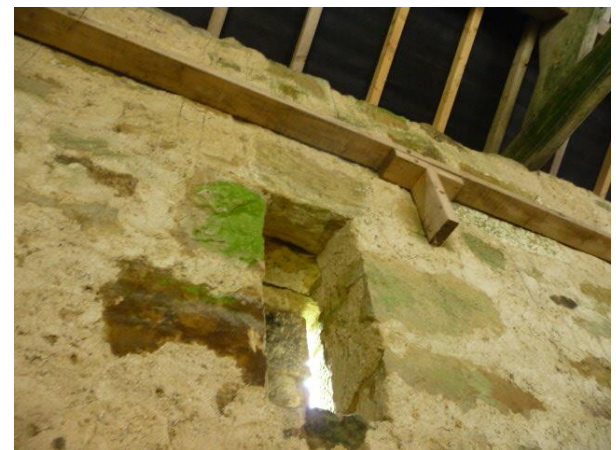
**Barn 3: Large Barn** (section of wall to be removed)

The section of barn wall to be removed was inspected on 15<sup>th</sup> January 2020. Internally the wall was very well pointed, with the only potential suitable crevices associated with a small number of gaps within the arrow slit windows. These were inspected with an endoscope and no bats or field signs were found associated with them. The wall tops were also well sealed, with no gaps noted. The roof will be retained. The external wall could not be inspected in detail due to the narrowness of the gap between the cottage and barn, complicated further by the fact that drainage was currently being installed between the gap making access difficult. However, this section has been surveyed throughout the years, with surveyors standing at both ends of the gap between the two buildings whilst monitoring the cottage/farmhouse structure, and no possible roosts were identified and no bats were seen potentially emerging from this space.

- Immediately adjacent to the cottage, with very narrow walk-way between the two structures allowing access to the lightwell area of the cottage
- Random stone construction
- King trusses sit on wall tops
- Internal walls generally appear well-sealed with the area to be affected very well sealed.
- There are arrow slit windows and a small number of potential gaps associated with these where the walls are to be removed.
- Traditional sarking
- Open in two areas to one side
- Possible gaps on gable walls (unaffected)
- **No evidence of bat use within section of wall to be removed or immediately adjacent.**

It is recommended that works are undertaken to a precautionary method statement, including an endoscope check of the small number of crevices within the arrow slit windows prior to removal, and avoiding the hibernation period (mid Nov to end Feb) as good working practice.
