Highgreen Manor: Danish Barn

Design and Heritage Statement

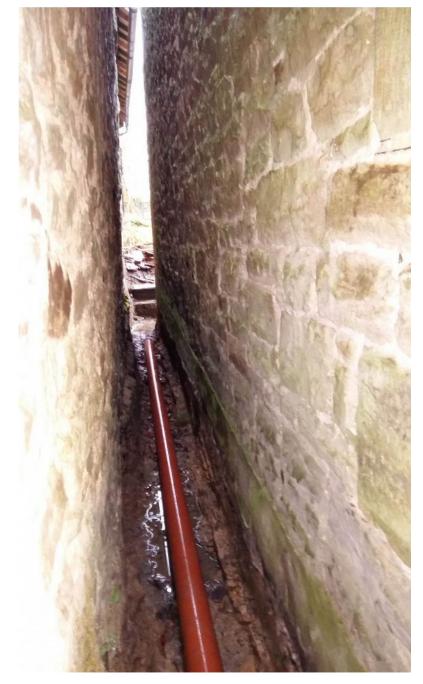
Area of stonework to be removed to the left of the photo to enable better access to Unit 3 and to reduce the risk of damp

It is only proposed to remove the area of stonework adjacent to Unit s (The Cottage). The area of Unit 3 has historically suffered from damp and moisture issues which is degrading the fabric of the building. Recent opening up of the floor and removal of plaster off the walls in an attempt to dry the building out has only served to emphasise the extent of the problem.

Due to the close proximity of the Danish Barn to The Cottage it is virtually impossible to excavate the gap between in order to insert a French drain to lower the water table and begin to dry the wall out. Refurbishment work cannot be carried out until the moisture content of the wall is lowered.

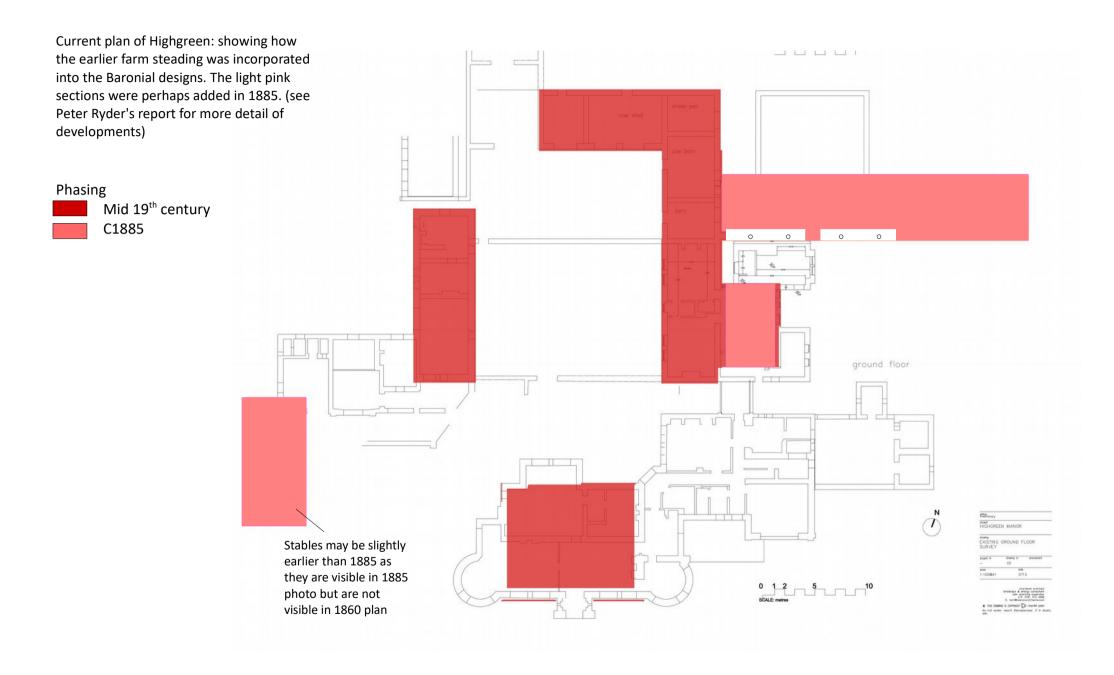
Plan showing 1894 baronial additions sheep pen danish barn ground floor ROS-Mary Project HIGHGREEN MANOR EXISTING GROUND FLOOR
SURVEY

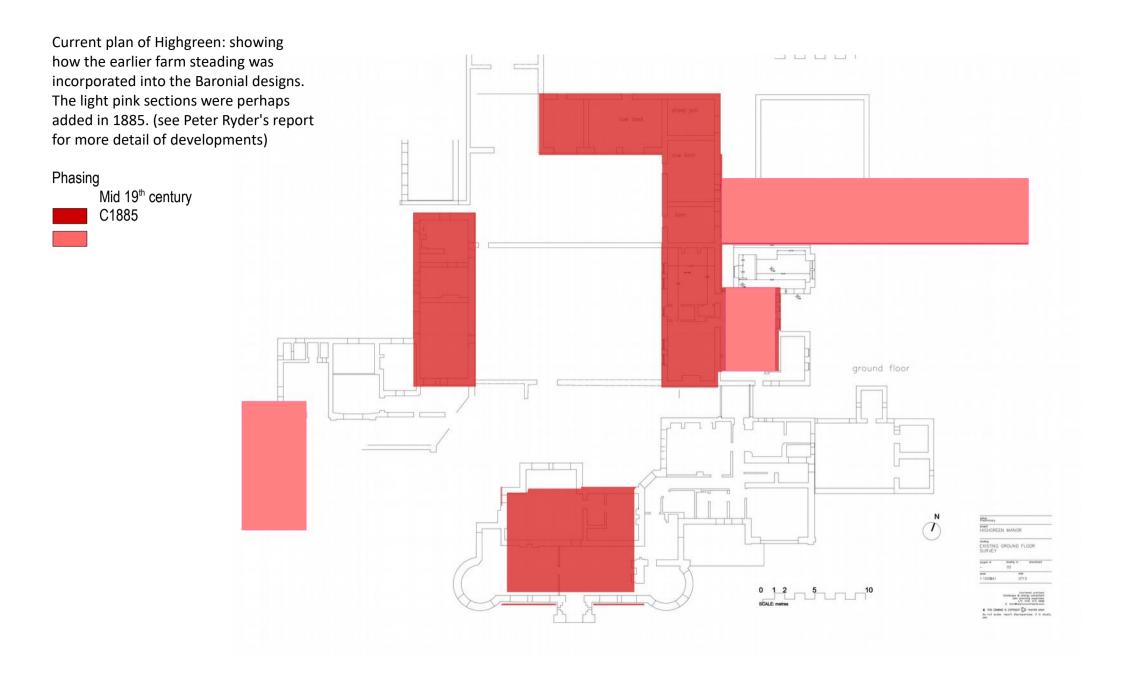
3d view from north east showing all the phases of the Manor House development

Infill of Danish Barn Hidden Behind 'Cottage' Unit 3

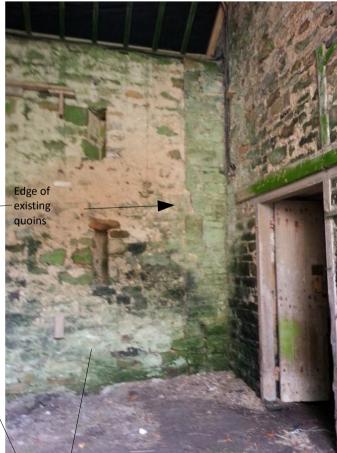
Stone to be removed

The proposal is to removed a 20th C Panel of stonework which walled up the open south side of the Danish Barn when the access to the barn was turned round during works to extend the Manor House. It is then proposed to install 2 no circular steel columns replicating the columns that would have originally supported the roof. A wide gutter between the Danish barn and unit 3 will prevent moisture getting to the base of the building.

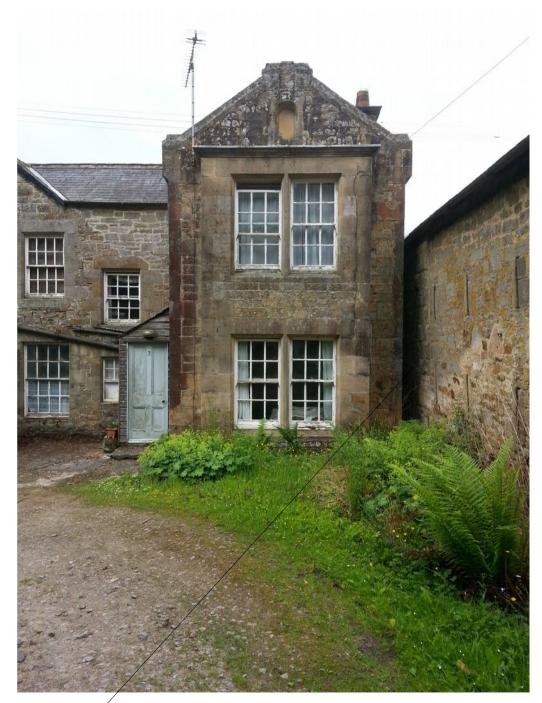
Area of stone to be removed hidden down side of unit 3
