ADDENDUM TO BAT SURVEY

HIGHGREEN MANOR, TARSET

January 2020

This report forms an addendum to 3833 High Green Manor R03 which the council ecologists have already received as part of the planning application.

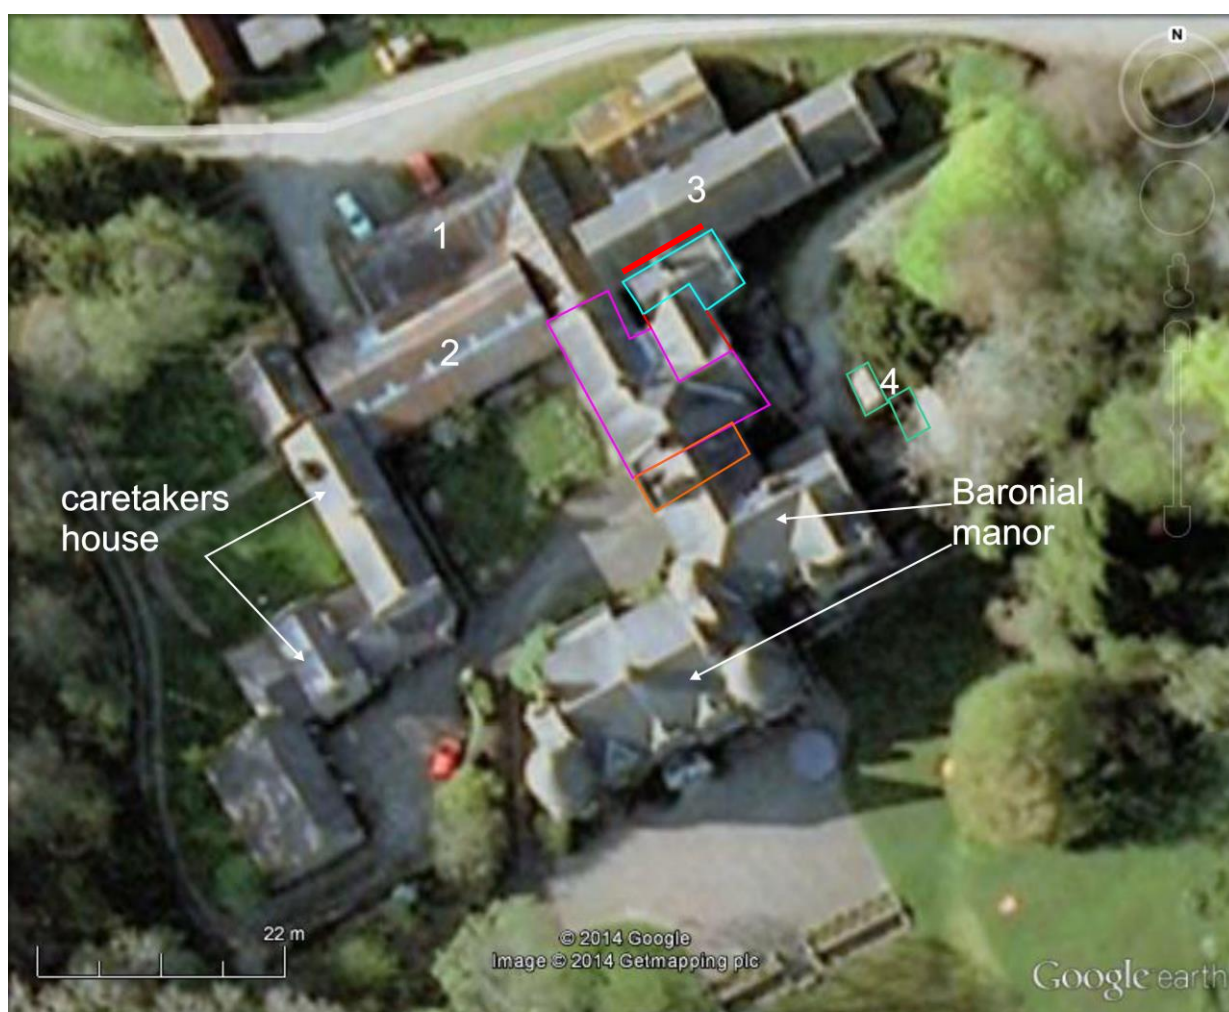
Figure 1 – Aerial photograph illustrating the extent of the site with a key buildings outlined (Reproduced under licence from Google Earth Pro.)

A section of wall (approx. location marked by a red line below) will be removed from building 3, to allow access to the cottage and minimise damp.

Cottage
 	Cottage link to farmhouse
 	Farmhouse
 	Single storey barn
 	Archway
1-4	Barns

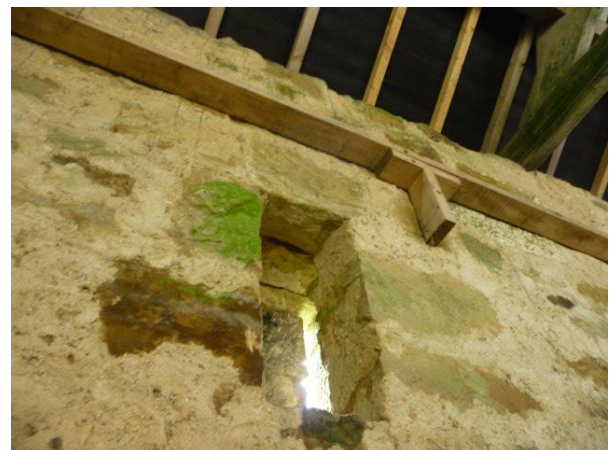
Barn 3: Large Barn (section of wall to be removed)

The section of barn wall to be removed was inspected on 15th January 2020. Internally the wall was very well pointed, with the only potential suitable crevices associated with a small number of gaps within the arrow slit windows. These were inspected with an endoscope and no bats or field signs were found associated with them. The wall tops were also well sealed, with no gaps noted. The roof will be retained. The external wall could not be inspected in detail due to the narrowness of the gap between the cottage and barn, complicated further by the fact that drainage was currently being installed between the gap making access difficult. However, this section has been surveyed throughout the years, with surveyors standing at both ends of the gap between the two buildings whilst monitoring the cottage/farmhouse structure, and no possible roosts were identified and no bats were seen potentially emerging from this space.

- Immediately adjacent to the cottage, with very narrow walk-way between the two structures allowing access to the lightwell area of the cottage
- Random stone construction
- King trusses sit on wall tops
- Internal walls generally appear well-sealed with the area to be affected very well sealed.
- There are arrow slit windows and a small number of potential gaps associated with these where the walls are to be removed.
- Traditional sarking
- Open in two areas to one side
- Possible gaps on gable walls (unaffected)
- **No evidence of bat use within section of wall to be removed or immediately adjacent.**

It is recommended that works are undertaken to a precautionary method statement, including an endoscope check of the small number of crevices within the arrow slit windows prior to removal, and avoiding the hibernation period (mid Nov to end Feb) as good working practice.
