**HOLYSTONE GRANGE, HOLYSTONE, PROPOSED DEVELOPMENT
BAT AND BARN OWL REPORT – SUMMER 2020**

SECTION 1 BACKGROUND AND SUPPORTING INFORMATION

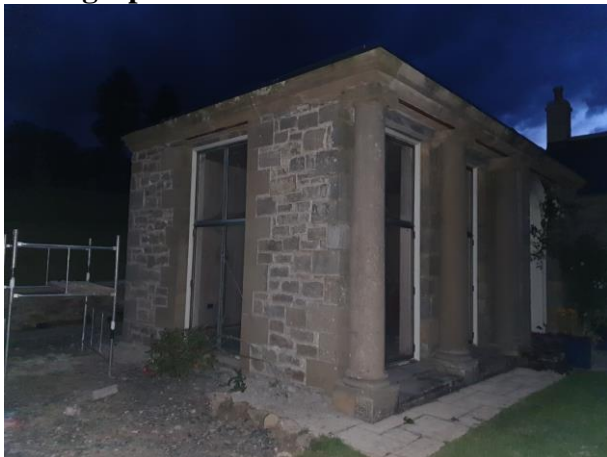
The garden room from the southeast

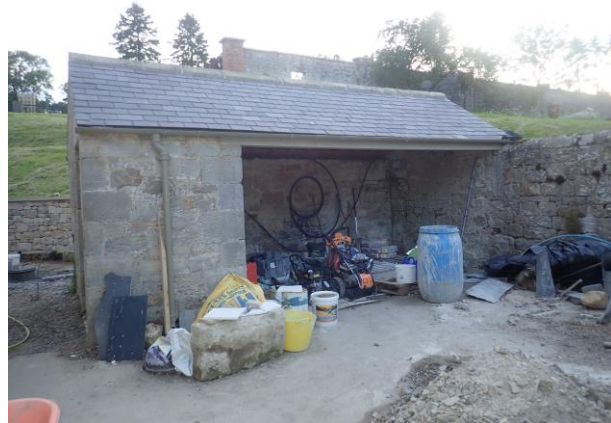
The log store from the southwest

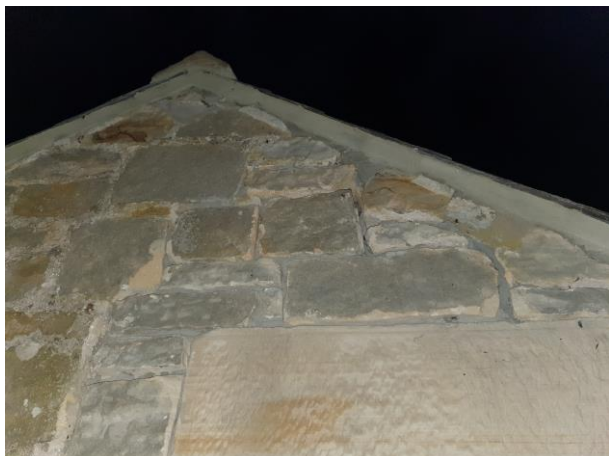
Gable end of log store from where a bat emerged. Crevice in the stonework above the lintel.

Bat roosts identified in the log store and garden room will remain as at present. Also no repointing will be carried out behind the pillars. Please see plan at C1.4 for locations.

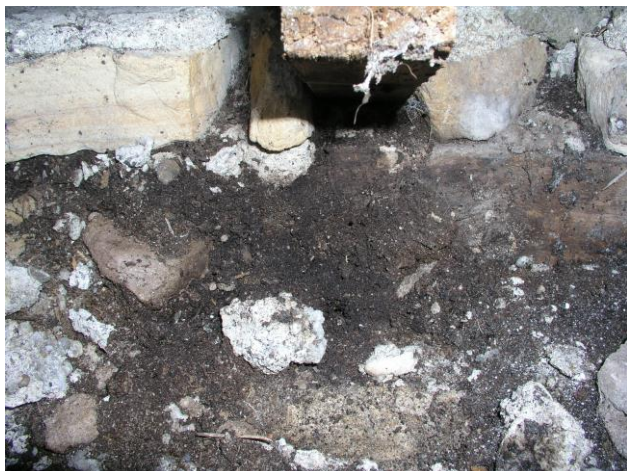
Photo showing disintegrated bat droppings beneath coping stones. If examined carefully, in the black dust exoskeletons of insects can be seen shining.
