Bat Survey and Roost Appraisal

The Star Inn,

Harbottle,

Northumberland.

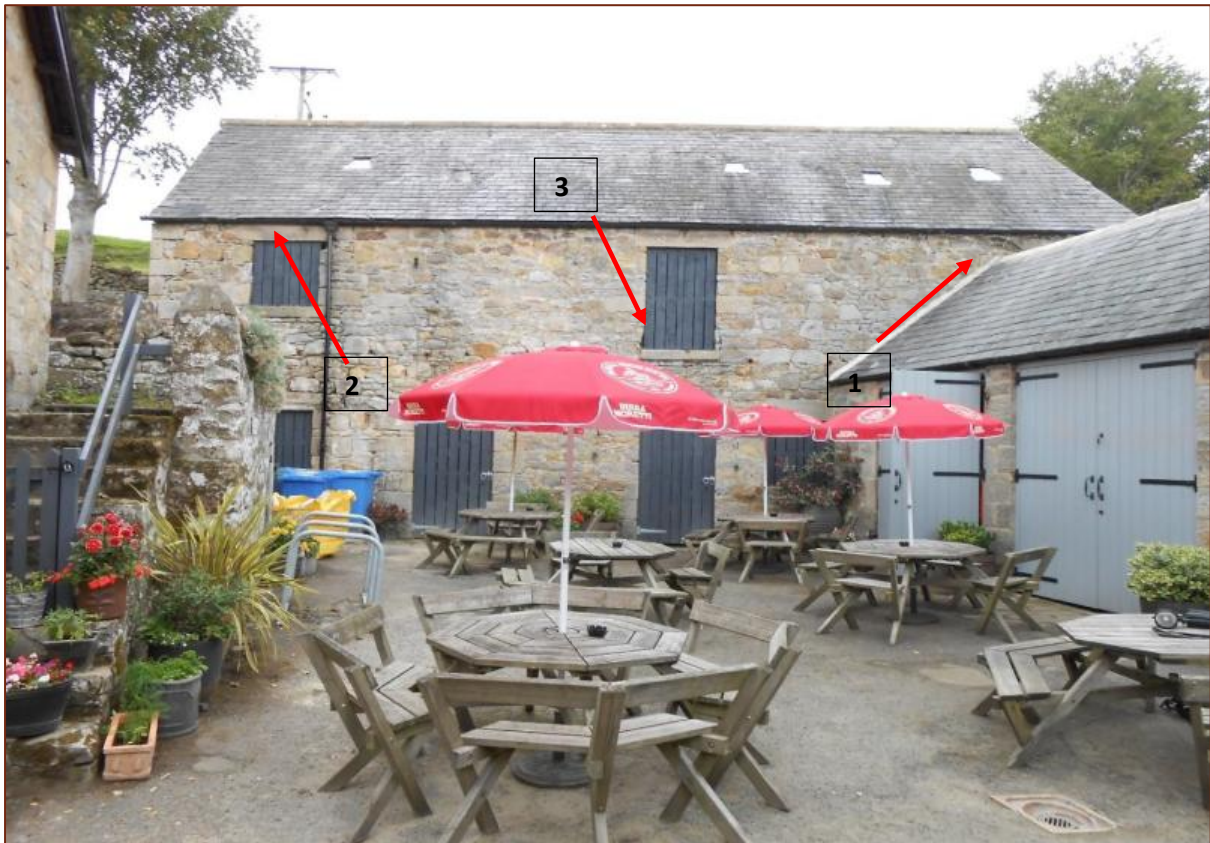
Figure 7-1 Emergence locations

A soprano pipistrelle was noted to emerge from the upper right-hand side of the south facing wall of building 1 above the ridge of building 2 at 19.34.

A single myotis bat was observed to emerge from the upper south western corner of the barn/stable building 20.04.

Finally, a single common pipistrelle bat was observed to emerge from the hayloft entrance doorway lower western corner 20.29. See image below for locations.

However, the single evening emergence survey noted 3 different species of bat emerging from the south face of building 1 two from wall tops and a further bat from a hayloft doorway clearly showing that bats utilise this structure as a roost albeit in low numbers.

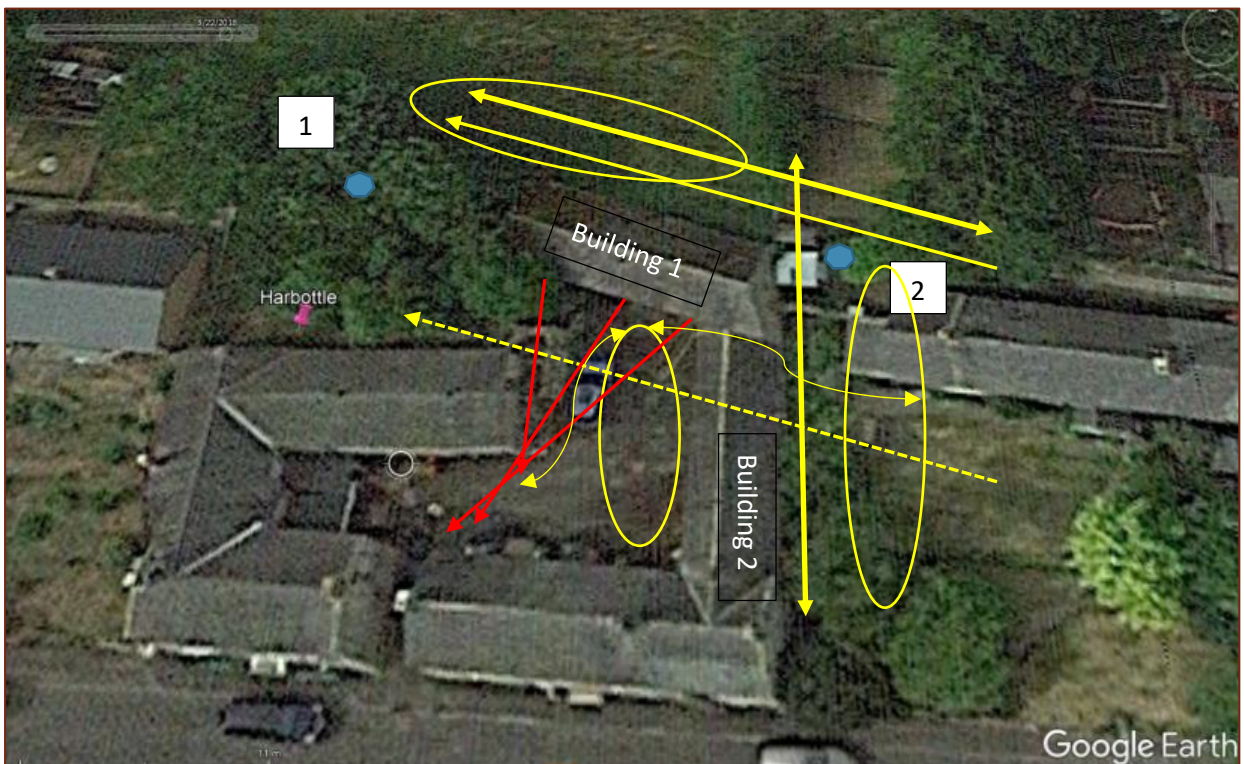
Figure 7-2 Observed Flight

Bats primarily common pipistrelle with occasional soprano pipistrelle were noted feeding to the north and east of the site together with occasional foraging behaviour within the courtyard area.

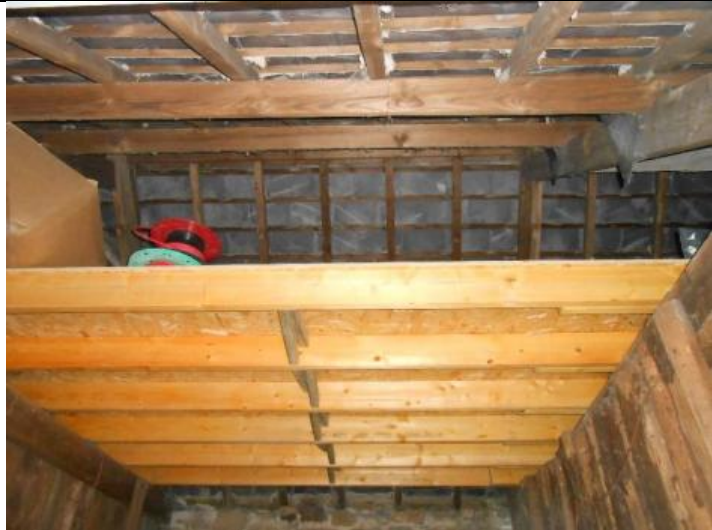
5.

Mezzanine floor from above showing roof construction and cobwebs. No evidence of a bat presence.

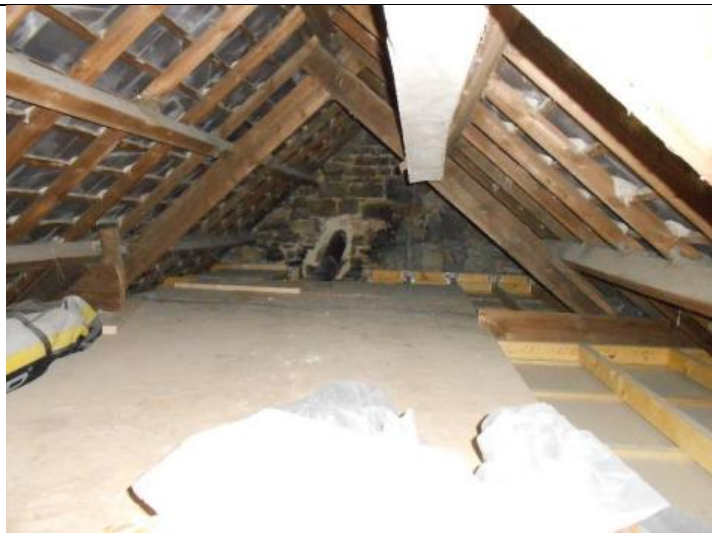
6.

Storage area no evidence of a bat presence.

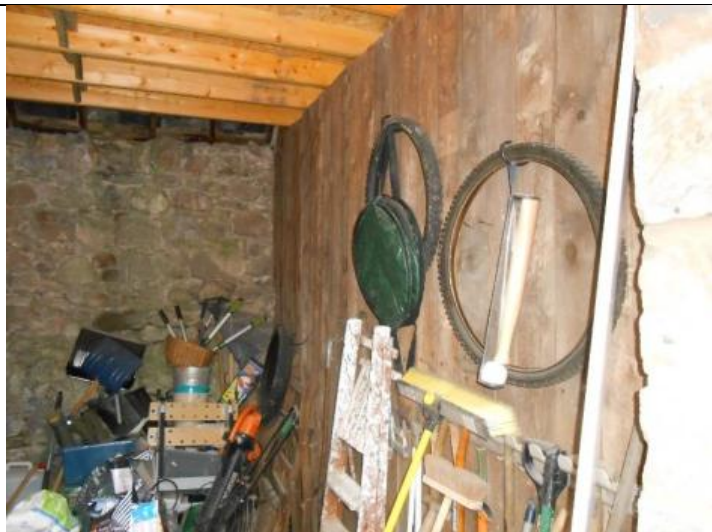
<p>7.</p> <p>Final garage space no evidence of a bat presence.</p>

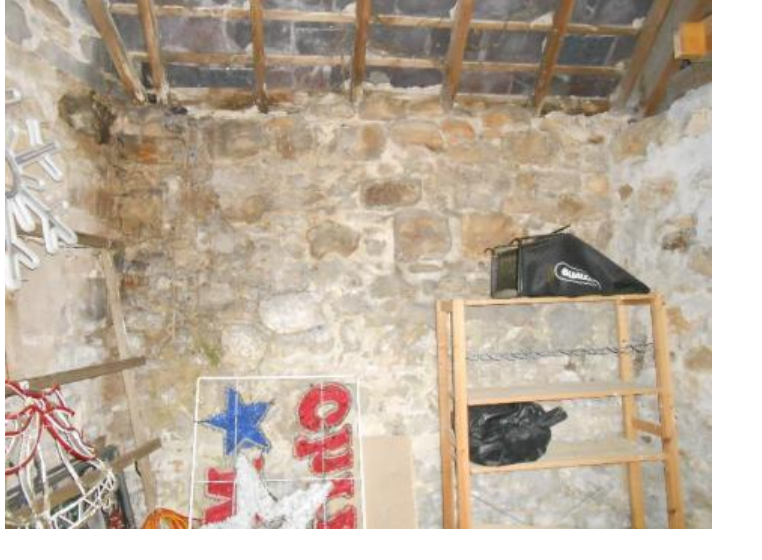
A photograph showing the interior of a stone-walled garage. The walls are made of rough-hewn stone. The ceiling has exposed wooden beams. In the foreground, there is a wooden ladder, a black bag, and a sign with a blue star and red text. The floor is cluttered with various items, including a red and white striped object.
<p>8.</p> <p>Ground floor building 1 south east corner note butterfly wings.</p>

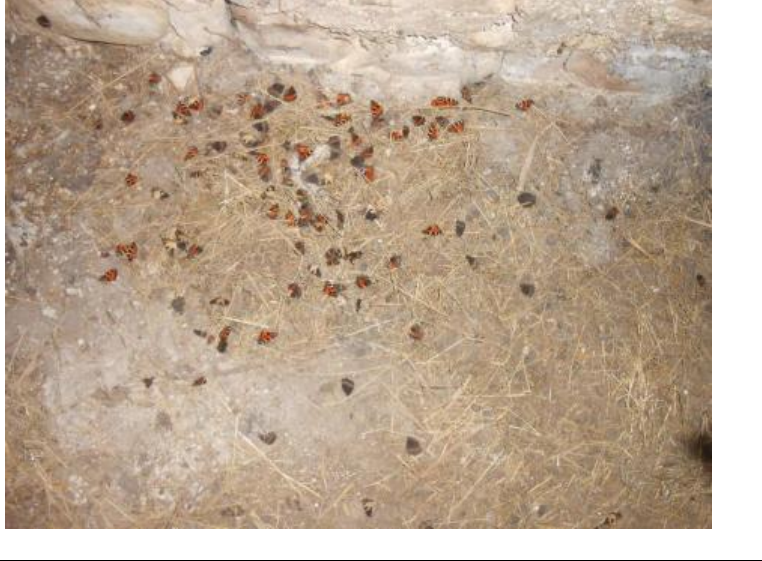
Evidence of a probable bat feeding perch to the internal south east corner of the ground floor was observed with numerous butterfly wings being found to the cobwebs to the wall and to the floor at this point. No bat droppings or other indicators of a bat presence was noted to the ground floor of this structure. No access was possible to the upper floor.

A close-up photograph of a floor covered with straw. Numerous butterfly wings are scattered across the straw, indicating a large number of butterflies or a roost.
<p>9.</p> <p>Ground floor building 1 south east corner note butterfly wings to wall..</p>

An Audio Moth detector was placed within 2m of the feeding perch location on the day of the PRA survey and ran for some 6 nights before the batteries failed. No evidence of this location being used as a roost or feeding perch by bats was recorded. Some poor-quality calls were recorded however these were considered to be from bats echolocating close to but external to the structure.

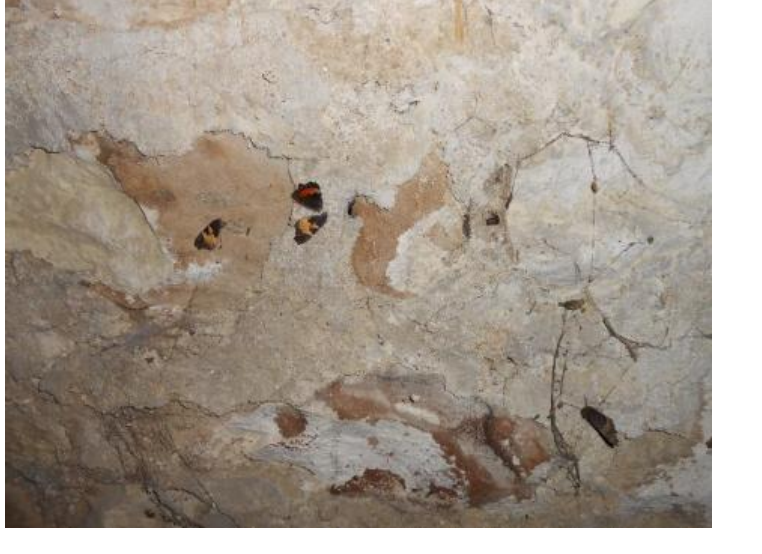
A close-up photograph of a stone wall. Several butterfly wings are attached to the wall, likely due to the insects' behavior or the texture of the stone.

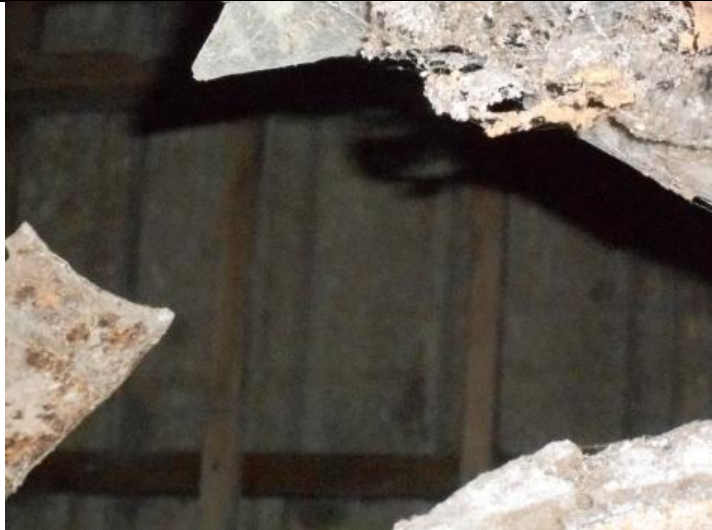
The flooring of the upper floor is in an extremely poor state as a result of water ingress over a considerable period of time and was deemed unsafe to access the upper floor.

<p>10.</p> <p>Looking up through upper floor building 1 rot hole and showing roof to north side.</p>

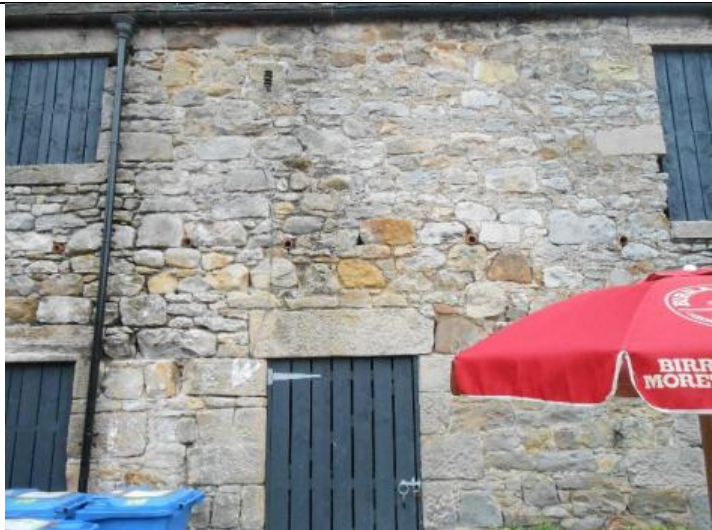
Missing mortar together with a number of holes are evident predominantly to the south facing wall.

<p>12.</p> <p>Showing missing mortar to wall of building 1 south side.</p>

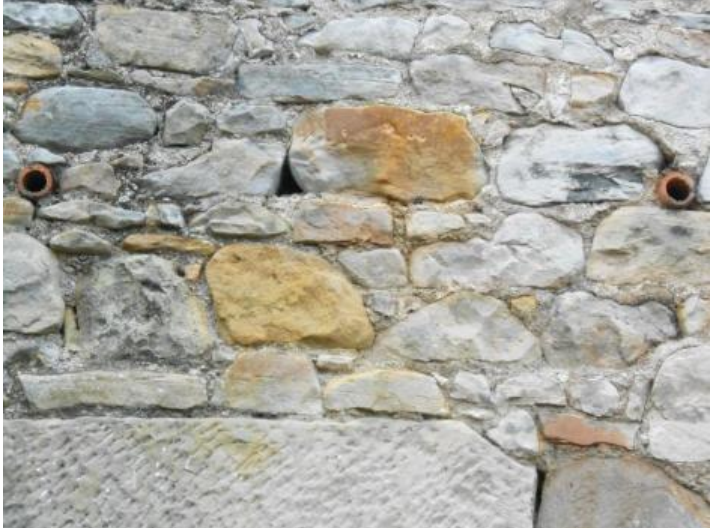
Externally the walls show that minimal maintenance has been undertaken to this structure some stone work is missing to the western side of the south face providing potential access to the rubble infill by bats.

<p>13.</p> <p>Showing missing mortar to wall of building 1 south side a potential roost site.</p>

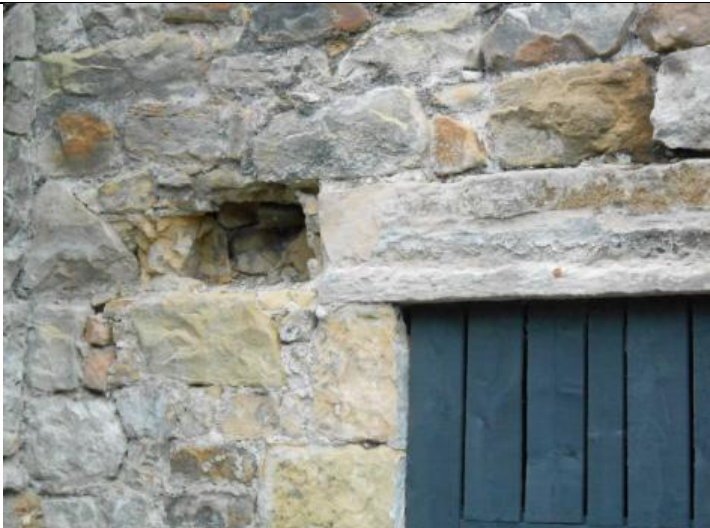
A close-up photograph of a stone wall. The stones are irregular in shape and color, ranging from light grey to yellowish-brown. There is a noticeable gap in the mortar between two stones in the upper center. Two small, circular holes are visible on either side of this gap, one on the left and one on the right.
<p>14.</p> <p>Showing missing mortar and stone to wall of building 1 south side which potentially could allow bats to enter the rubble infill.</p>

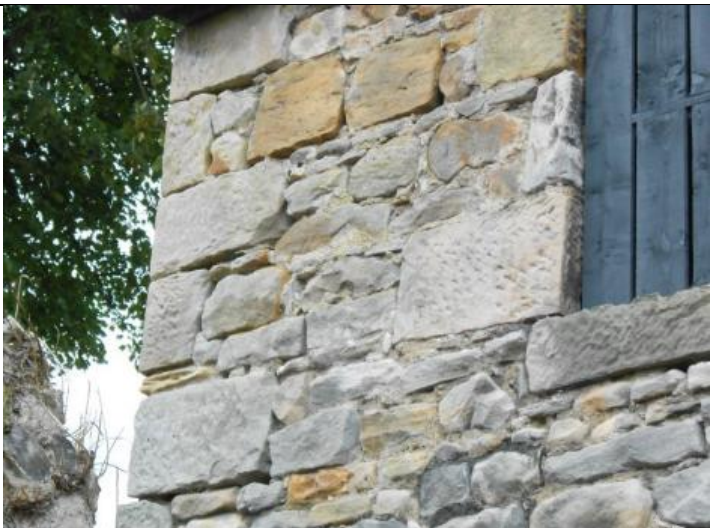
A close-up photograph of a stone wall. The wall is made of irregular stones in shades of grey and yellow. A dark blue wooden door is visible on the right side. There is a hole in the masonry above the door, where the mortar and stone appear to be missing or crumbling.
<p>15.</p> <p>Showing missing mortar to wall of building 1 south side.</p>

A close-up photograph of a stone wall. The wall is made of irregular stones in shades of grey and yellow. A dark blue wooden door is visible on the right side. There is a hole in the masonry above the door, where the mortar and stone appear to be missing or crumbling.
