**WOOLAW FARM,
NORTHUMBERLAND**

**PROTECTED SPECIES
REPORT**

BATS & BARN OWLS

March 2021

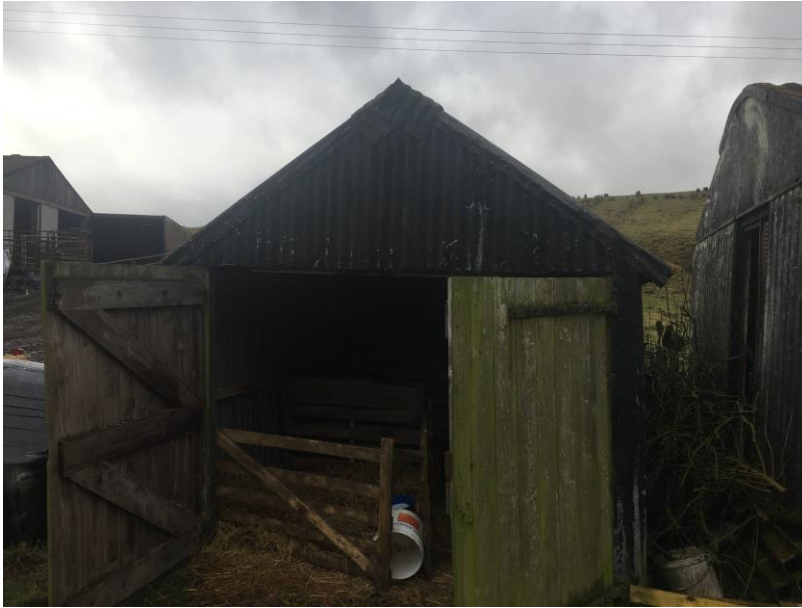
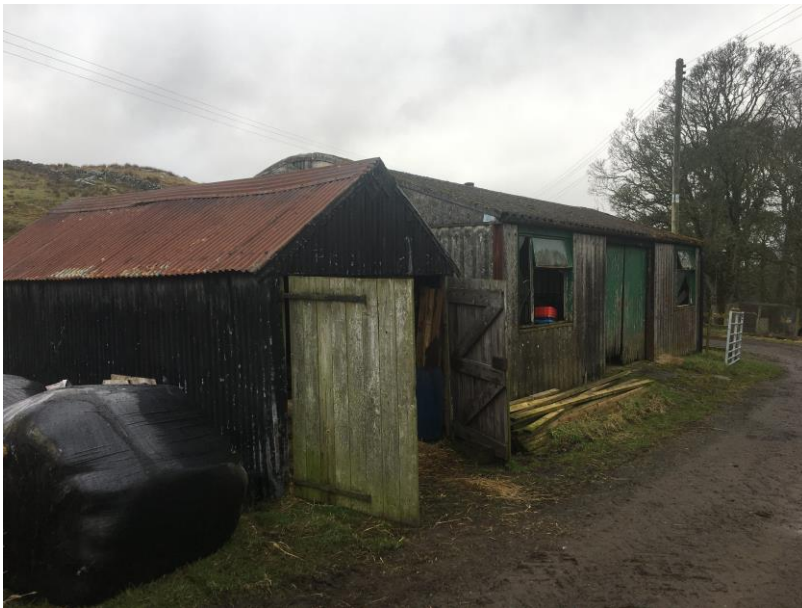
The small corrugated metal shed (Photographs 1&2) is deemed unsuitable for both bats and Barn Owl.

Photograph 1: Corrugated metal shed

Photograph 2: Corrugated metal shed with asbestos shed behind

Both the corrugated metal shed and the asbestos shed are unsuitable for bats to roost in therefore have negligible roost potential.

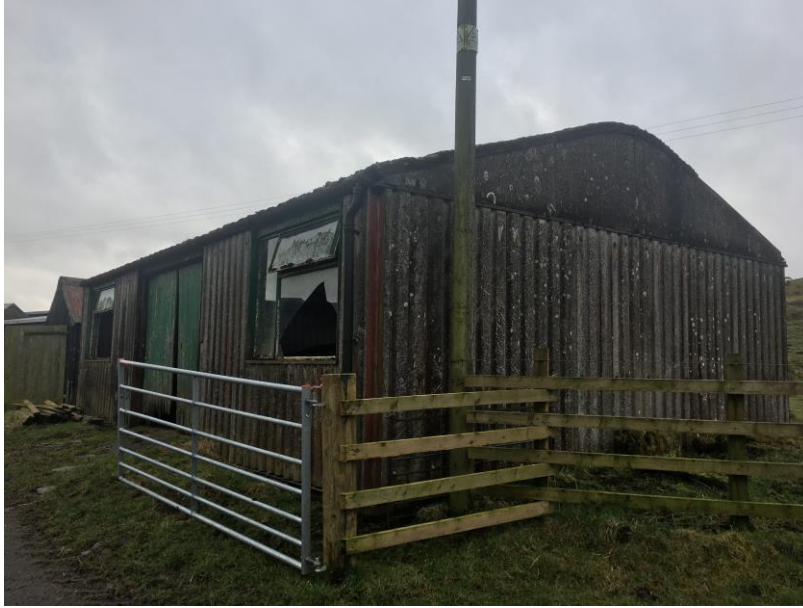
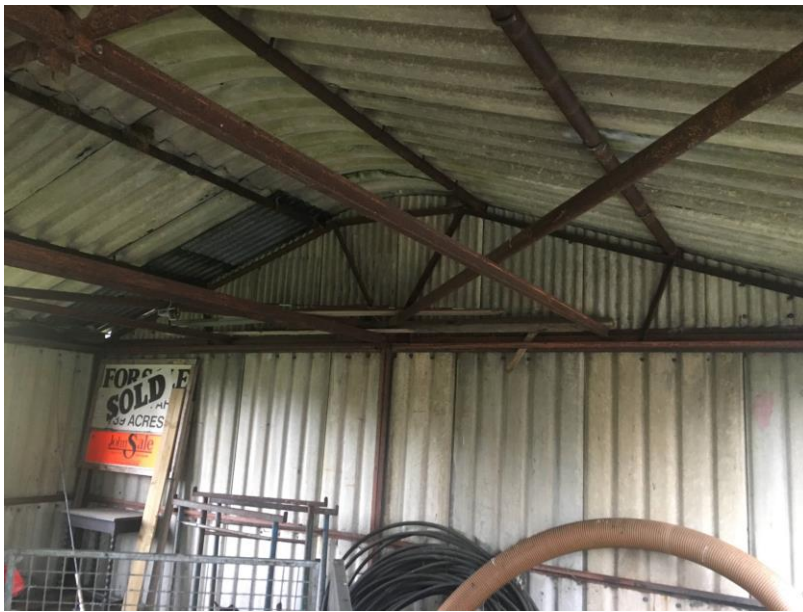
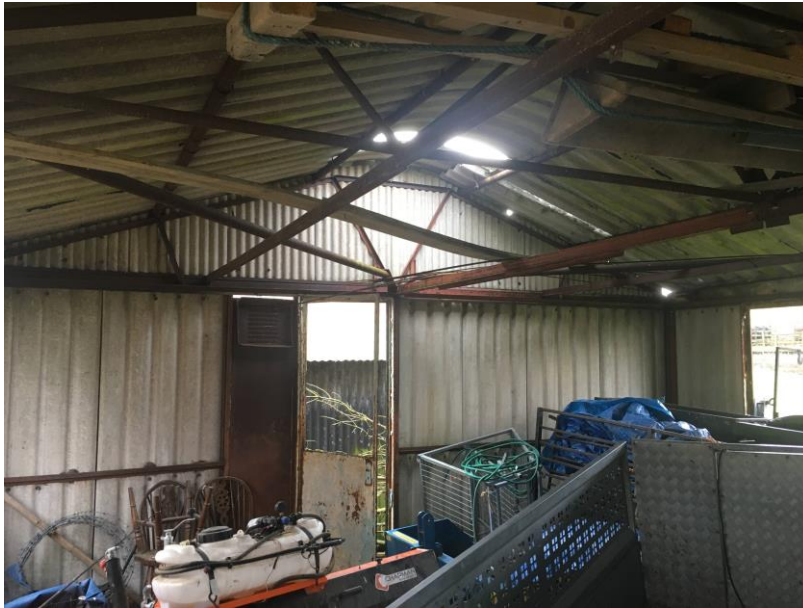
The asbestos shed (Photographs 3-5) is deemed unsuitable for both bats and Barn Owl.

Photograph 3: Asbestos shed

Photograph 4: Interior of asbestos shed

Photograph 5: Interior of asbestos shed

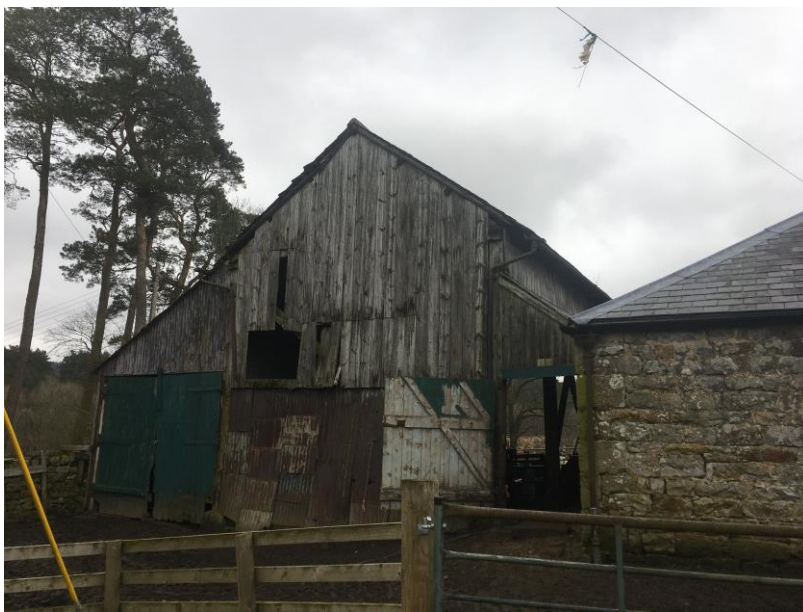
The wooden barn (Photograph 6) potentially is more likely to be more favourable for bats and Barn Owls to use so a careful examination of the structure was undertaken.

Photograph 6: Wooden barn

The wooden barn in theory should have some bat roost potential as wooden structures usually have some areas that can be used by bats. However this structure is in extremely bad repair and the slates in roof are nailed onto thin slats of wood rather than boards, giving bats no opportunity to roost under slates. The roof also has large holes in it and is letting in both wind and rain which makes for quite varied temperature and humidity levels. The roof is also in danger of collapsing more in the near future meaning even more wind and rain getting in. The internal walls and some of the roof are made from corrugated metal which is unsuitable for bat roosting. The only real potential could be the double skinned gable end of the barn. However the distance between the external and internal wooden skin is too large to give bats any roosting opportunity and the internal skin has large gaps between each slat and the external skin also has small gaps letting in wind and rain meaning the gap is not attractive as a roosting option for bats. It is the considered opinion of the author that the wooden barn's structure and current state of repair makes it have negligible roost potential.

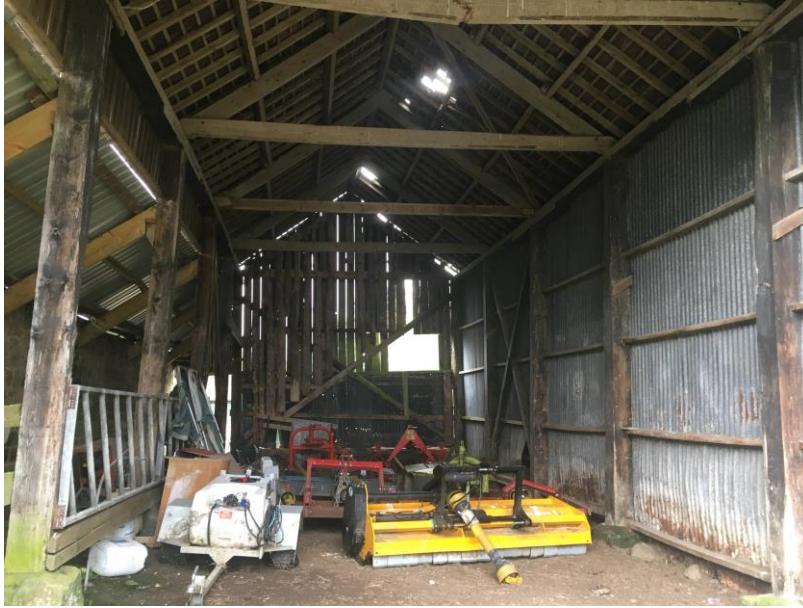
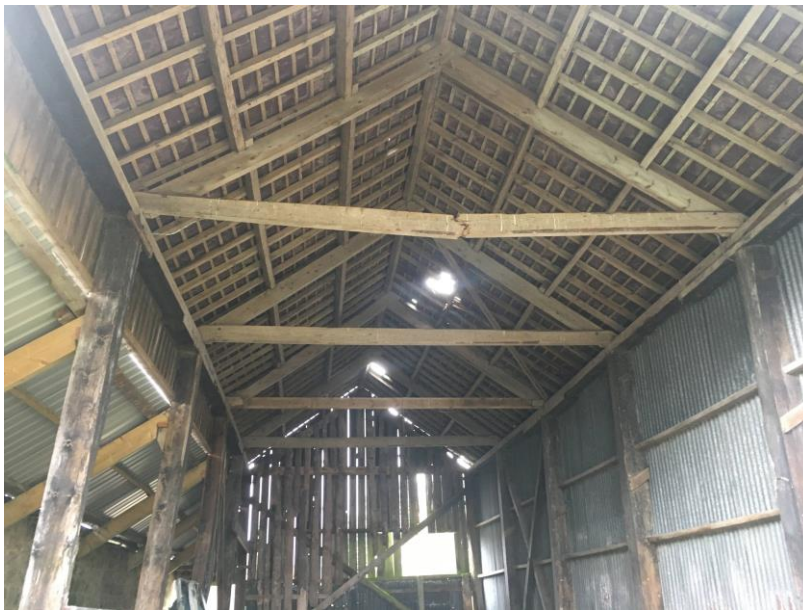
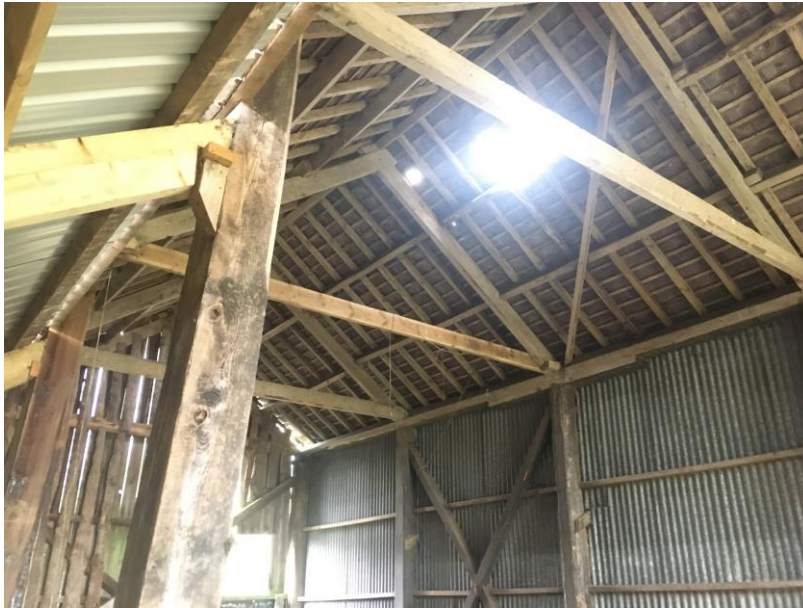
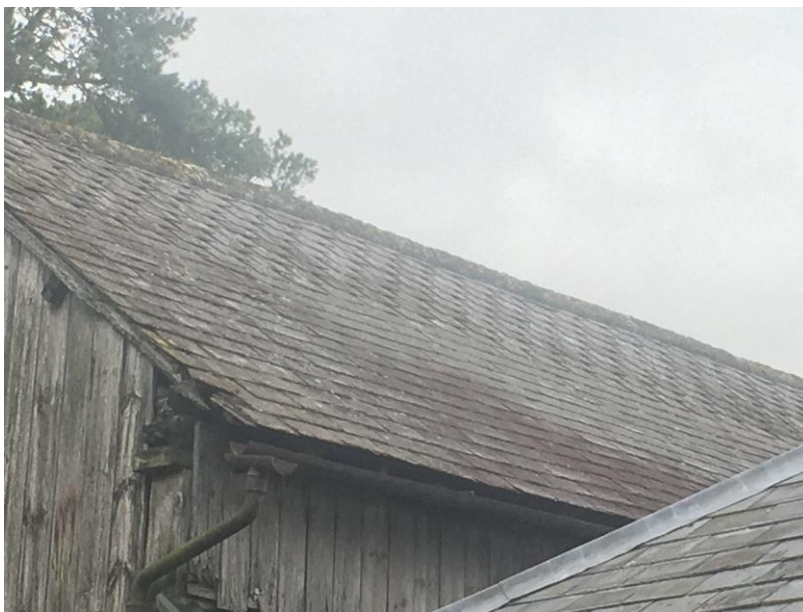
The internal walls and part of the roof is corrugated metal and the rest of the roof is slates nailed onto slats of wood rather than onto boards giving no places for bats to roost. (Photographs 7-10) Some of the slate roof has already collapsed and the author assessed more will collapse in the near future letting in more wind and rain to structure.

Photograph 7: Interior of wooden barn

Photograph 8: Interior roof of wooden barn

Photograph 9: Interior roof of wooden barn

Photograph 10: Exterior of roof of wooden barn

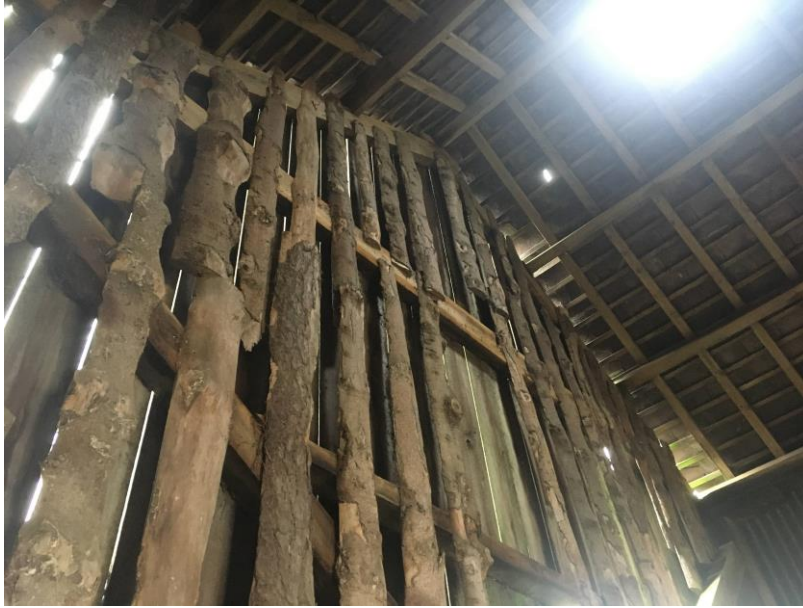
One end of the wooden barn (Photograph 11) has a double skin of wood but with large gaps between internal slats of wood. The author inspected these closely and determined that the gaps between slats and also the distance between external and internal skin is too large to give bats any roosting opportunity.

Photograph 11: Interior gable end of wooden barn

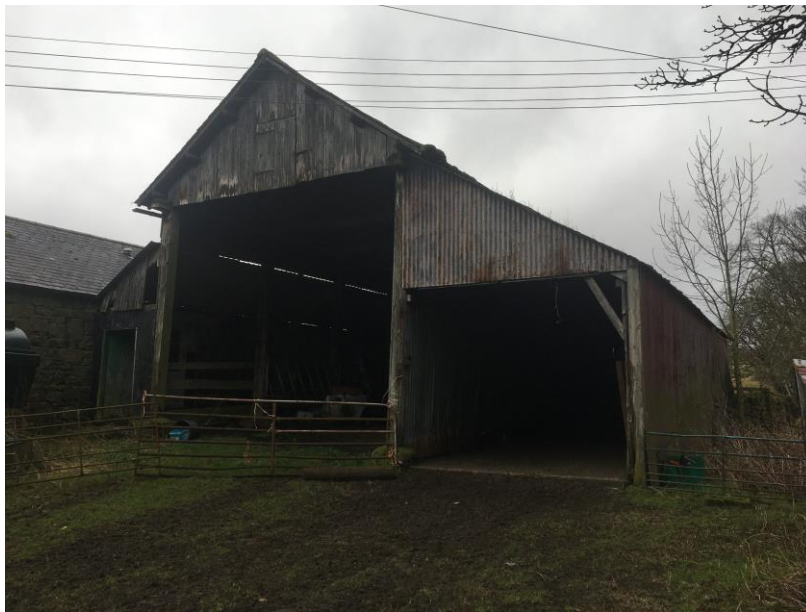
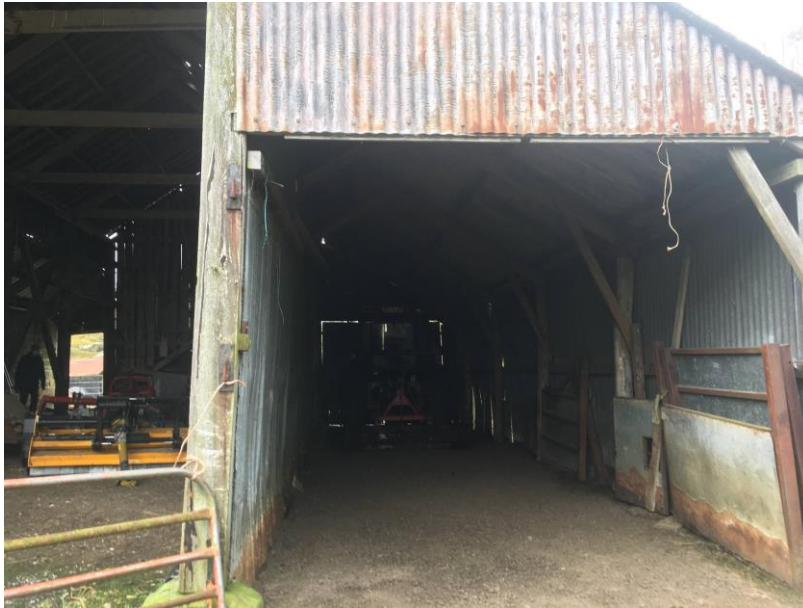
The garage area that is integrated into the wooden barn structure (Photographs 12&13) was also examined closely. The roof is the same slates on slats rather than boards and therefore offered no bat roosting opportunities and the walls are corrugated metal which is unsuitable for bats.

Photograph 12: Separate garage on right that is part of wooden barn

Photogrpah 13: Interior of garage
